2022 Strategic Preservation Master Plan

Valley of the Moon

Enchanted Garden, Cathedral Room & Wizard's Tower Complexes

The Cathedral Complex

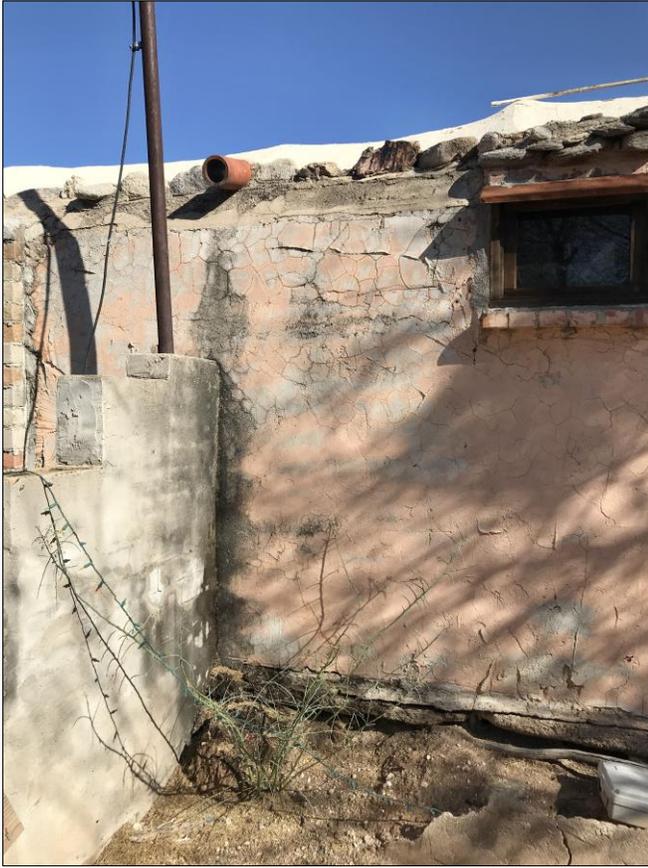
Above: View of southeast portion of exterior. The roof drains to a clay pipe which directs water to the top of the concrete wall and onto the foundation. Water flowing into the lower wall may be contributing to a cavity below the floor (to be investigated).

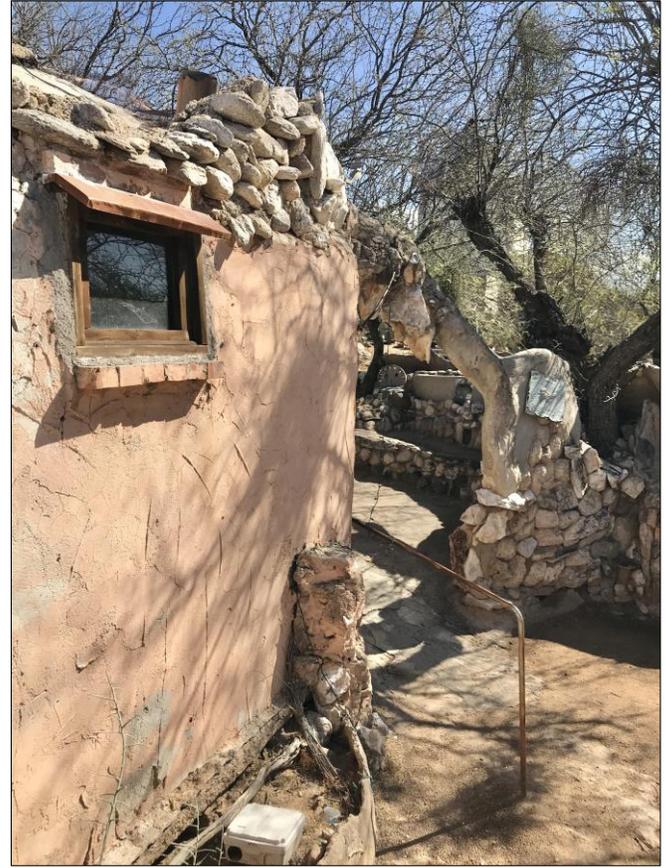
Above: oblique view of southeast corner showing the Dragon's Teeth arch at right. This portion of the exterior concrete wall has been covered with stucco and painted tan color. It would be preferable if the stucco was removed and the concrete wall repaired.

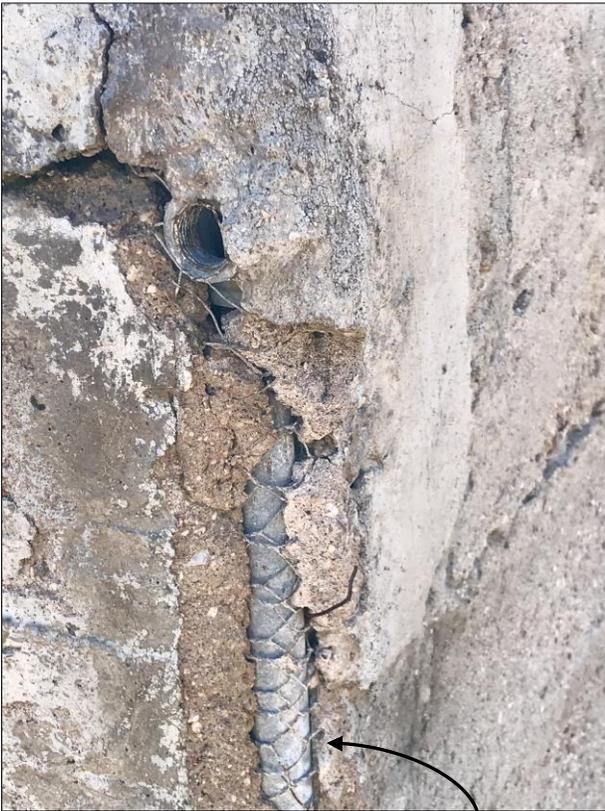
Above: Exterior northwest corner. Exposed is part of the galvanized pipe frame that forms the initial shape and structure of the building. Concrete has exfoliated at the corner and will need to be repaired with suitable a patch.

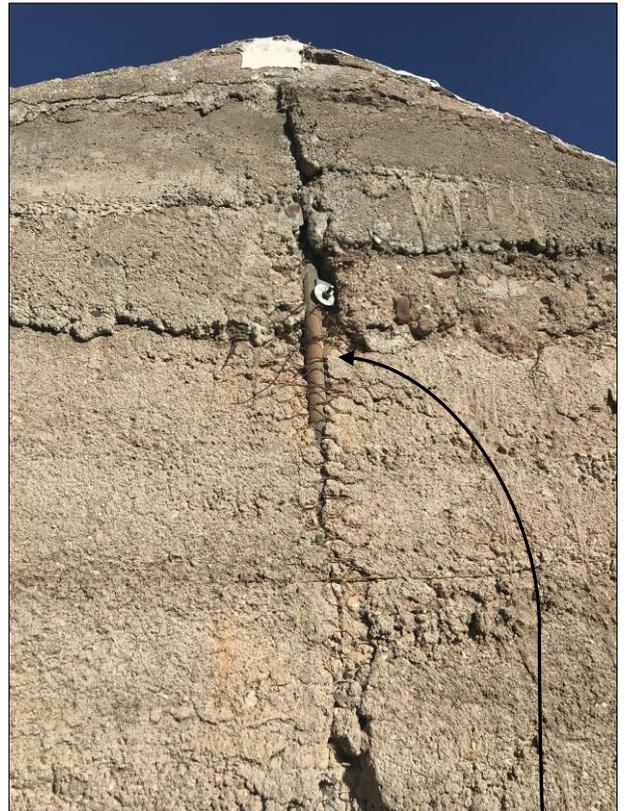
Above: West side wall near gable. The exposed vertical pipe at center shows more of the pipe framework, with chicken wire reinforcing material exposed.

Where chicken wire is exposed, loose ends should be removed, and the remainder treated with a rust converter.

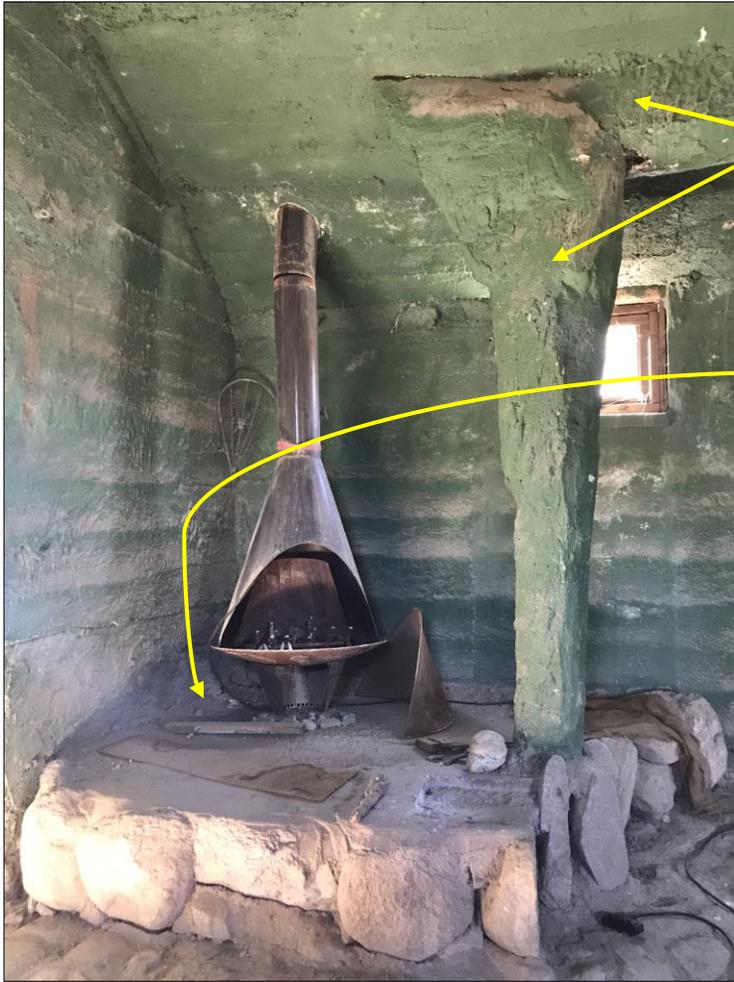
- g) Some of the concrete materials and integral structural systems have "aged out".
- h) The raised concrete floor in the area below the stove is cracked and springy when stepped on. This indicates a void below and must be exposed for investigation, analysis, and repair. At this point a decision should be made about restoring the raised section or removing it. **This condition constitutes an immediate hazard for visitors and staff.**

Left: Stove on raised concrete platform.

- 9) Remove the stove (permanently) and cut into the raised concrete floor to determine conditions.
- 10) Included in this work are two items: (a) Checking the watertightness and treatment of the structure over the stairway entry, which appears as a lower extension of the main room, and (b) restoring the metal castellated roof sculpture located above the west end gable.

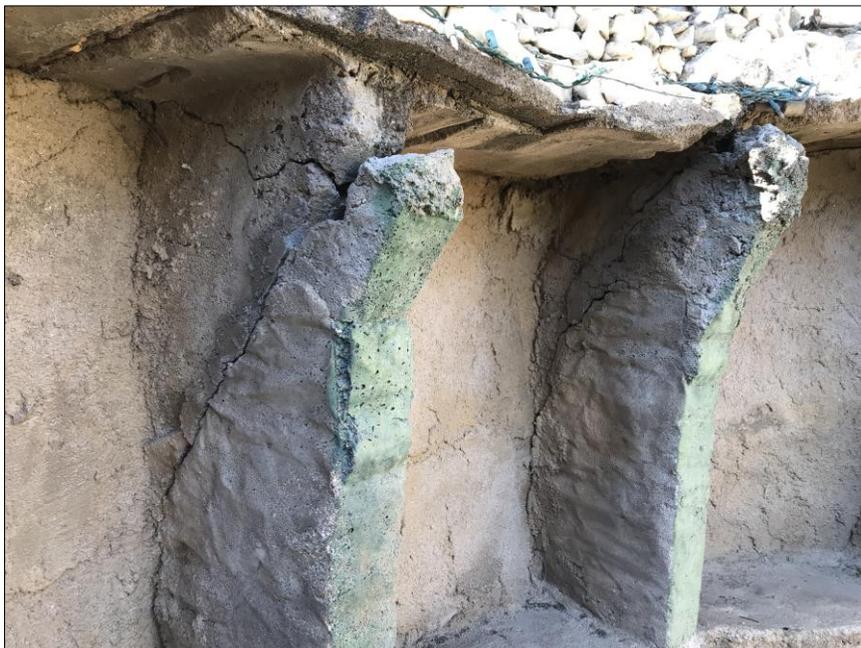
Highlighted buttresses **3,4 & 5** require some repair work due to cracking and material loss.

Left:
Buttress Nos. 5 & 4 showing cracking and delamination from the rear wall structure.

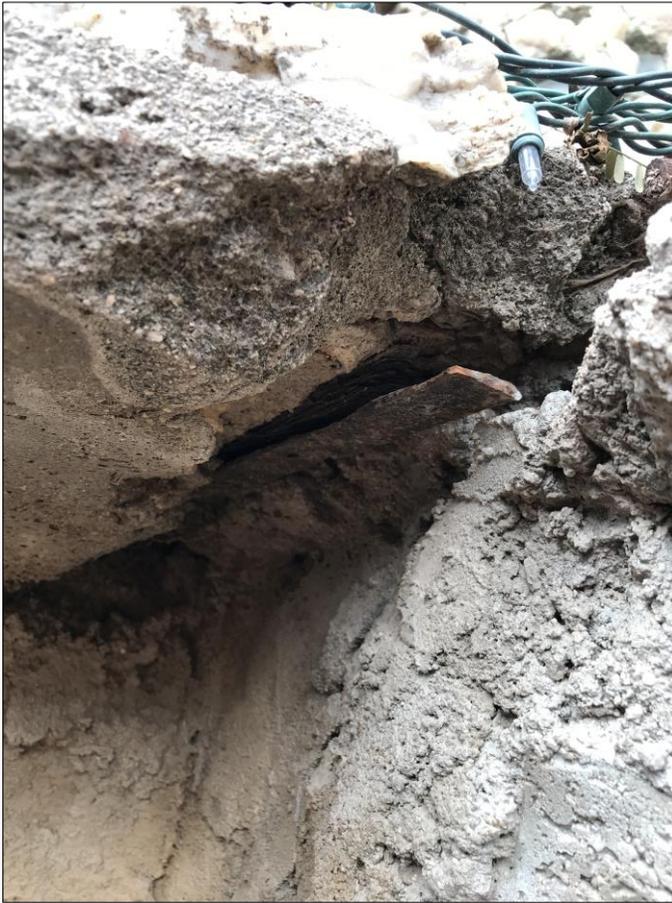
Left: A piece of loosened metal support for the concrete shell next to the top of one of the buttresses.

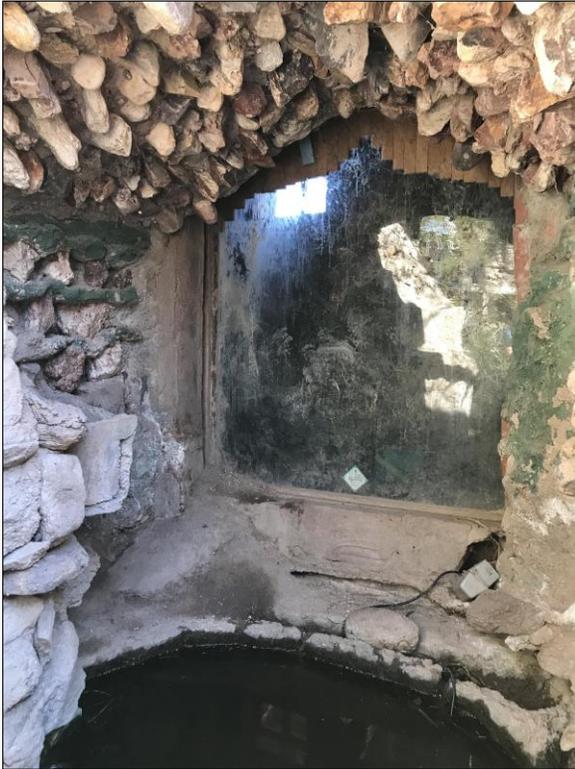
Right and above: Exterior views of the large viewing window, with the pond in the foreground. Electrical cables supporting pond function (pumps, etc.) are visible. Loose soil is being deposited from a gap between the side of the wall and the glazing window frame, indicating rodent activity.

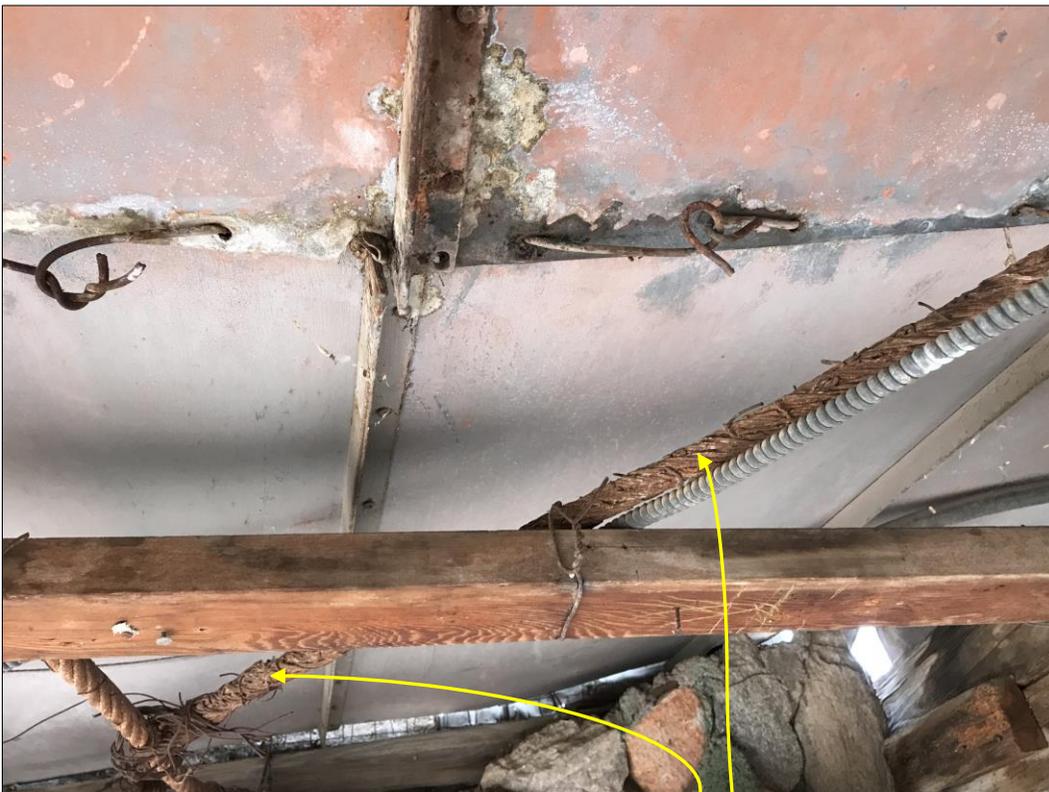
Above: Close-up view of the typical under-floor conditions.

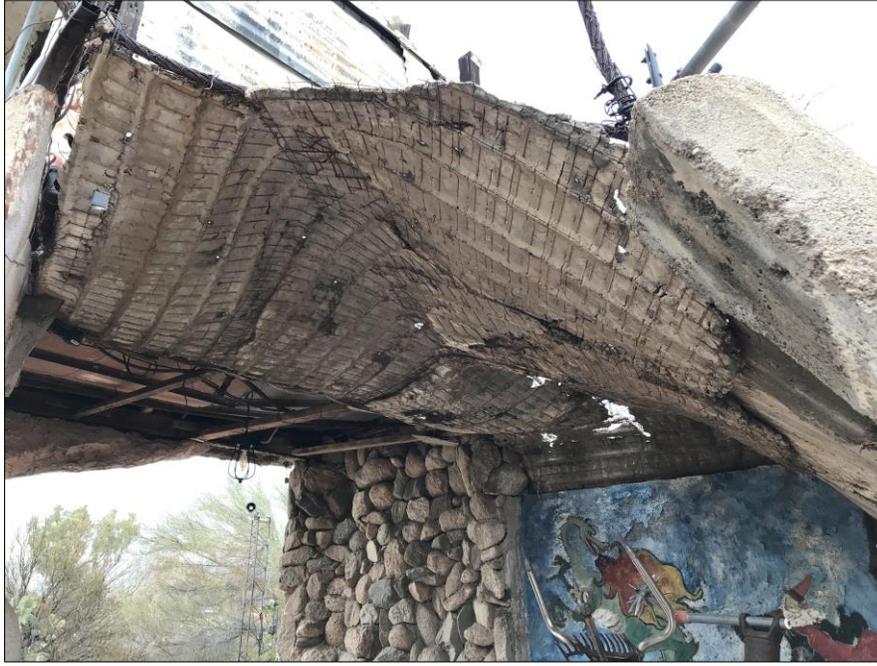
This Page: Views of the roof portion of the thin shell concrete “nave”. The structure is deflecting downward under its own weight and is in a dangerous condition. Many areas of the concrete material have already dislodged and are open to the elements. This portion of the structure should be rebuilt using stronger materials that retain the intended appearance.
