2022 Strategic Preservation Master Plan

Valley of the Moon

Enchanted Garden, Cathedral Room & Wizard's Tower Complexes

The Cathedral Complex

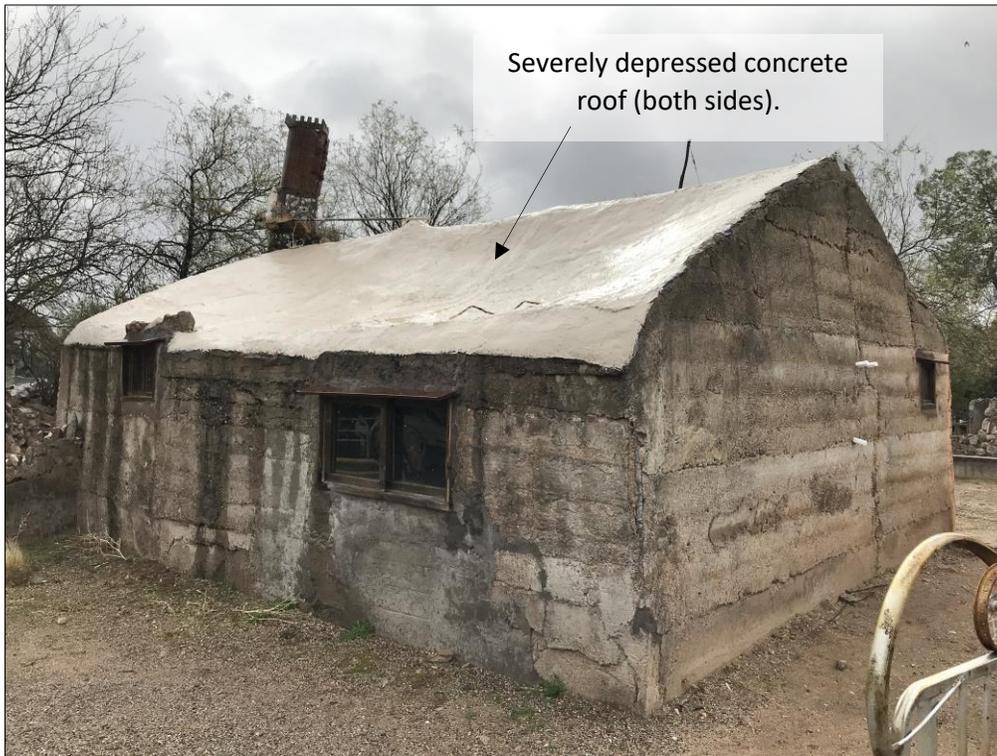
Above: View of Cathedral building looking southwest.

Taken on a rainy day, this photo shows how water drains directly from the roof to and down the walls. Small metal rain-guards over the windows greatly help shed water away from the window frames.

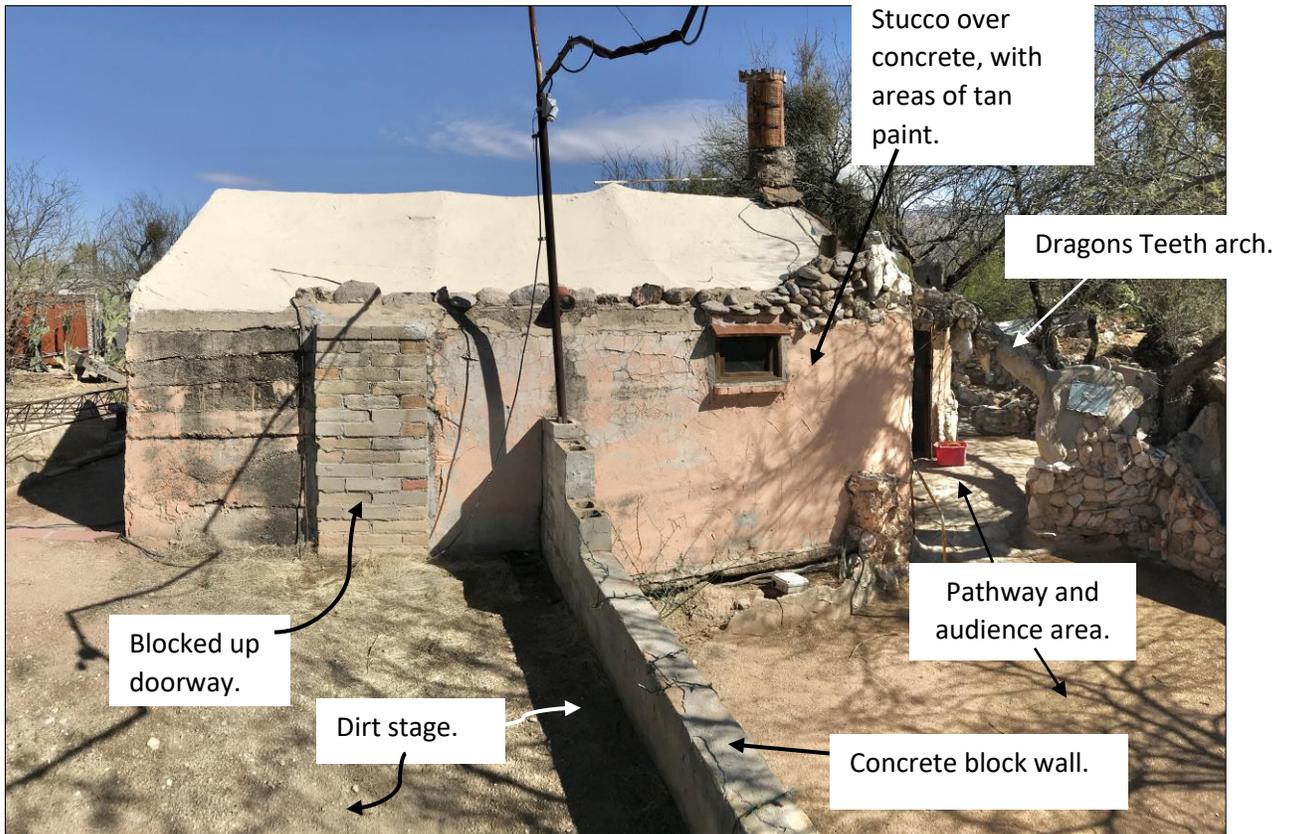
Above: View to the north.

In the foreground is part of the Witches Cauldron raised stage, with the blocked-up doorway at center left.

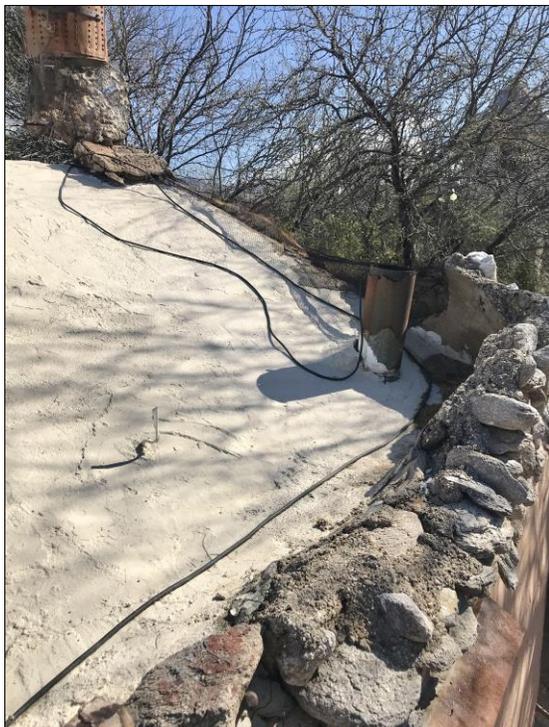
View of the "gutter" system on the southeast part of the roof.

The stones arranged at the edge help direct rainwater to the clay pipe drain. It is likely that the addition of stones came after the construction of the Cathedral building, as problems with water infiltration developed.

The placement of stones along the edge are not a visual intrusion on the very organic appearance of the building, and their extended use may be a good way to integrate a better drainage system at the roof edge as part of the rehabilitation work.

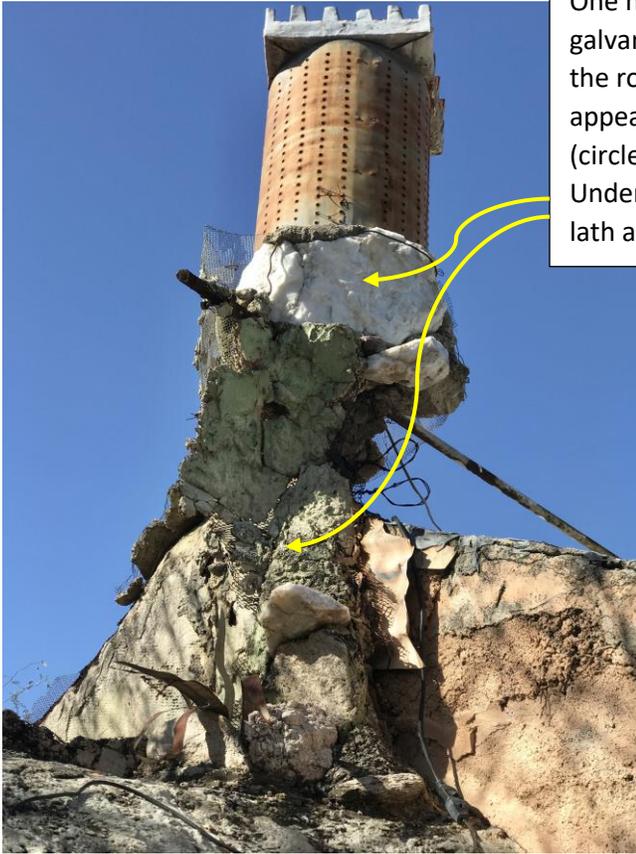
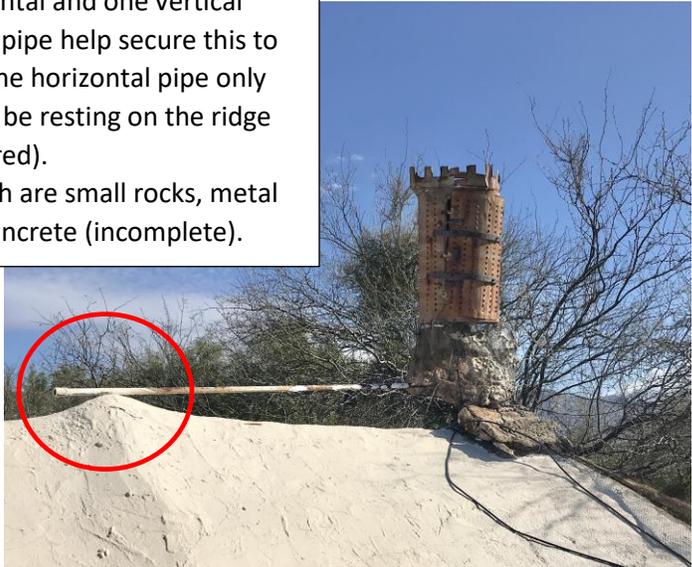
One horizontal and one vertical galvanized pipe help secure this to the roof. The horizontal pipe only appears to be resting on the ridge (circled in red).
Underneath are small rocks, metal lath and concrete (incomplete).

This whimsical structure is known as “**Old Mother Hubbard’s House**” and was apparently relocated to the ridge from an adjacent hillside location. It is recommended a choice be made to either move it back (if a suitable location be found) or make it a permanent part of the building. Either way, the structure must first be removed for roof repairs to take place. Without further examination, it was difficult to determine what was preventing this from imminent collapse.

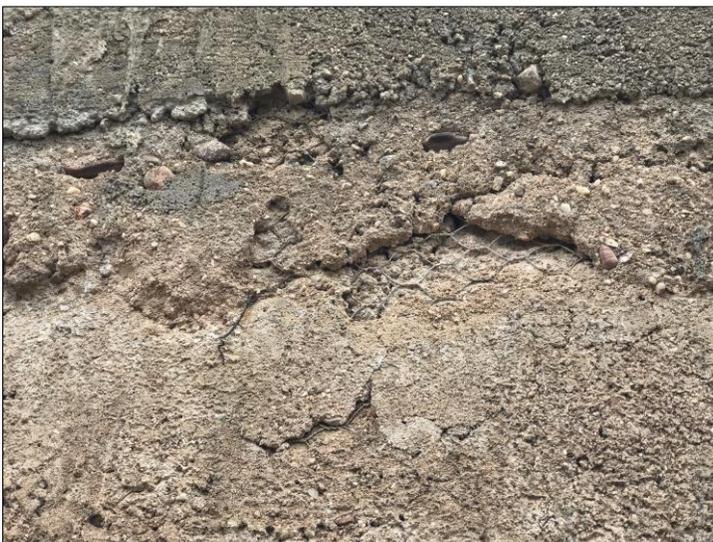
Left: Typical concrete detail.

Where chicken wire is exposed, loose ends should be removed, and the remainder treated with a rust converter.

Where material loss has occurred, a repair patch should be carefully installed to match surrounding historic material.

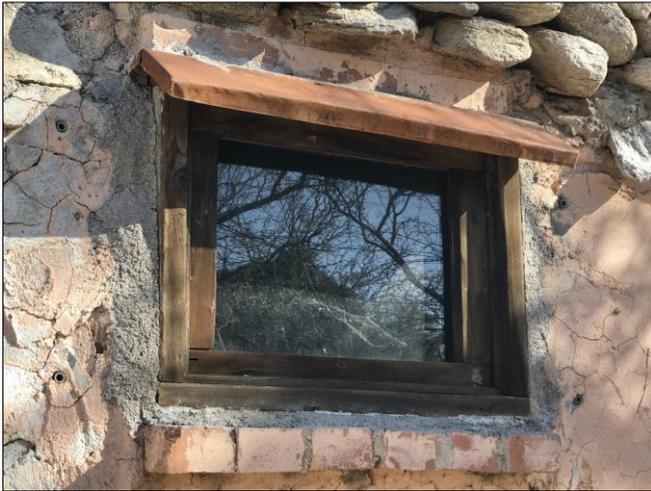
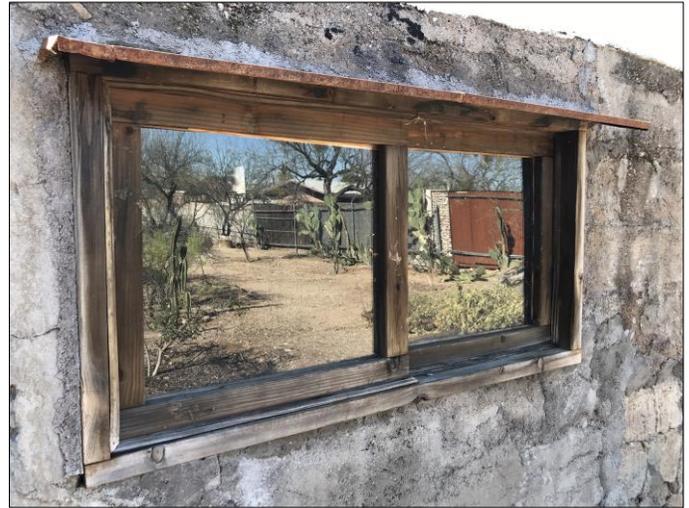
Above: Examples of wood framed windows.

All the windows appear to be of near recent construction, made from 2x material with newer patched-in mortar securing them into the wall. While they are unpainted, they may have been treated with a wood preservative. An additional application of preservative is recommended, along with servicing them for opening/closing. Where joints are loose, remove the sash and repair.

While the metal caps over the windows are not original, they serve an important function of shedding rainwater away from the windows and the building. They should be retained as they also complement the rustic nature of the building.

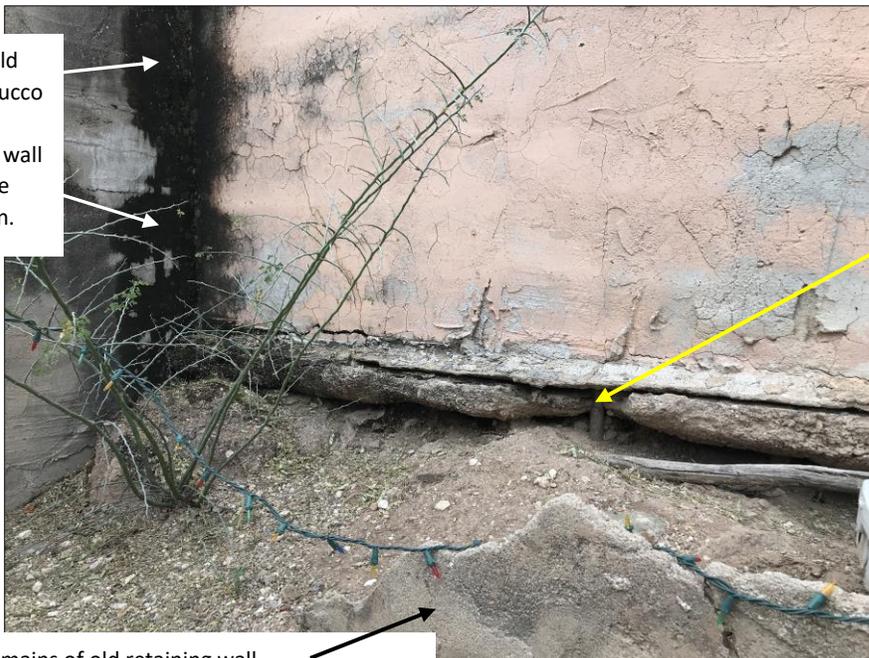
Left: Base of exterior wall near southeast corner.

This shows the section of wall with exposed galvanized pipe and either a concrete footing or old floor. The horizontal crack is evidence of settlement, and above this area on the interior is the fireplace with a settling floor.

After examination and repair, the existing low retaining wall in poor condition should be rebuilt.

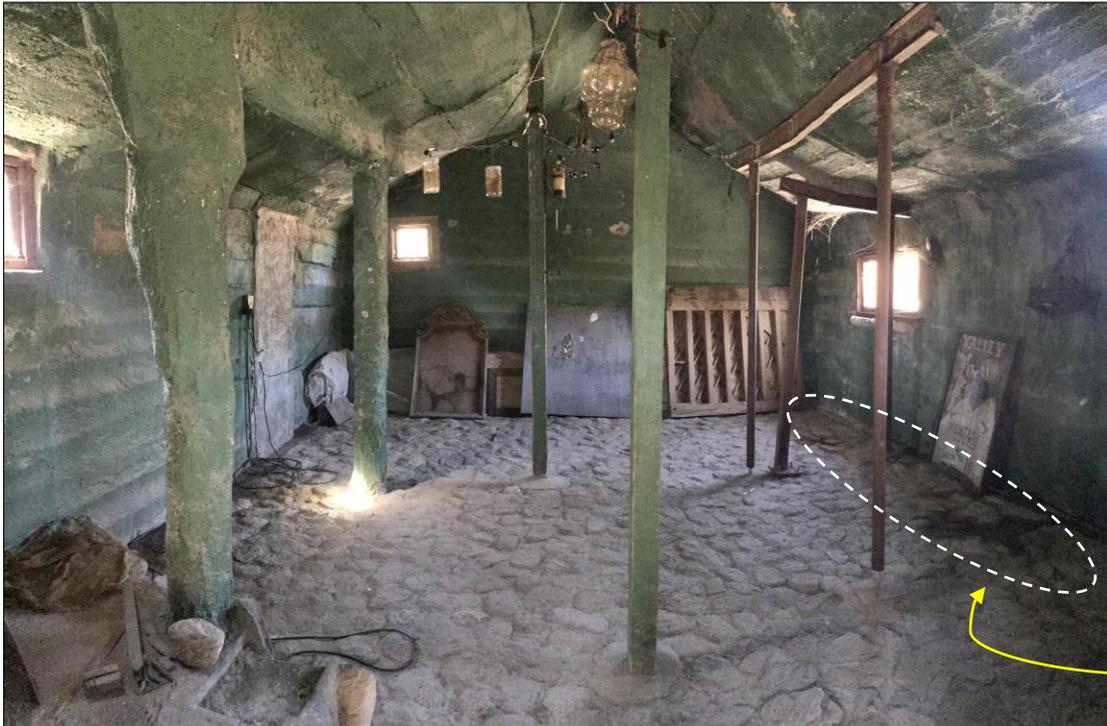
Left: Interior view looking west (from entry).

The eight supports are made from wood and metal, with custom support girders installed to contour the sagging concrete roof.

The floor is stone. Damp areas from recent rain are circled.

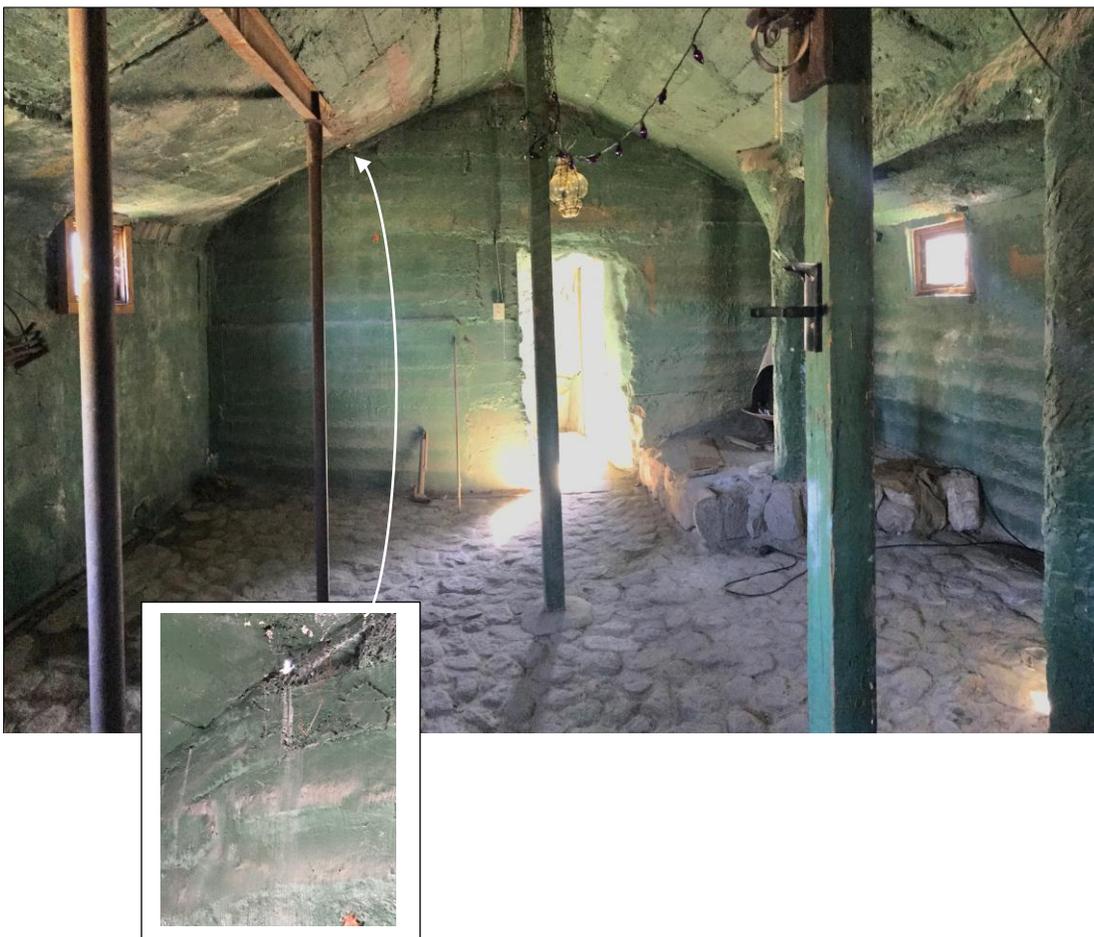
View east toward the entry door.

Inset: a hole at the wall/roof intersection lets light and water in.

A concern of staff has been a separation crack in the floor at the threshold. This should be examined at the same time as the weakened floor below the fireplace.

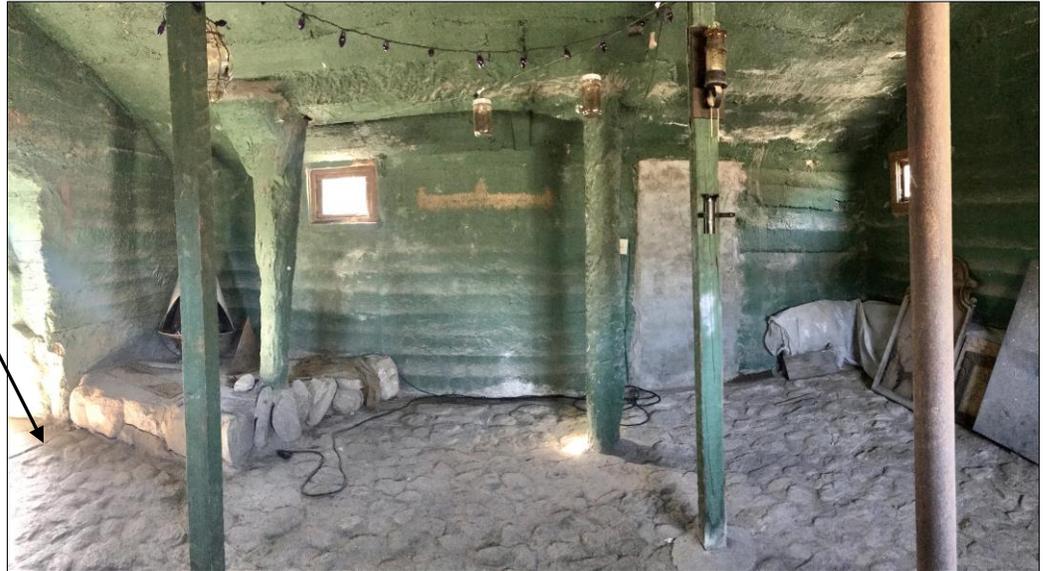
Above: View of south wall.

The two columns near the wall along with the supporting girder at ceiling height have been covered with chicken wire and concrete or plaster. This was an attempt to “hide” the supports. The other posts and girders are not disguised.

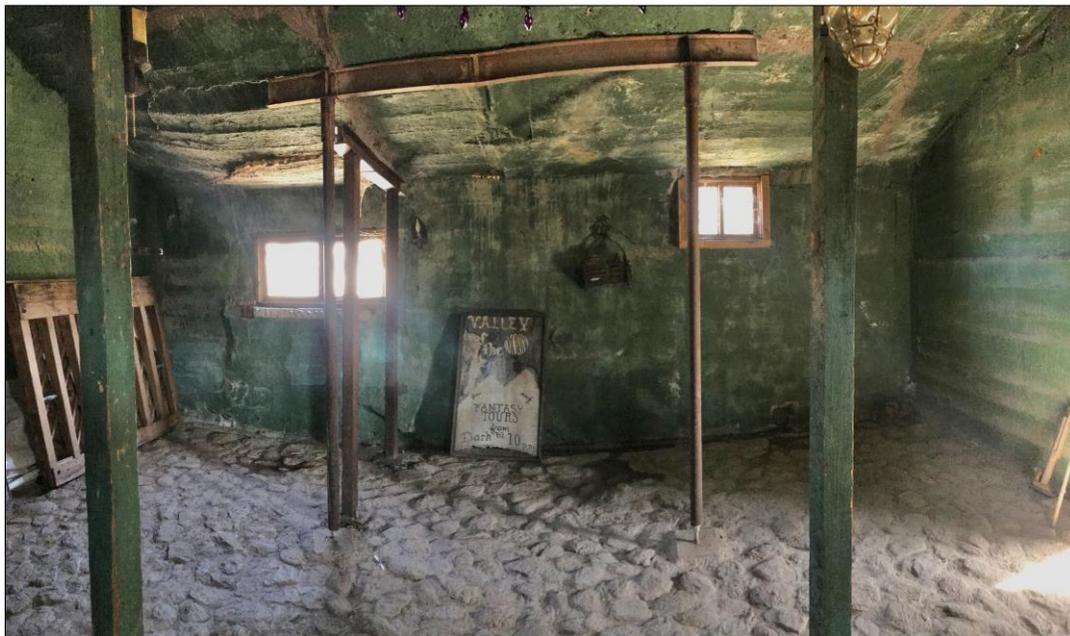
Above: View of north wall. The sag of the roof on this side is more severe, with a downward deflection of approximately 17 inches within a length of 21 ft. – 6 inches.

The interior space is severely compromised due to the profusion of supporting posts.

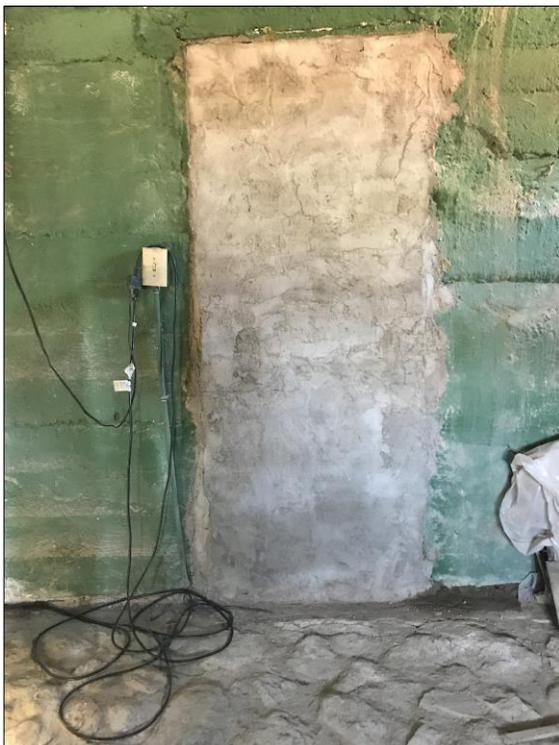
Left:
South wall showing the bricked-up entry.

Enclosed after the interior was painted a dark green (paint removal to bare concrete recommended), the 32-inch wide x 6 ft-6-inch high opening exits to the Witches Cauldron performance area.

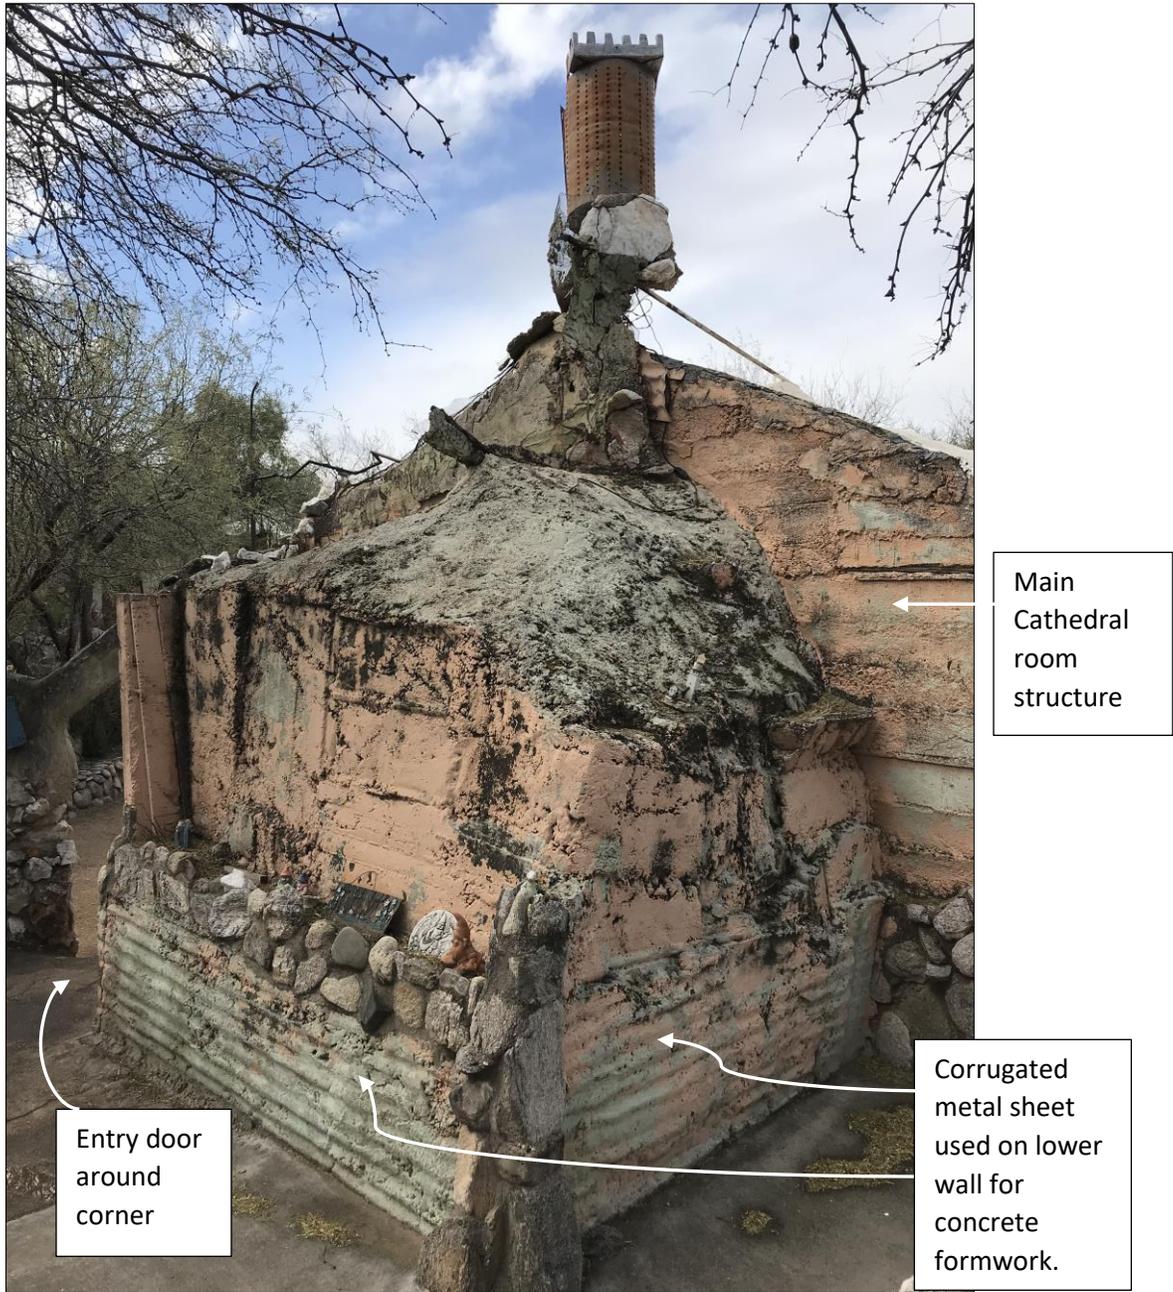
Above: Entry Vestibule, view of northwest corner.

During any repairs, it will be important to maintain the strong textural character of the building, including the entry vestibule.

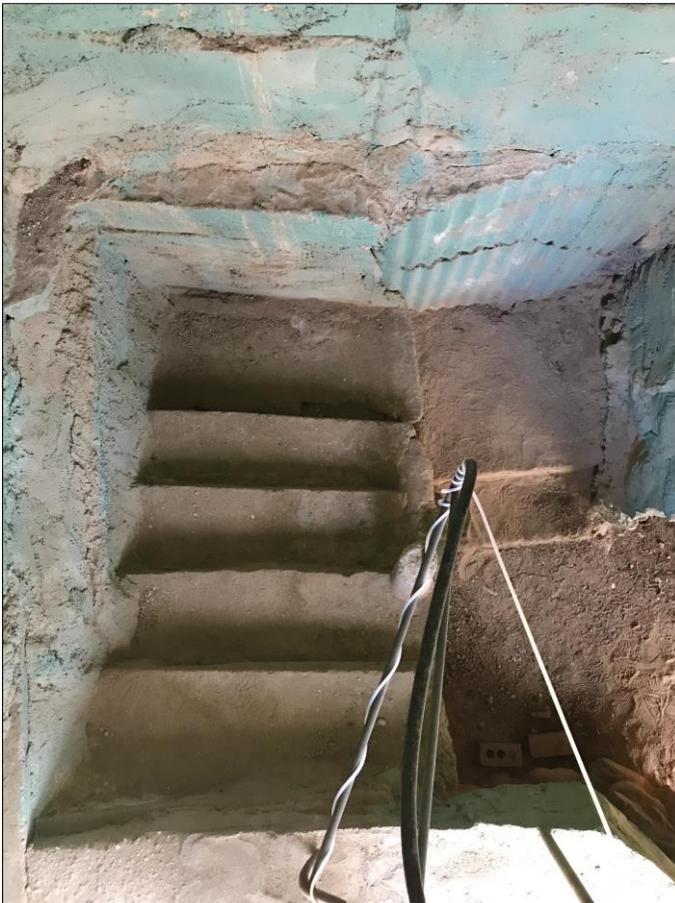
Left: View looking down the stairway.

Each step is different in size and height, requiring the user to pay attention. While some might see this as a safety hazard, this aspect of many built features at Valley of the Moon is one of its chief attractions, allowing the visitor a sense of adventure and experiences outside of "normal" everyday life.

The varied shuttering technique will be enhanced with the removal of the green paint.

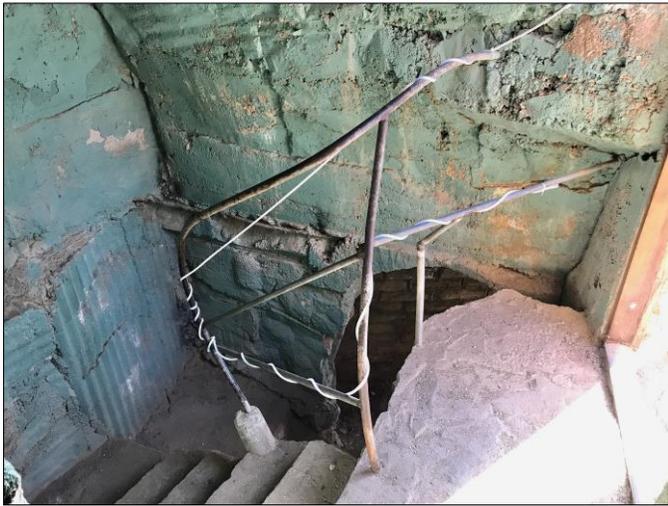
Above: View of the stairway with entry door at right.

The decorative metal pipe handrail provides an adequate barrier in most situations and should be retained. The cast concrete support on the second step is not original but is necessary for stability.

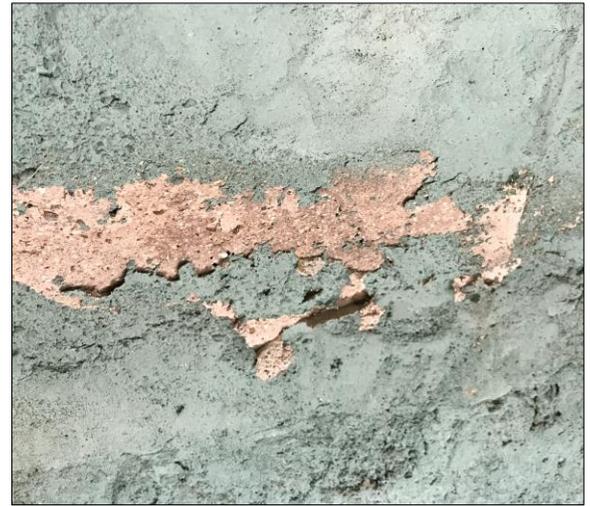
Above: Detail of delamination of paint from the concrete surface in the vestibule ceiling.

The exfoliation seen here is evidence of water entering the concrete roof structure and migrating to the inside. Internal pressure pushes against the less-porous paint causing loss of both paint and concrete. Removal paint will help the system breathe, and greatly improve the appearance of the space.

Some surface repair is likely, but only removal of the paint will allow for a full inspection.

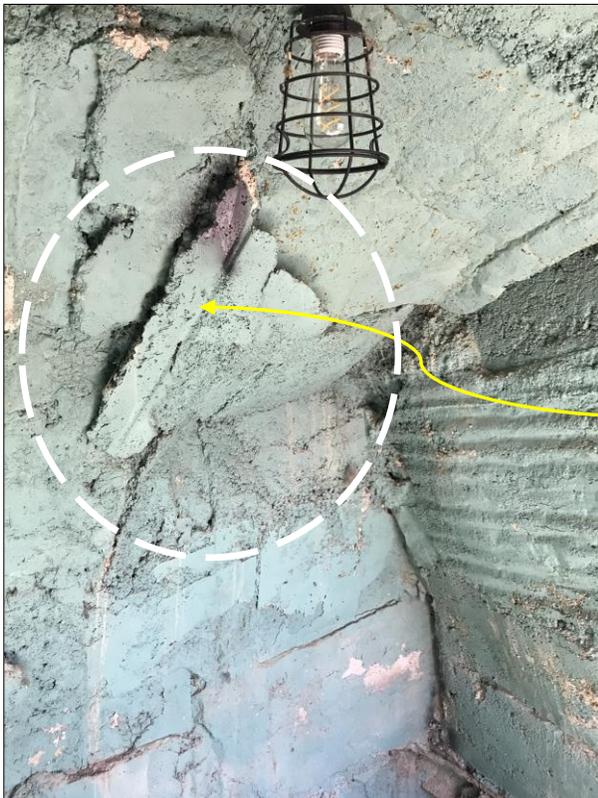
Left: View looking over the stairwell to the wall and ceiling curvatures.

A portion of the sloped ceiling concrete work appears to have shifted over time. This will need further examination to determine if this is connected to a structural problem.

The lighting fixture illuminates the interior vestibule. The electrical supply cable runs through a hole in the concrete ceiling which also allows water through. The fixture should be replaced with a properly wired fixture of more suitable design.

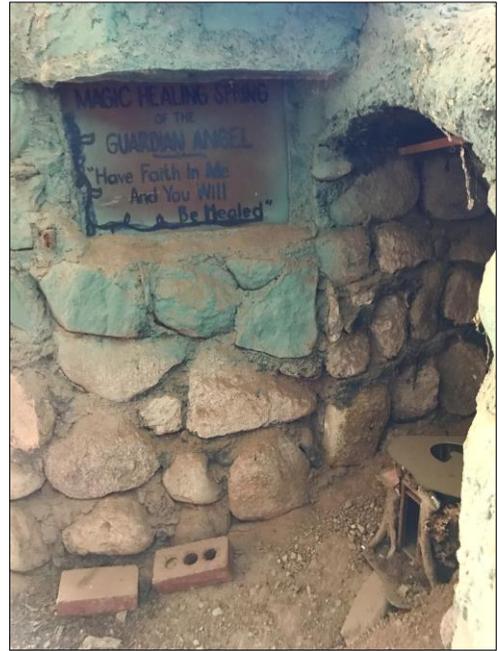
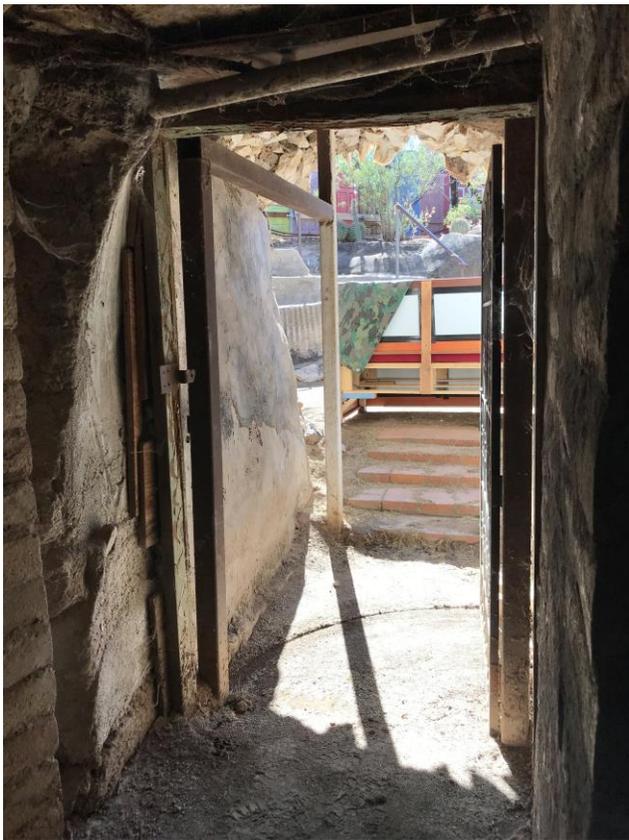
Above and below: Two views of the nook under the stairs. The area needs to be cleaned out and a small accent light installed.

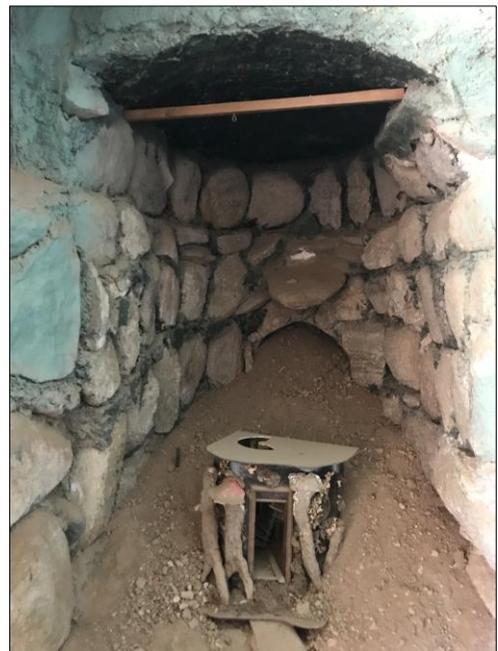
Above: View looking out southwest to the Pennyland performance area. A door once stood here, but only the rotting wood door frame remains.

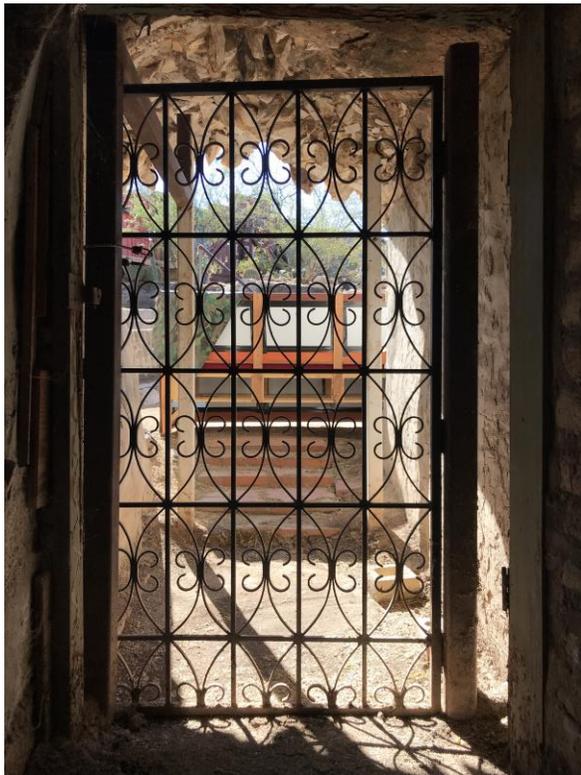
Left: View from inside the passageway with the security gate closed.

The metal framework is independent of the stone and concrete passageway. The gate does not properly close and will need adjustment.

All metalwork should be sanded, primed and re-painted.

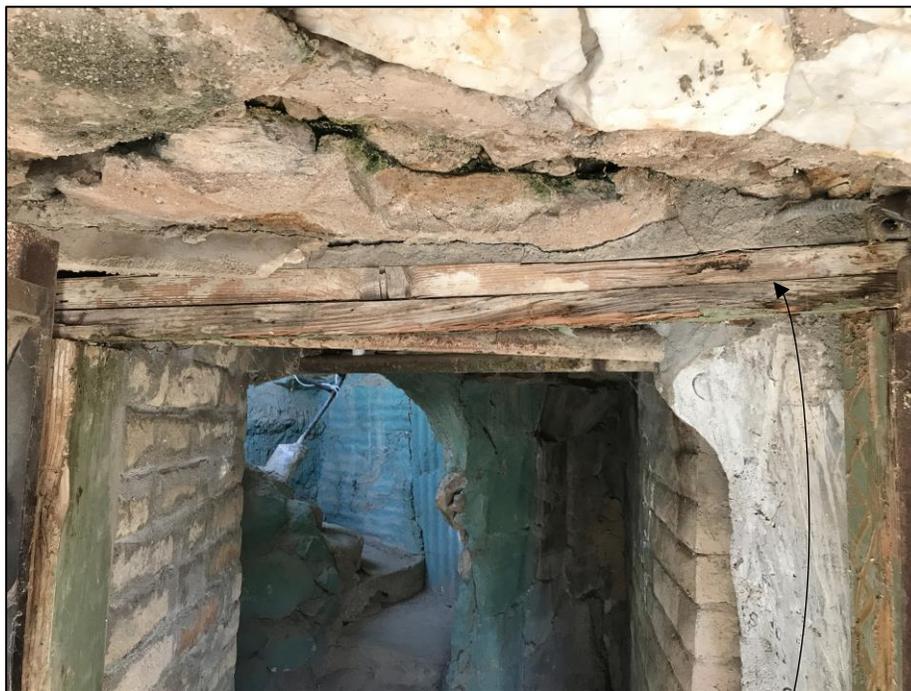
Above: View toward the stairway showing the ceiling at the old door frame.

Some re-mortaring of the stones is recommended. The wooden frame is rotten and should be replaced with a frame of treated lumber, including a new sill/threshold. A new rustic wooden door needs to be installed that will prevent entry of animals and rodents. This will help make the building more secure and sanitary, and cut down on cleaning and maintenance.

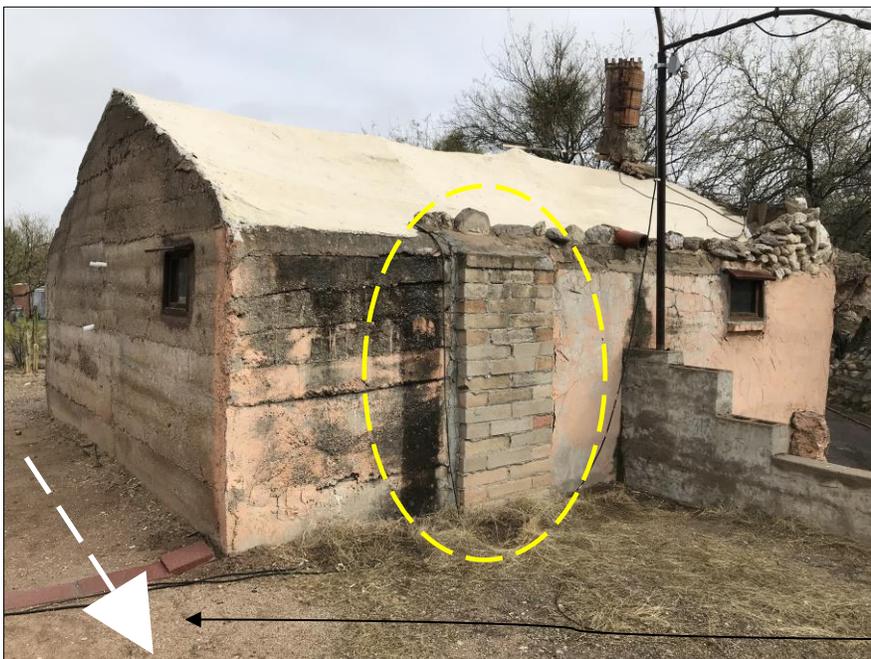
Although it is unclear if this doorway was original to construction, it was roughly bricked-up in the past for reasons unknown. The burnt adobe bricks appear to match those used in the nearby entry passage to the Enchanted Garden, so it is possible the work dates to a similar time frame (thought to be the 1970s or 1980s).

Left: View of south façade with the bricked-up doorway (circled).

It is recommended this doorway be restored by removing the adobe brick and installing a frame and door. Doing so carries several potential benefits for programming events at Valley of the Moon:

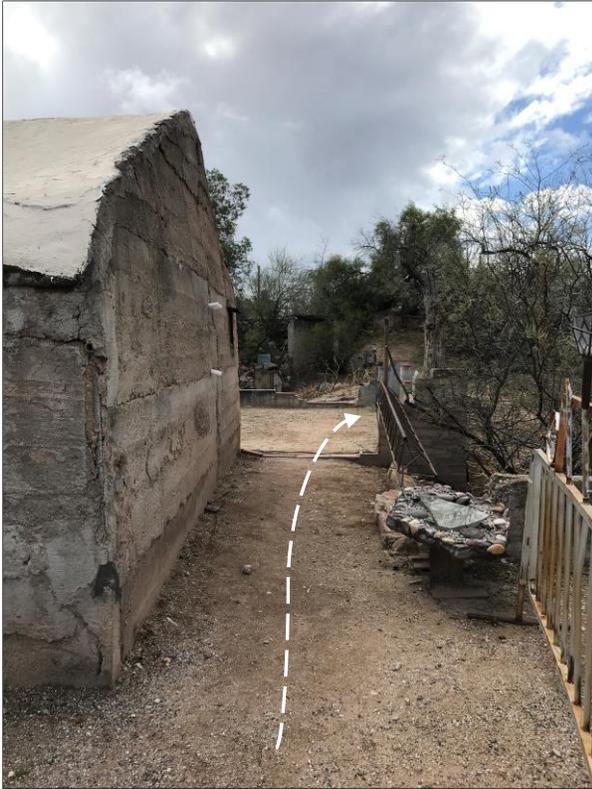
Above: View south showing existing pathway between the east wall of the Cathedral building and the unused pit (at right).

This pathway will form part of the proposed new ADA pathway to the Enchanted Garden (dotted white line).

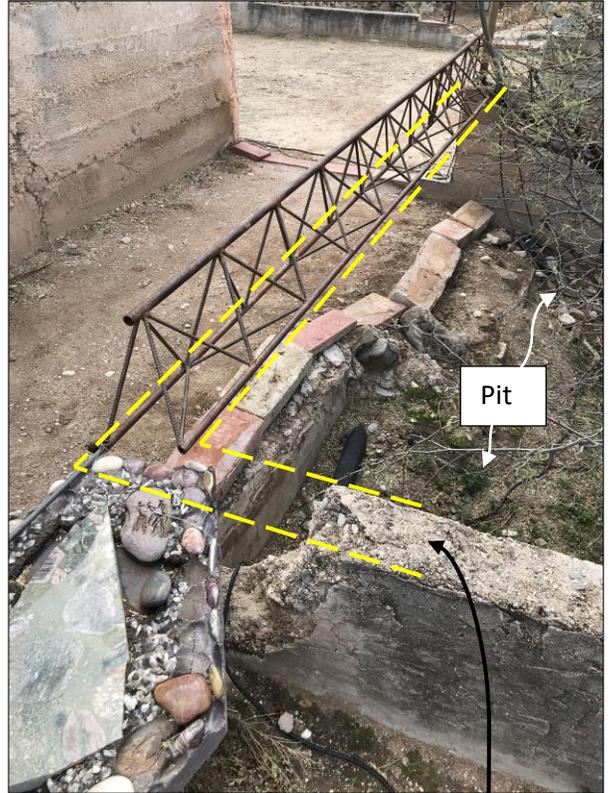
Above: Detail of the pathway.

The existing concrete wall should be repaired in formed concrete and extended to the south, replacing the deteriorated brick edging. Approximate location of top of new wall shown as yellow lines. The metal girder was placed there to prevent people from falling into the open pit at right, which needs to be cleaned-out and properly landscaped.

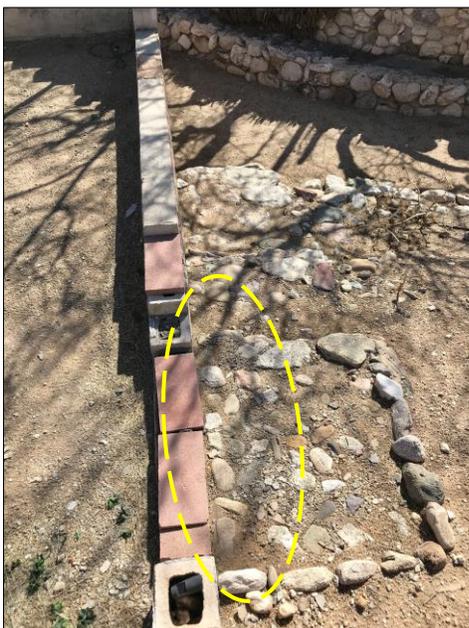
Left: View looking down on the stone steps aside the stage.

These need to be rebuilt and integrated into a re-contoured landscape which also integrates with the new pathway. Additionally, the access through the block wall at left needs to be repaired and properly integrated with the stage area (circled in yellow dotted line).

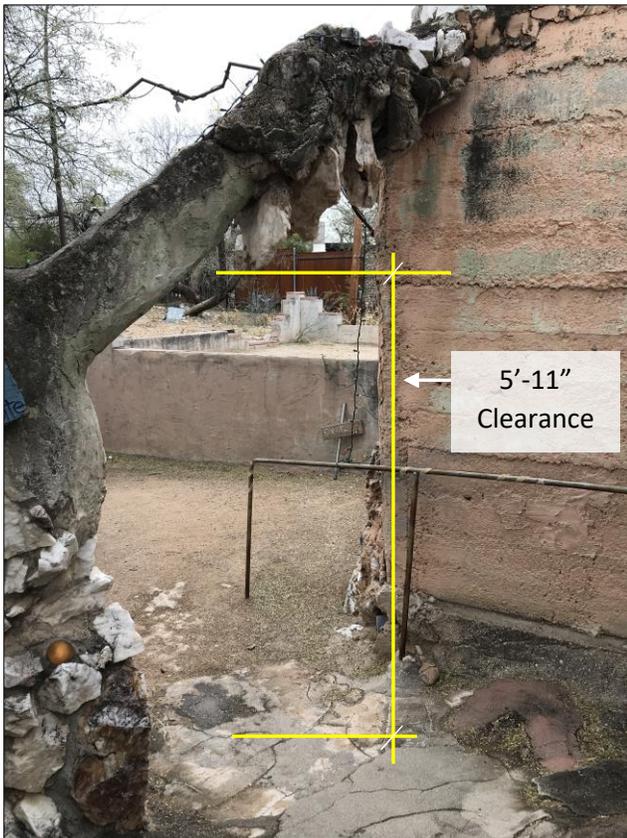
This feature has a clearance of just 5'-11", making it potentially hazardous for tall individuals, especially at night. The potential for injury from this feature is a concern, as the jagged rocks hang down to head-height. While no injuries from this hazard are known, it is recommended this feature be reconstructed at a safer height. This was also the recommendation of the 2008 report by the architectural firm of Burns Wald-Hopkins Schambach (p. 29) which states:

Above: Dragon's Teeth arch view to southeast.

The minimum measured head clearance under the arch was 5'-11", making the arch too low for safe passage of taller persons.

"The Dragon's Teeth will require additional investigation to ascertain the original materials used and requirements for supplemental support. We recommend that it be taken down and then reconstructed, and somewhat higher to provide better clearance."

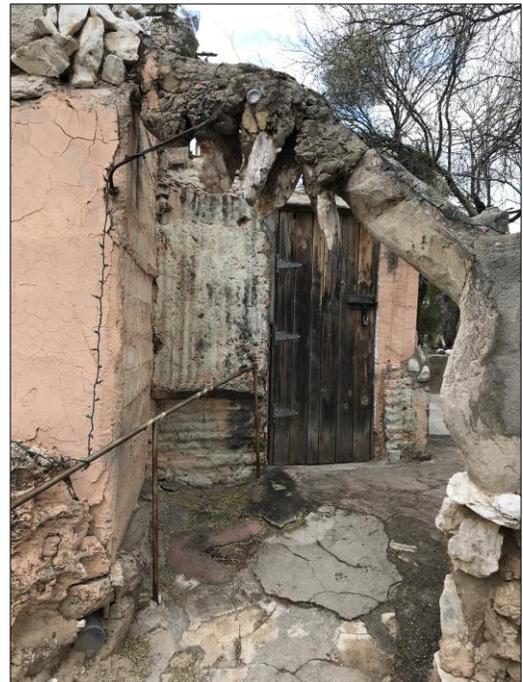
Above: Dragon's Teeth arch view to northwest.

It should be noted that the slope of the pathway through the arch is steep and does not meet ADA requirements. Changing the slope by lowering the grade is not possible as below the concrete lies the passageway to Pennyland performance area. See the section on accessibility improvements (p.38).

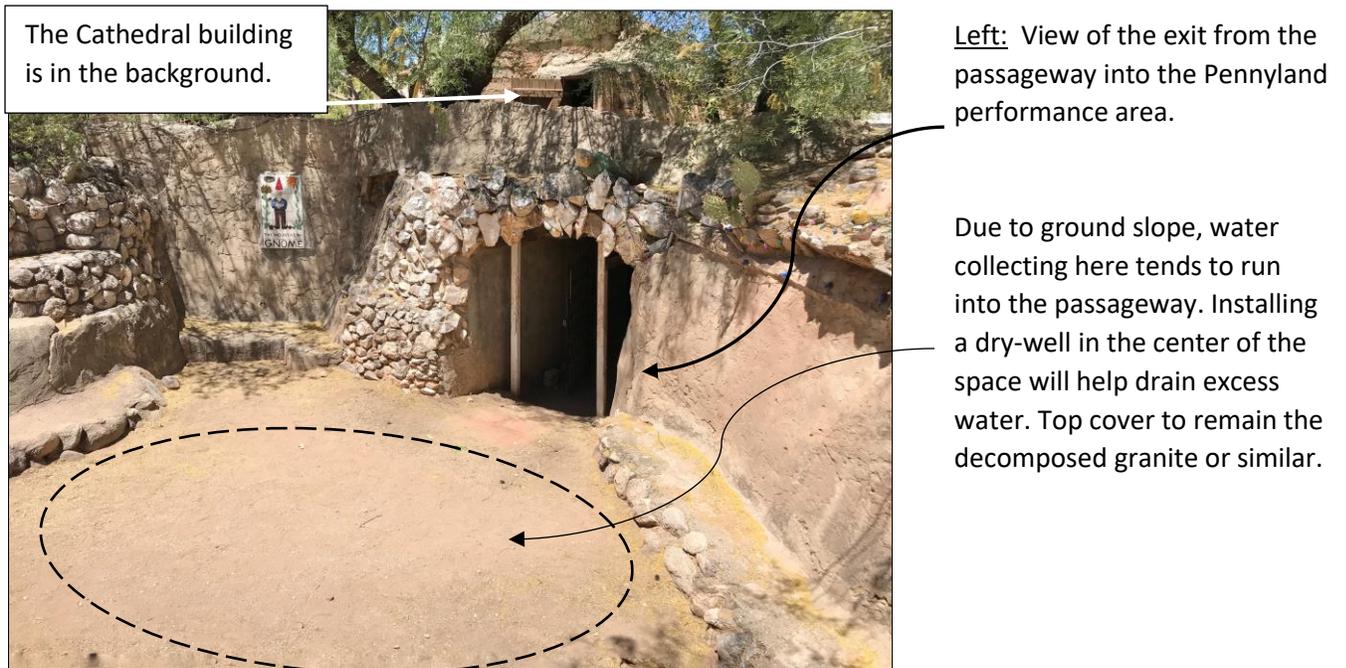
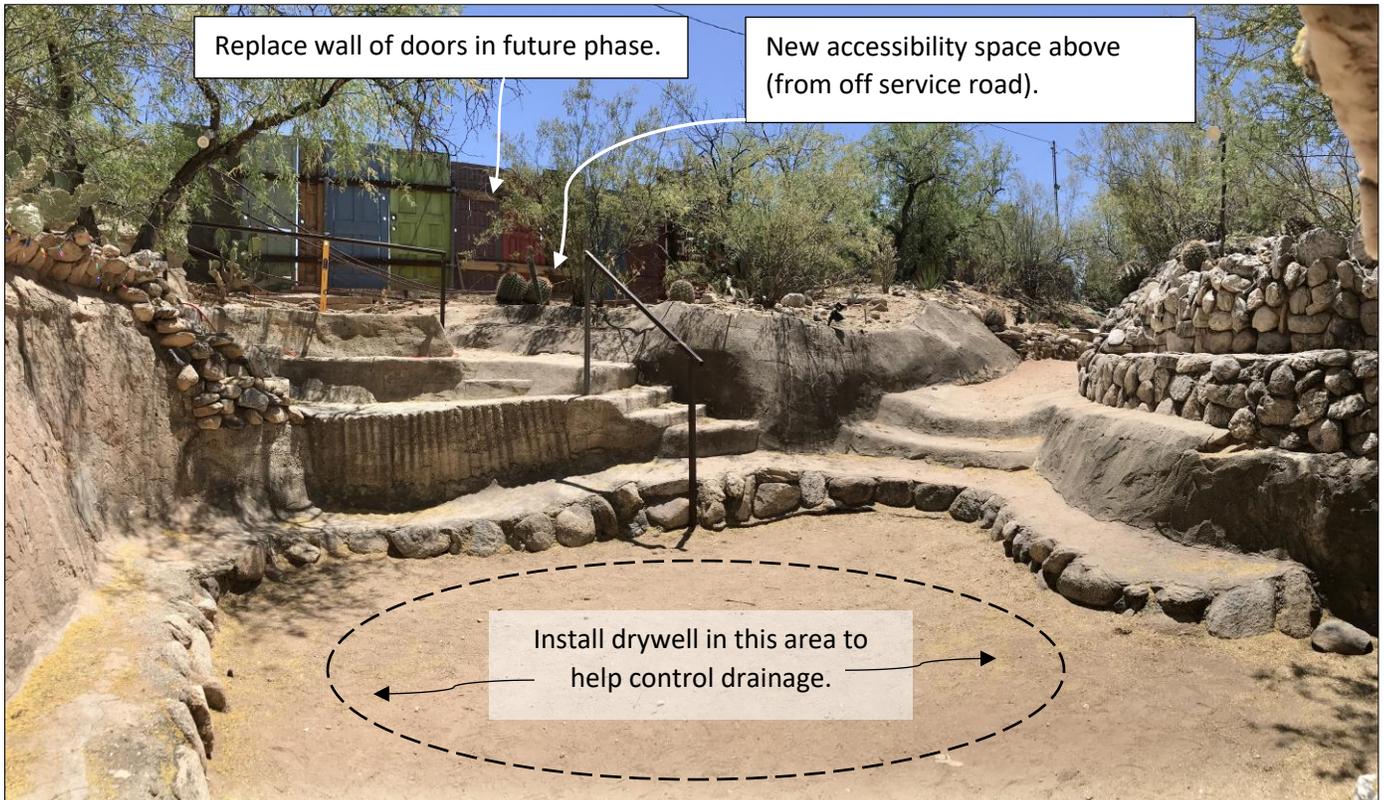
Above: View of the Pennyland amphitheater with the organic seating and steps (from passageway exit).

Some repair work to the concrete seating area will be needed, with material replacement or consolidation where cracking has occurred.

The line of painted old doors is intended to shield views beyond the amphitheater, but a more suitable long-term solution is recommended, especially with the proposed accessibility improvements. The use of masonry walls and combined with native vegetation is recommended for a proposed future project.

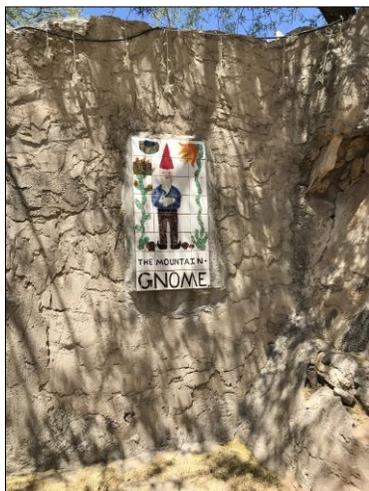
Left: Tilework art piece to left of exit from passageway.

While well-intentioned, this art piece is not original to the space and is distracting. Its removal is recommended and the wall behind restored to blend with surrounding finishes.

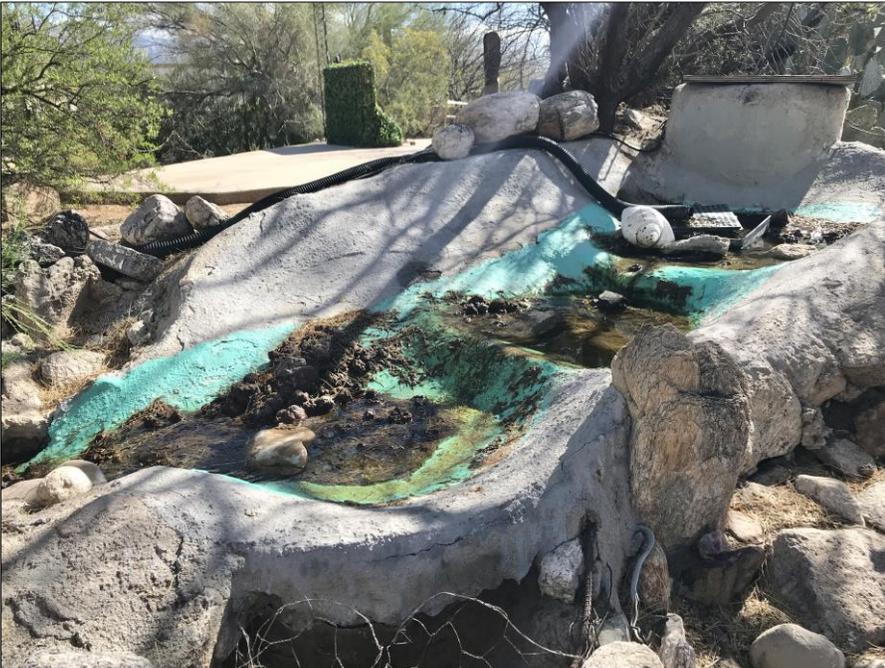
Left: The waterfall feature.

The placing and setting of more rocks around the spillway would enhance the feature while also hiding some of the waterlines and mechanicals.

The color of the paint is distracting and should be changed (color TBD).

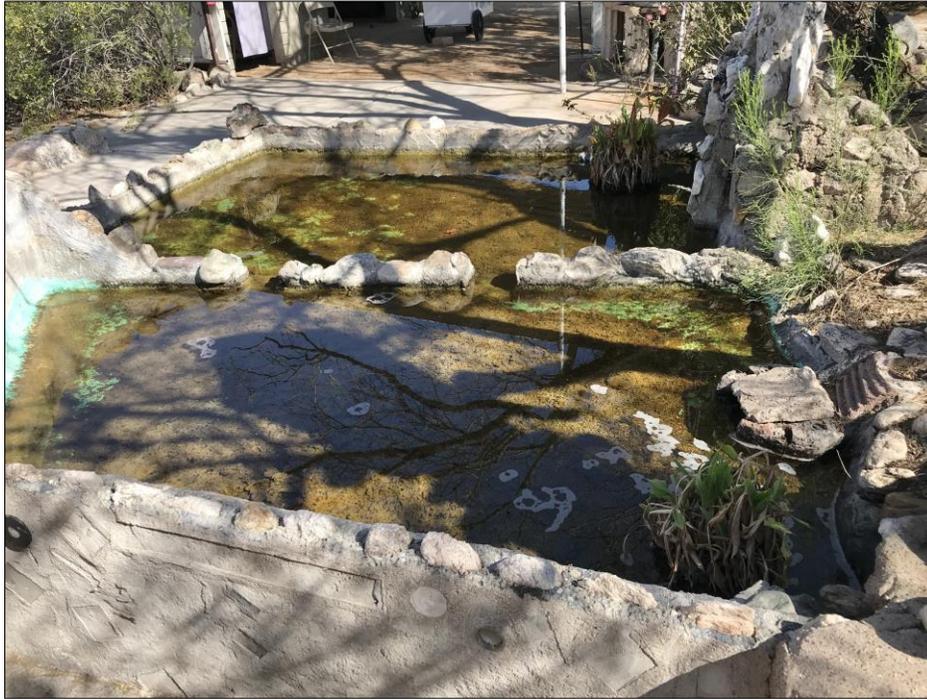
Above: The second pond (in background) has a lower wall, the result of construction activity. The wall heights should match each other.
