2022 Strategic Preservation Master Plan

Valley of the Moon

Enchanted Garden, Cathedral Room & Wizard's Tower Complexes

The Cathedral Complex

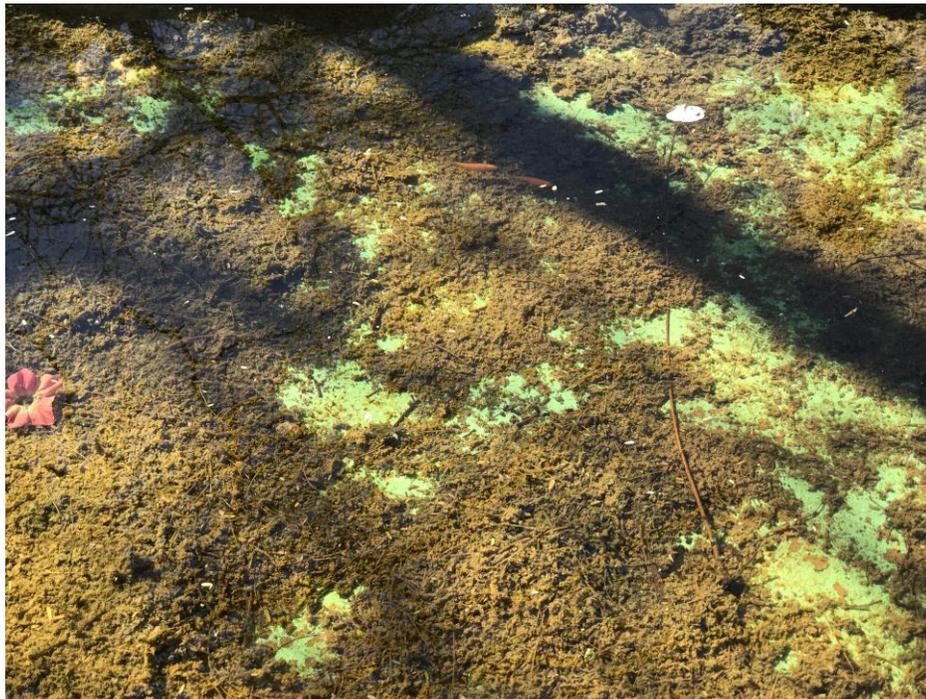
Below: The pond and waterfall need to be re-lined (made waterproof) with a suitable color to promote fish and associated vegetation. The ponds are difficult to keep clean from unwanted debris.

Part of the pond rehabilitation is to install a new water-proofing barrier of a suitable color. Discussions between Valley of the Moon staff and a pond expert is also recommended to determine what pond vegetation (if any) is desirable. There is certainly good potential in upgrading the aesthetic quality of the pond for the visitor's enjoyment. An outside pond consultant may be needed.

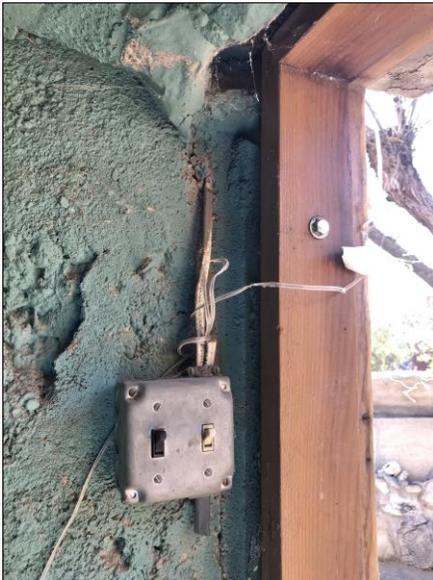
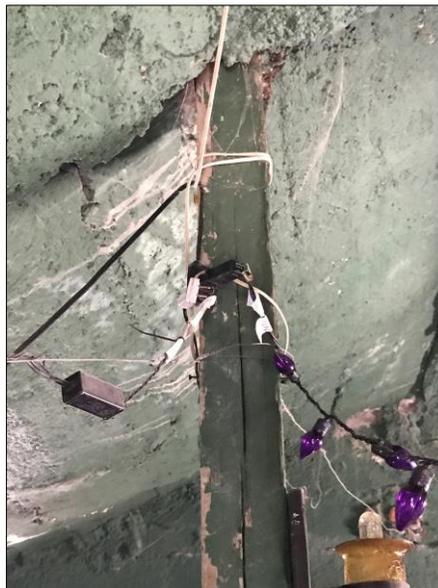
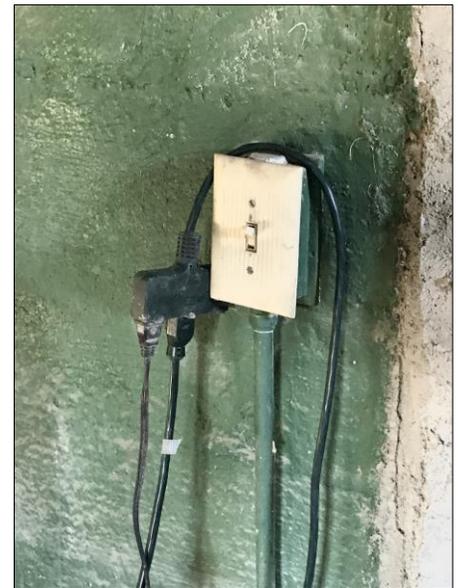
Above: Examples of existing electrical work.

Wiring runs are a maze of cabling to support switches, lights, and extension cords, some which are defunct or cut-off to expose bare wires. This detracts from the visitor experience.

Integrate a new electrical system as part of the repair work to minimize the intrusion of supply conduit, etc. Some runs might be run inside the roofing system, and a discreet location for the breaker found. Lighting should have the ability to showcase the unique spaces on the exterior and interior, making this a major focal point of the Valley of the Moon complex.

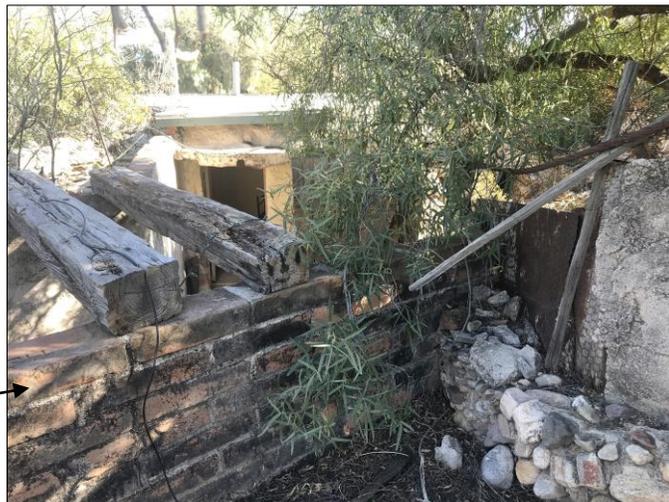
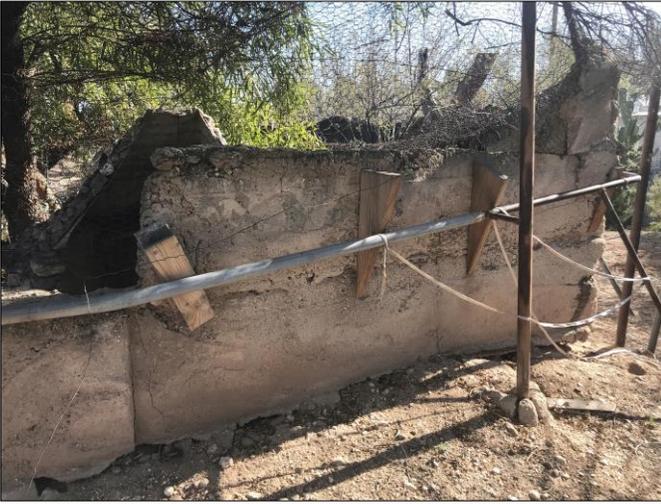
Above: The thin-shell wall is supported with vertical and horizontal metal pipes installed over time. Large wooden wedges provide contact with the wall for support, and to reduce movement.

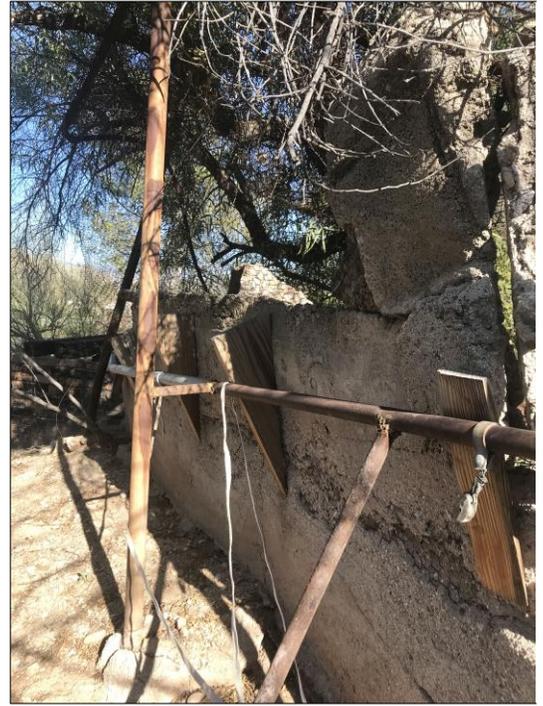
Above: Pipe supports run in several directions, and tie-into vertical pipes supporting the cable and chicken wire canopy.

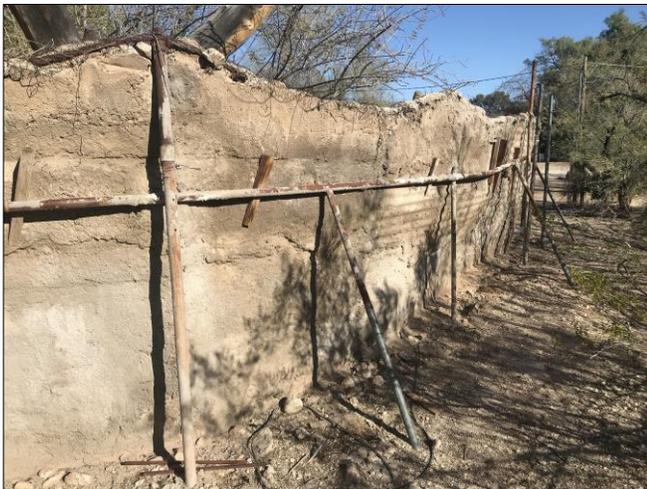
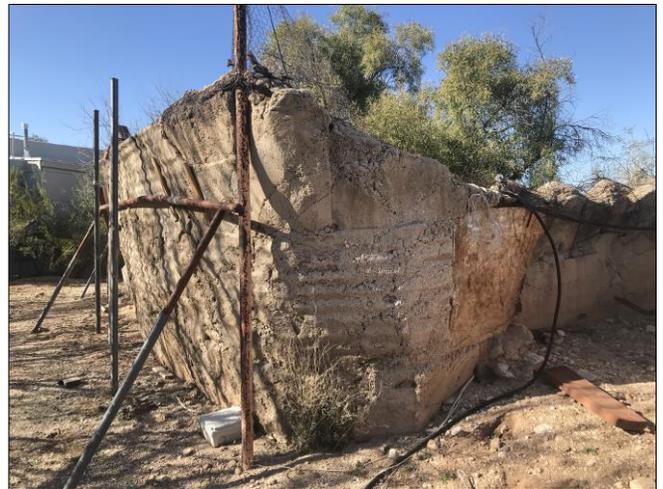
Above: Both photos show to good effect the methodology used in pouring the concrete during the construction period (1920s – 1930s), with a combination of smooth and corrugated formwork mirrored in the concrete. The vertical and horizontal metal poles help to keep the wall stable, but a more permanent solution is recommended.

- Replace the metal pipe support system with a new 8" wide concrete block retaining wall on a continuous reinforced concrete foundation, reinforced with rebar and core-filled with concrete.
- Fill the space between the new block wall and the back side of the uneven concrete shell wall with grout.
- Keep the new structure approximately 4 inches below the original wall on the rear/back side of the thin-shell concrete wall, which varies between approximately 2'.00" and 6'.00 high.
- Use rust inhibitor on all remaining and exposed metal reinforcing material not removed during repair work.

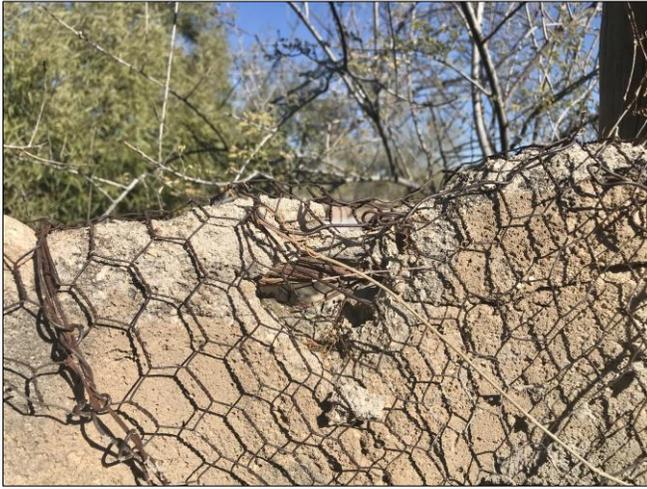
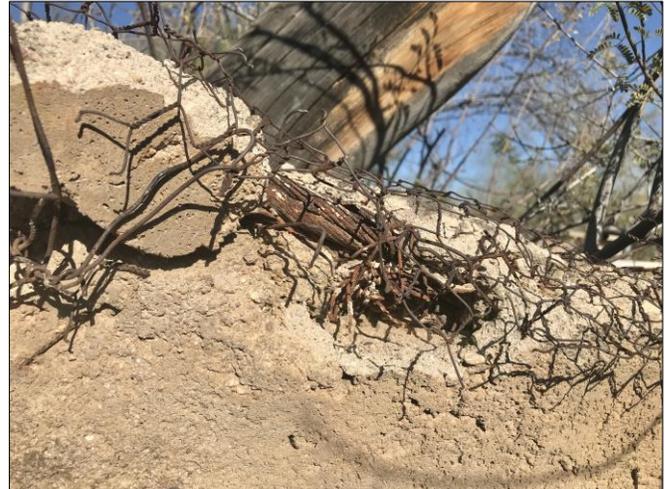
Above: Both photos showing details of how the chicken wire and thick mining cable are intrinsically tied into the system. In places the concrete is damaged, and the chicken wire canopy frequently is woven into the thin-shell concrete wall system, making repairs to either system challenging.

In many locations the concrete thin-shell has fractured – the likely effect of ground movement over time and metal within the wall being subjected to moisture, and consequent rust-jacking. Loose areas will need to be stabilized or removed and repaired.

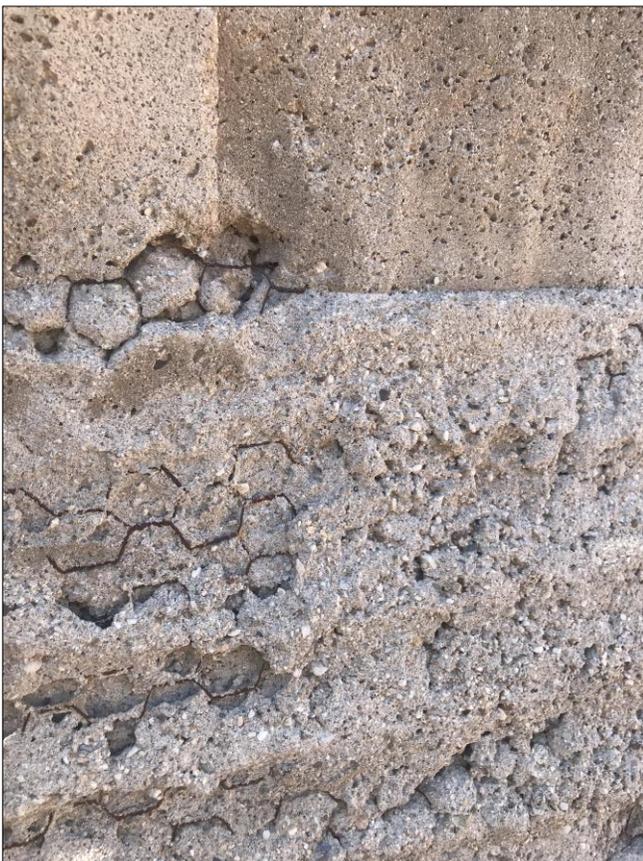
This image gives a good idea of the challenges facing repair work:

- Different concrete pour-stages during construction (the wall was not poured in “one go”, but over a period of time, likely leaving some “cold joints” which are prone to cracking and movement.
- Different textural finishes.
- Variable colors within the wall.
- Exposed chicken wire reinforcing material that is slowly rusting within the thin shell wall.
- Different erosion speeds of concrete based upon material composition and other factors.

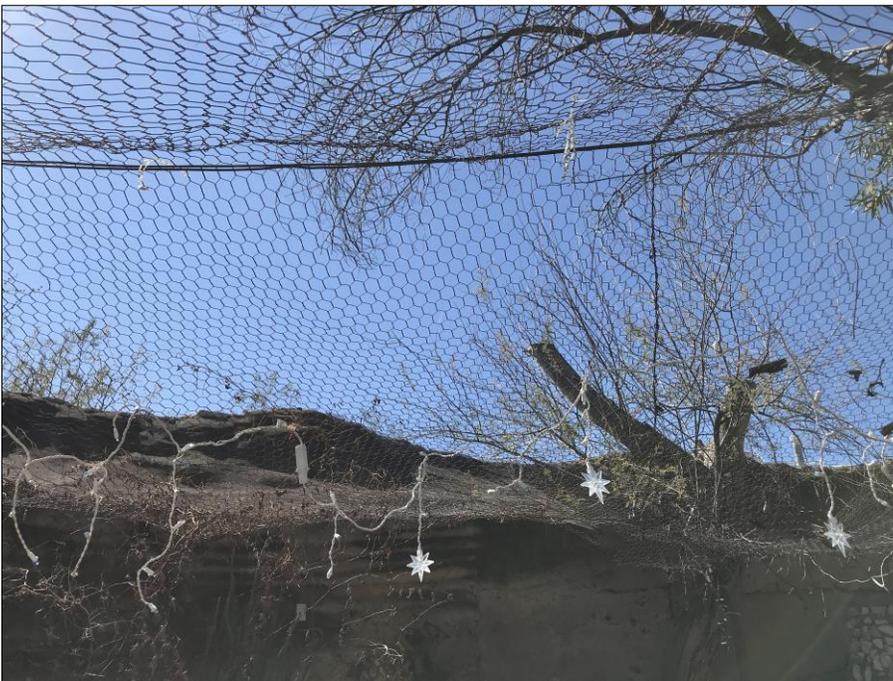
The canopy likely dates from the construction period, as portions of the chicken wire are imbedded into the concrete wall at the top and intertwined with other construction materials. There are significant gaps, and portions of the canopy missing due to age, damage from falling branches, and animal (and possibly human) intrusion. Racoons are known to enter the garden area, and use several areas to defecate, their feces being evident among some of the miniature stone buildings.

Left: The chicken wire canopy viewed from below.

One of the cable braces supports the canopy.

The chicken wire canopy material has aged out, is not repairable, and needs to be replaced along with the cables supporting them. As mentioned above, the supporting posts may need to be replaced, but the decision will fall within the realm of the structural engineer once the retaining wall system has been evaluated. The location of cables and replacement chicken wire must be carefully designed since the African Sumac tree and some of the vegetation must be considered. The options for chicken wire replacement are galvanized or stainless steel (which will last longer but will remain “bright” rather than dull over time).

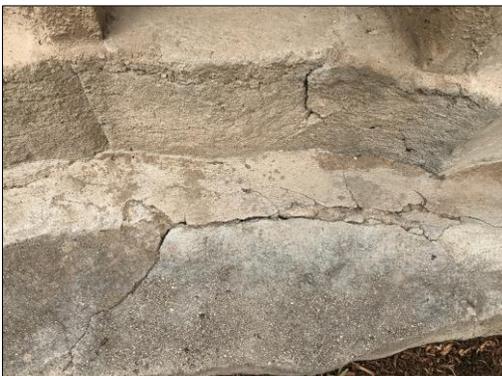
- The lower curving concrete bench seat shows signs of possible movement over time, with some undulation and cracking of the surface.
- Three of the buttresses (Nos. 3,4 & 5 counting left of the entry door) are cracked, and separated at the top by about one inch, indicating downward movement. The cause of this is likely subsoil movement and compression over time coupled with the general weakness of the thin-shell concrete structure.

Detail of one of the seating/bench areas showing cracking of the concrete surface.

Patch and repair the tops of the buttresses in place and seating areas

- Drill slightly upwards and inwards into the concrete substrate, and epoxy a fiberglass rod, held short from the outer face (see drawing p.19).
- Once cured, fill the gaps with mortar colored and textured to match original concrete.
- Remove any loose material from the bench seat, clean and patch to blend in with original concrete.
- If the use of dowels into the concrete is not feasible, then replacement will be the only remaining option.

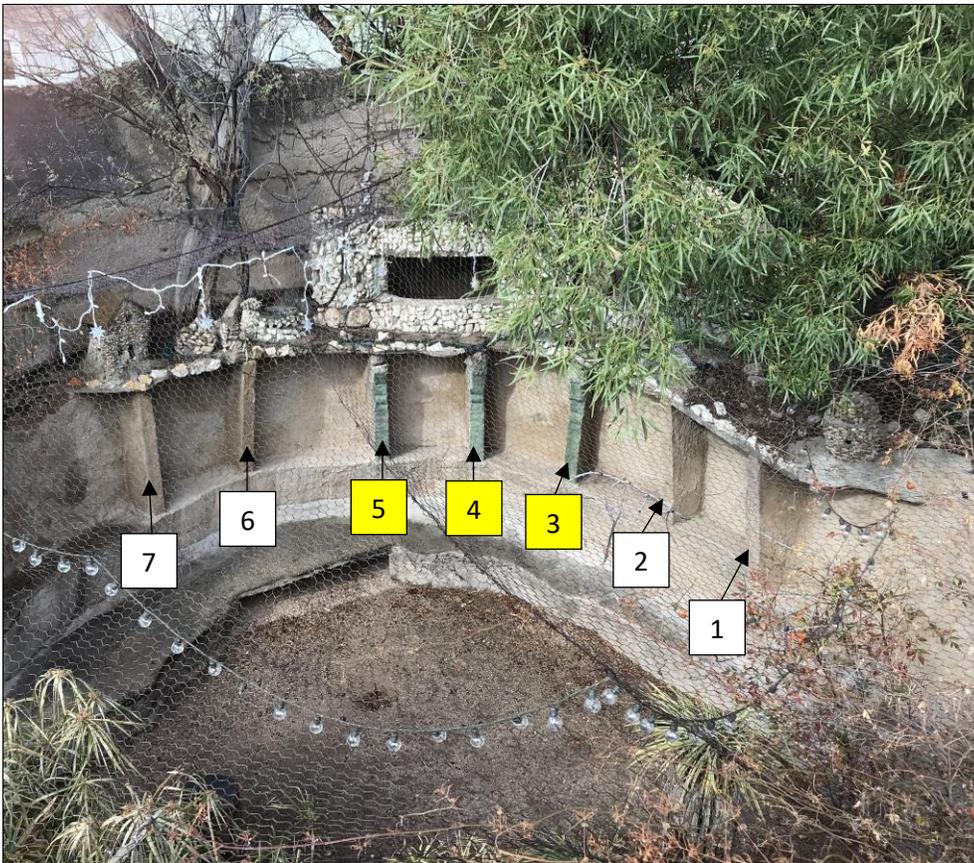
Seating area viewed from above the garden.

Highlighted buttresses **3,4 & 5** require some repair work due to cracking and material loss.

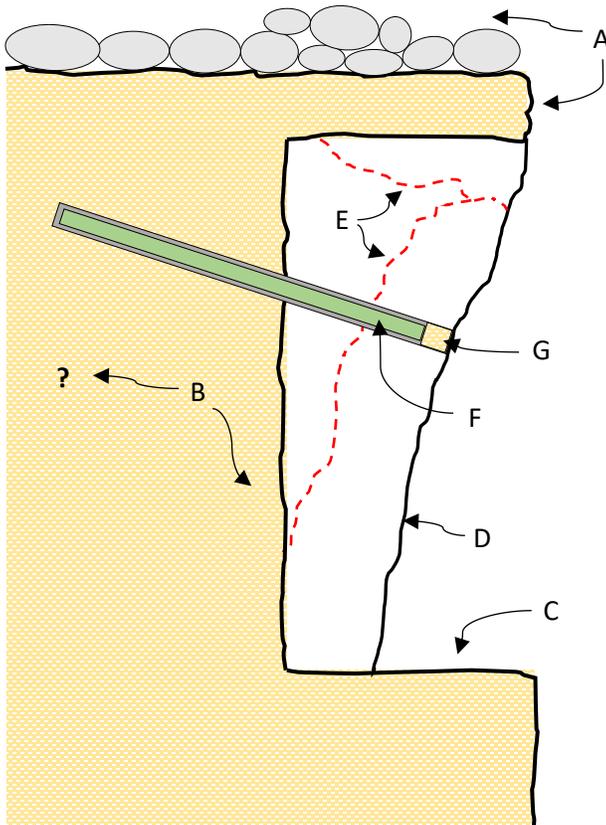
Left: Concept Drawing showing section through buttress repair
(by SWH – Not to scale).

Subject to Engineer's recommendations.

- A. Upper landscape terrace and supporting concrete ledge.
- B. Thin shell concrete structure (thickness of material currently unknown).
- C. Seating nook.
- D. Buttress.
- E. Cracking (typical).
- F. Drilled hole with fiberglass reinforcing rod set in epoxy.
- G. Mortar plug over recessed hole.

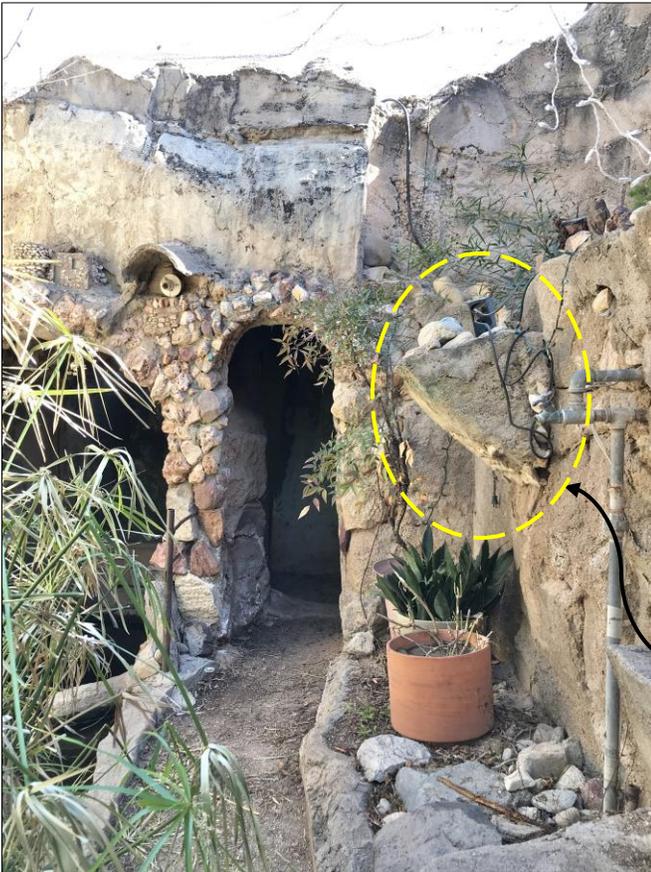
Located near the entrance to the lower chamber room by the pond, this 32" x 16" x 16" planter is pulling away from the wall supporting it. There is cracking and gapping on all sides, indicating progressive structural failure.

The planter has cracks around all sides where it attaches to the thin-shell concrete wall, indicating structural failure. The planter's removal is recommended at this time.

Repair options are to (A) build supporting walls or fill in below the planter with solid stones or concrete, which would keep the planter in place, but alter its original appearance. (B) is to remove it entirely and patch the hole. Option (C) would require a more invasive repair – to remove the planter, drill through the old concrete wall and install a new metal support basket before making a new cantilevered concrete planter. The recommendation is for **Option (B), removal of the planter**. Should this feature be desired later, it can be accomplished using Option (C). Additional repair will be needed to address

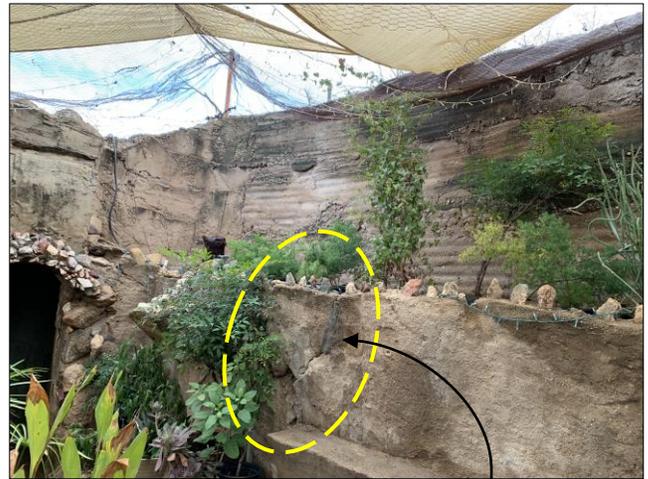
The vertical crack just north of the planter and above the concrete bench seating is also of concern. Loose material needs to be removed for inspection of its stability, and repairs made using similar methods to that being recommended for the buttresses (above section).

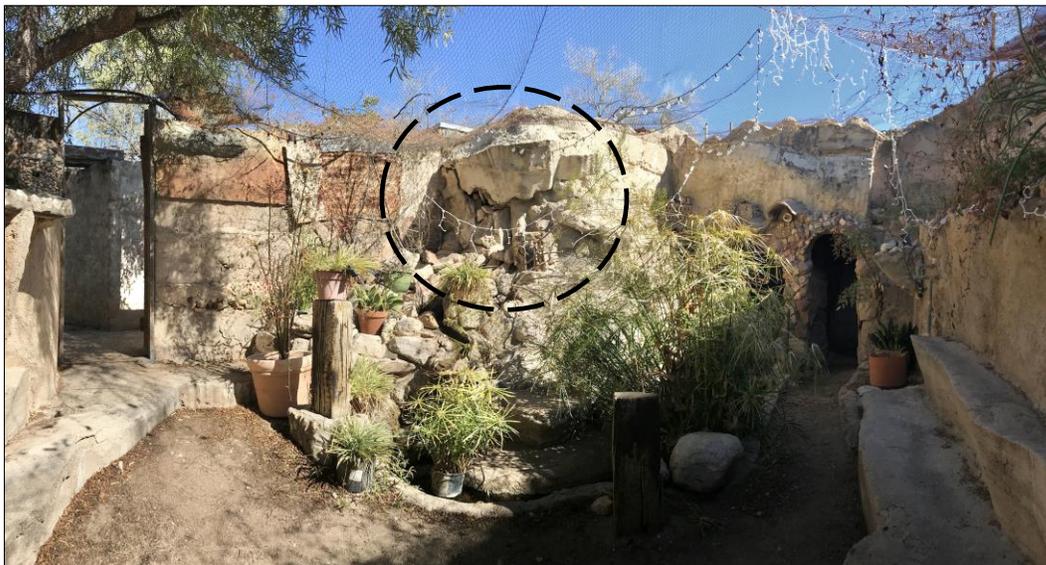
Above the pond is an “outcropping” feature of concrete which show cracks of between one and two inches. Cracking appears worst near the wall and corner of the adjacent building (the “Yellow Room”). The cause is possibly linked to rainwater getting in and behind the wall near the top, where a gap of several inches exists between the top of the thin-shell concrete wall and the roof of the building. Over the years, it is likely metal reinforcing within the thin-shell concrete has corroded, weakening the concrete, and leading to movement.

Above: Panoramic view of the pond area with the subject wall at top center (circled).

1. Remove all loose material between the fascia of the building and the thin-shell concrete (performed from above while lying on the roof of the Yellow Room). The fascia contains rot in this vicinity, which will be difficult to repair or replace due to space and roofing materials.

2. Make repairs to the fascia and install a waterproof membrane in the U-shaped spaced between fascia and concrete wall. Drain to grade. Alternatively, fill this portion of the gap with lightweight concrete and slope to grade. Coat the surface with white roofing cement. This will help prevent future water intrusion behind the concrete above the fountain and pond.

3. Infill gaps caused by the failure with matching stone and include a small sloping buttress wall along the wall. This will fill in a large gap in the existing wall (used by animals to enter the garden) and lend support to the failing outcropping above.

4. Fill any remaining voids and cracks with smaller stones and mortar to match existing finishes.

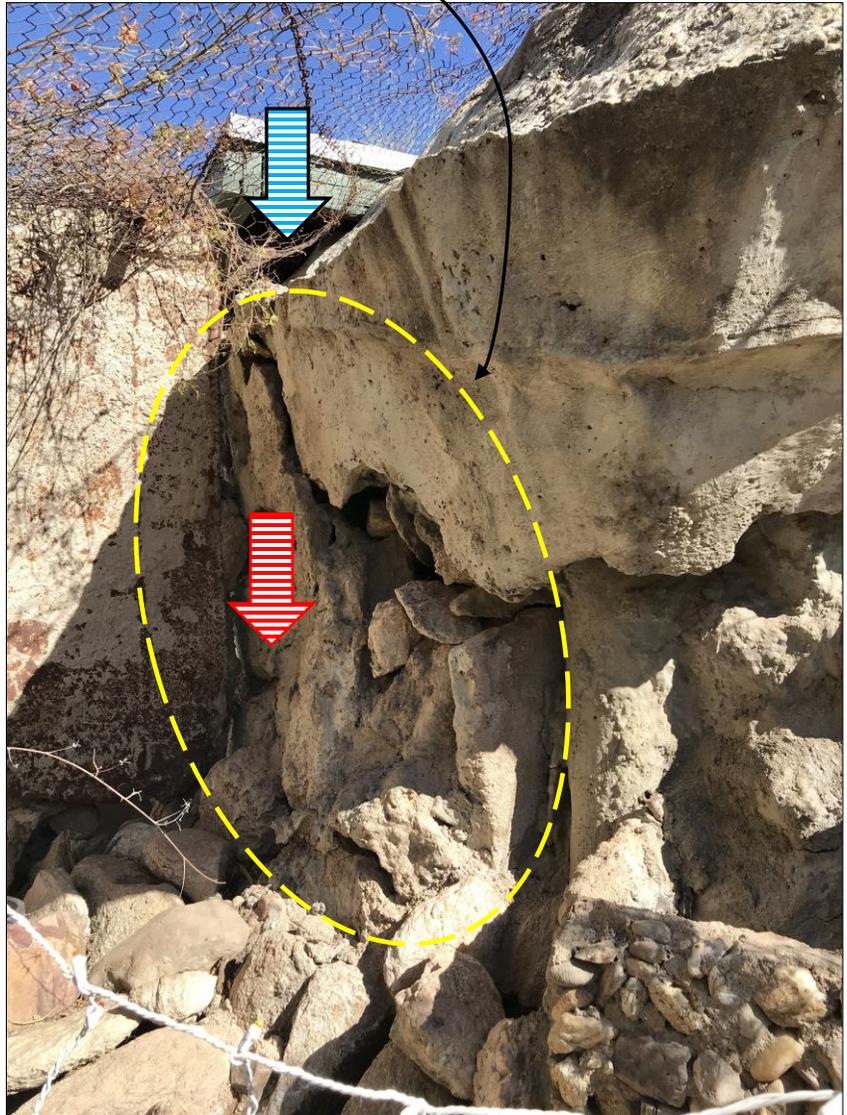
The corner of the roof atop the Yellow Room below has a gap of several inches between its outer wall and the back of the thin shell concrete forming the faux rock outcropping. It is likely water has been penetrating this area since it was built, resulting in weakening of material through loss of reinforcing metals and settlement (blue arrow).

The width of crack shown varies in width but indicates a downward movement of material in the section circled below.

The area containing gaps can be filled with new matching material including stones following removal of loose material.

This is a project area that will need the overview and final recommendation of a structural engineer.

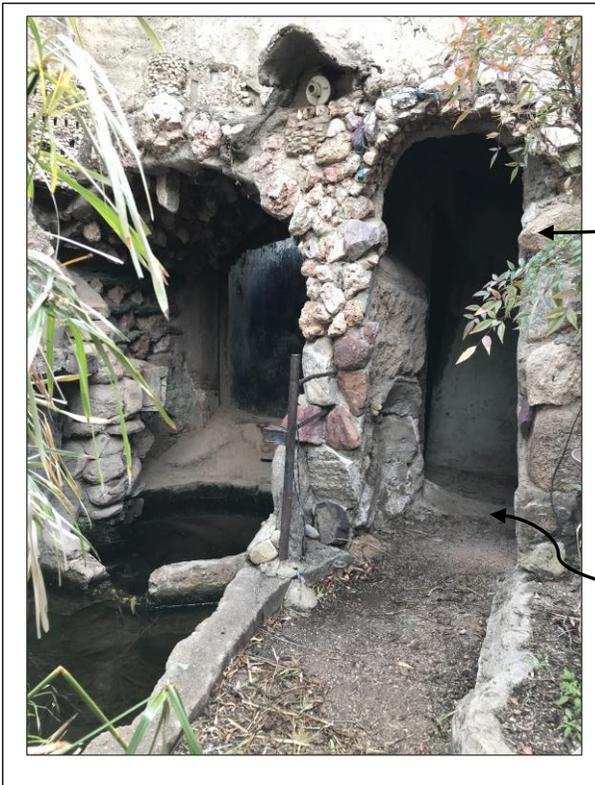
The door leading from the garden to George’s Bedroom (Lower Chamber (E) should be reconstructed to provide a closure to the chamber – thereby restoring an original feature currently missing. Doing so adds a measure of security, also resulting in increased cleanliness, which will in turn reduce maintenance and periodic cleaning. The rough opening is currently 28” wide x 6’-4” high.

Left: Exterior view the doorway/entry, with the arch over the window looking out onto the pond to the left.

The odd-shaped doorway is narrow at the bottom but wider at the top (on one side only).

Evidence points to there being a doorway that was hinged on the right, and opening inwards against the interior flat wall.

The concrete threshold mirrors the curvature of the top but may have been partially removed. The door closed against the inside of the threshold.

Recommendation is for a simple rustic door with vertical wooden boards. To reduce door thickness, and to maintain as wide a passageway as possible, apply 3/4-inch-thick vertical plank strips to marine grade plywood using waterproof glue, screwed from the inside plywood, which will be unseen once the door is opened and hinged against the entry wall. Install a metal throw-bolt like the one used on the main entry door to the garden. The finished door opening/clearance will be narrower than 28 inches when accounting for the frame and hinge-opening.

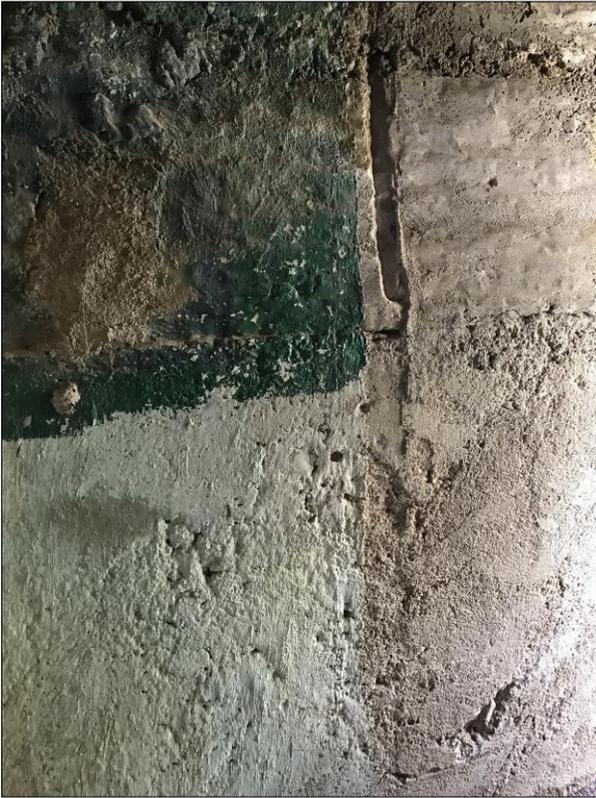
View of inside the entry passageway (right is to outside).

Evidence indicates the existence of door framework around the doorway.

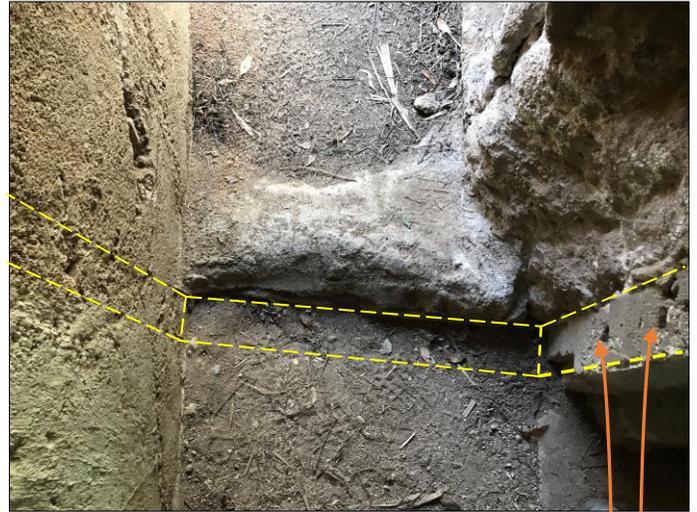
View looking down on the concrete threshold from the inside. The position of the door frame is shown by the yellow dotted lines. Exterior is to the top.

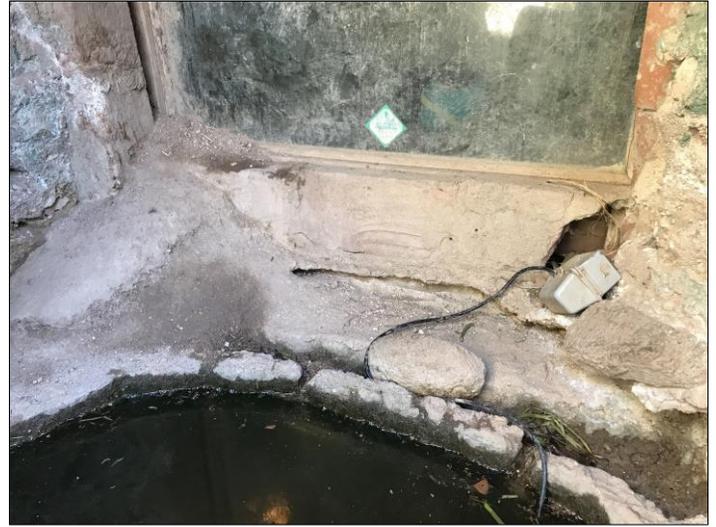
Right and above: Exterior views of the large viewing window, with the pond in the foreground. Electrical cables supporting pond function (pumps, etc.) are visible. Loose soil is being deposited from a gap between the side of the wall and the glazing window frame, indicating rodent activity.

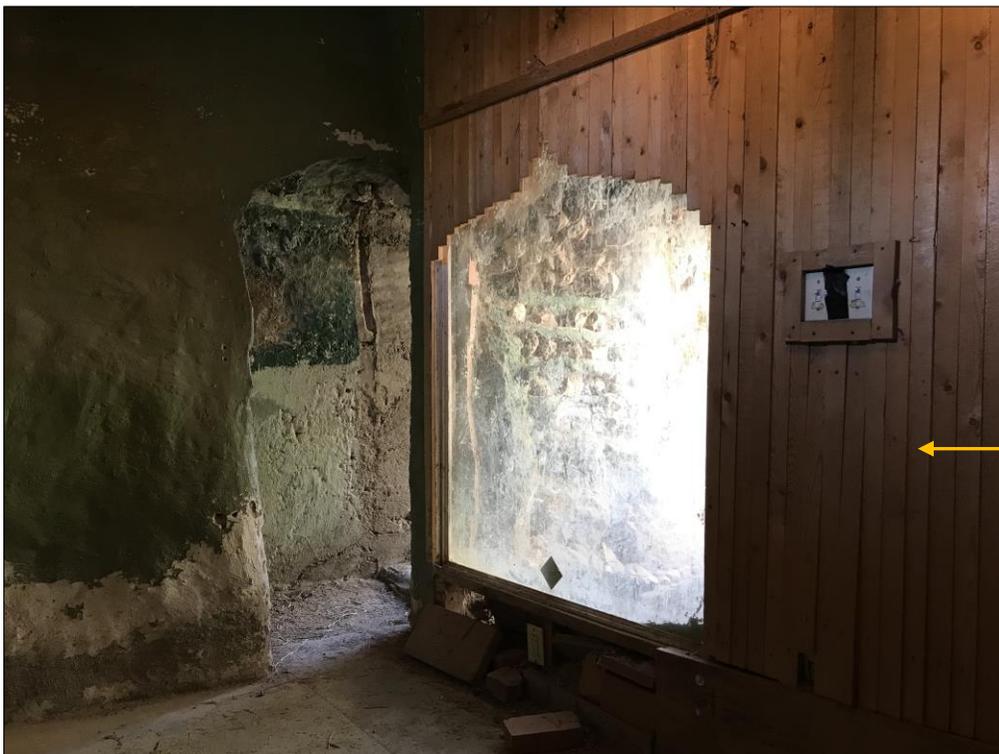
Left: Inside view of the glazed window, with the entry door to the left.

The wooden wall needs to be removed, and the substrate repaired after evaluation and a work plan has been established.

Electrical work includes removal of defunct services and upgrading live circuits where necessary.

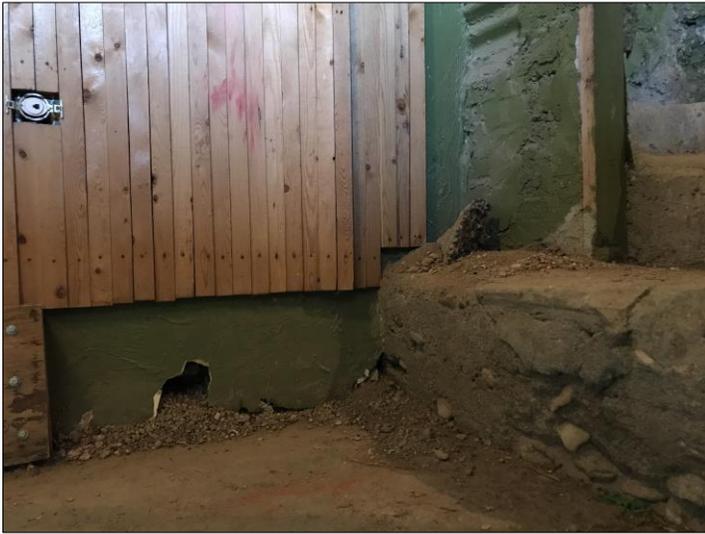
A hole exists at the base of the wall, with soil-like materials being pushed out. Once the wooden wall material has been removed, a thorough examination of this wall needs to take place to determine the next course of action.

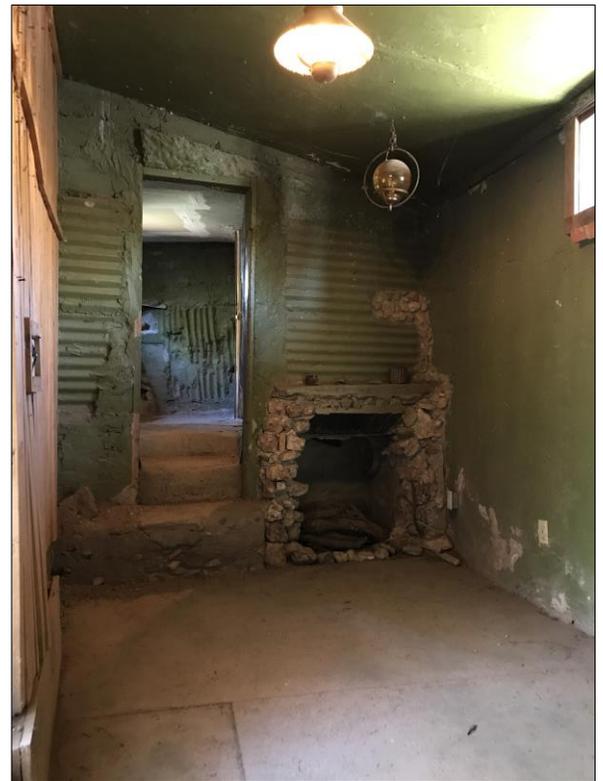
Above: View of the fireplace wall and steps leading up to the adjoining room (F).

The fireplace has a chimney and exterior clay stove pipe, but it is recommended this be formally abandoned and left in place as a decorative feature. If desired, an imitation electric fireplace could be installed to simulate a working fireplace. Partially visible top right is a small window to the exterior of the structure.

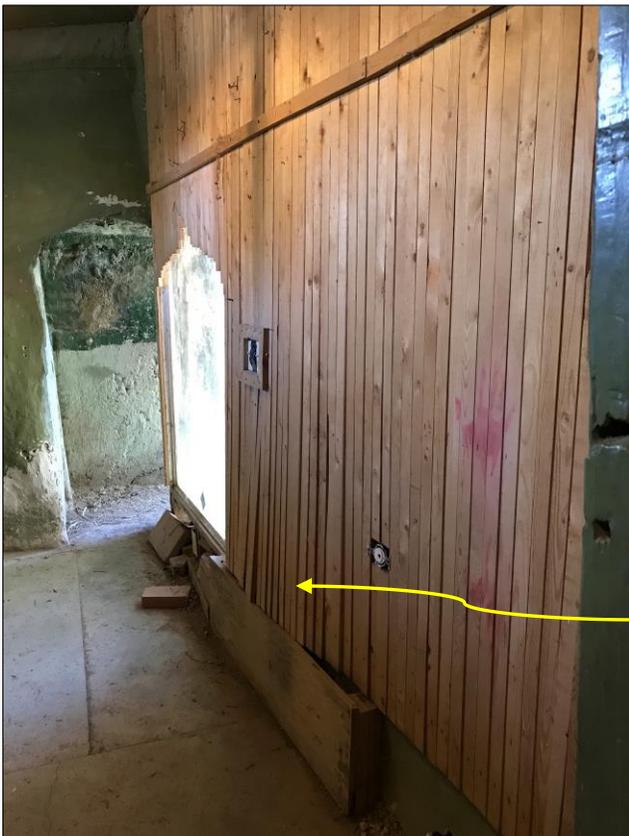
Left: Another view of the wooden curtain wall.

From this view it is apparent the vertical wooden strips are becoming loose in the bottom third due to loss of mechanical fastenings.

Exposing this wall is essential to determining the next steps including final treatment options.

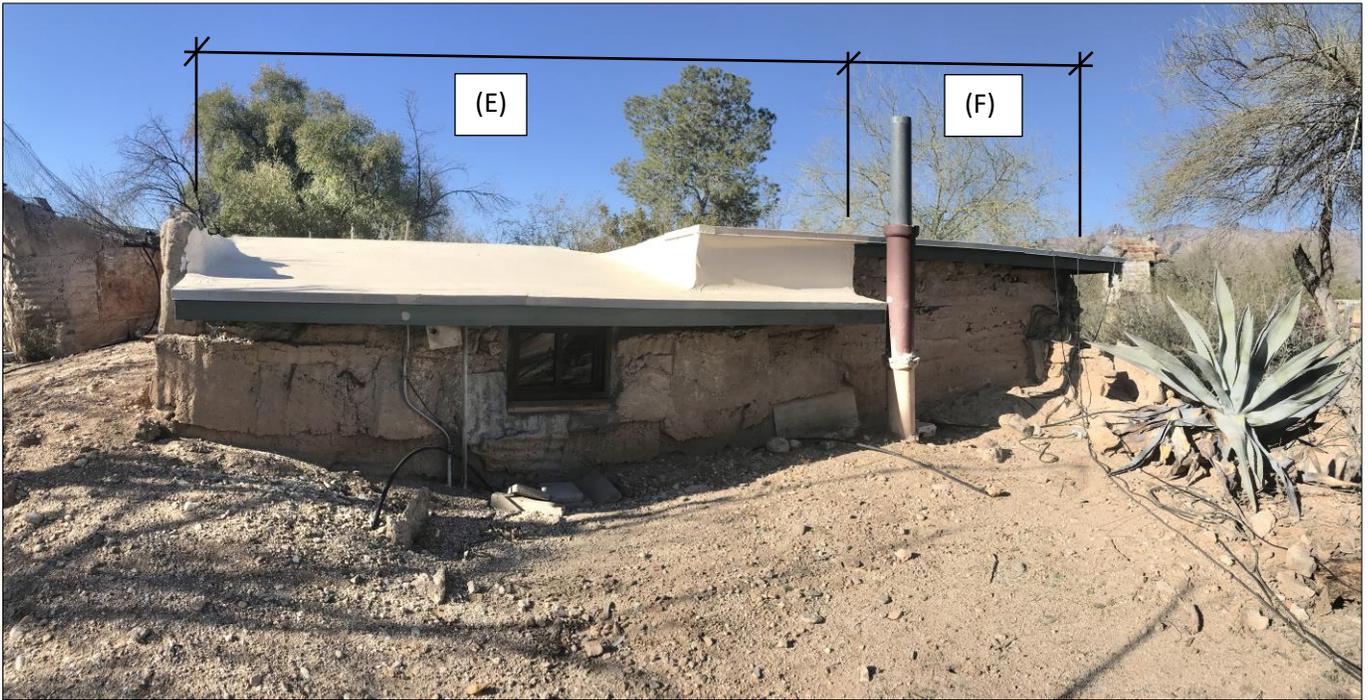
Above: Rear view (looking north) showing the exterior of George’s Bedroom **(E)** on the left, and Georges Writing Room/Office **(F)** on the right. The highly irregular wall texture is the result of the style and sequence of pouring the concrete as the building was constructed. The clay pipe seen near center is the chimney for the fireplace. In George’s Bedroom. While the fireplace should be closed off/abandoned, the clay pipe should remain.

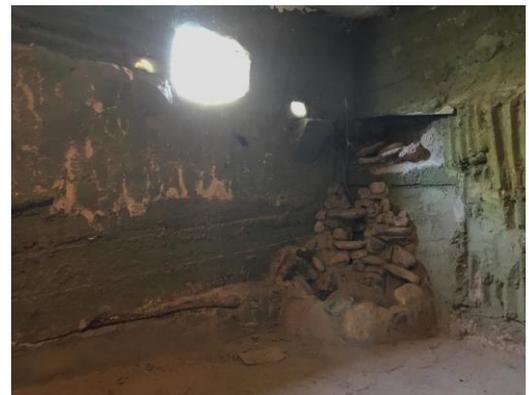
Above: The openings are window of different sizes used in Legler's story-telling narrative. The large window has broken glass which needs replacing.

Removal of the green paint in both rooms is recommended.

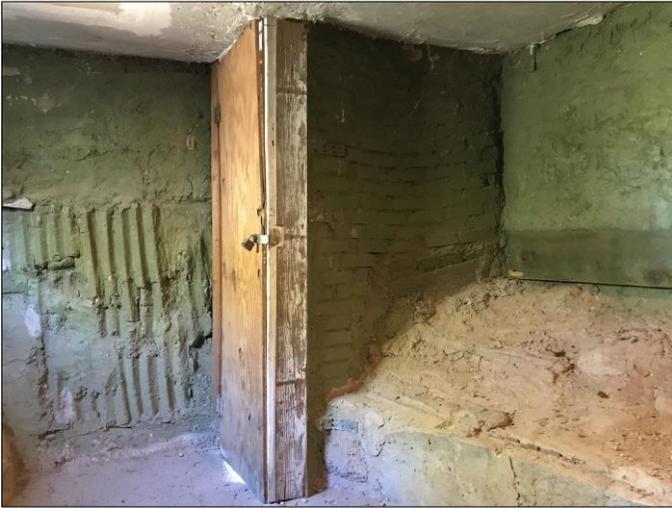
Above: View of the plywood door over the Rabbit Hole entry. The door is currently screwed closed for safety and security reasons.

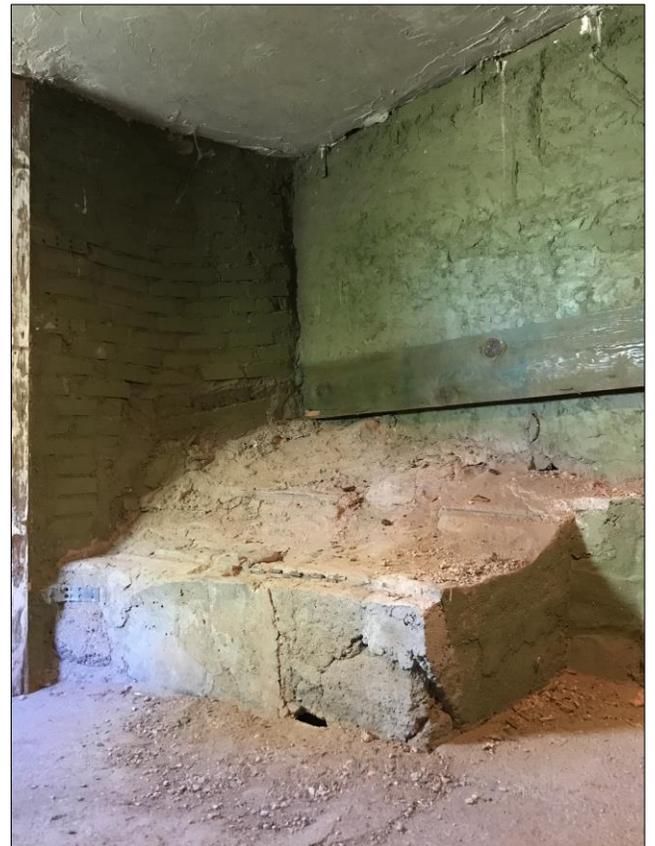
Above: The roughly made concrete form see here covers the top of the stone cave below. If this were to be made level (or stepped) it could provide increased programming and/or display opportunities.

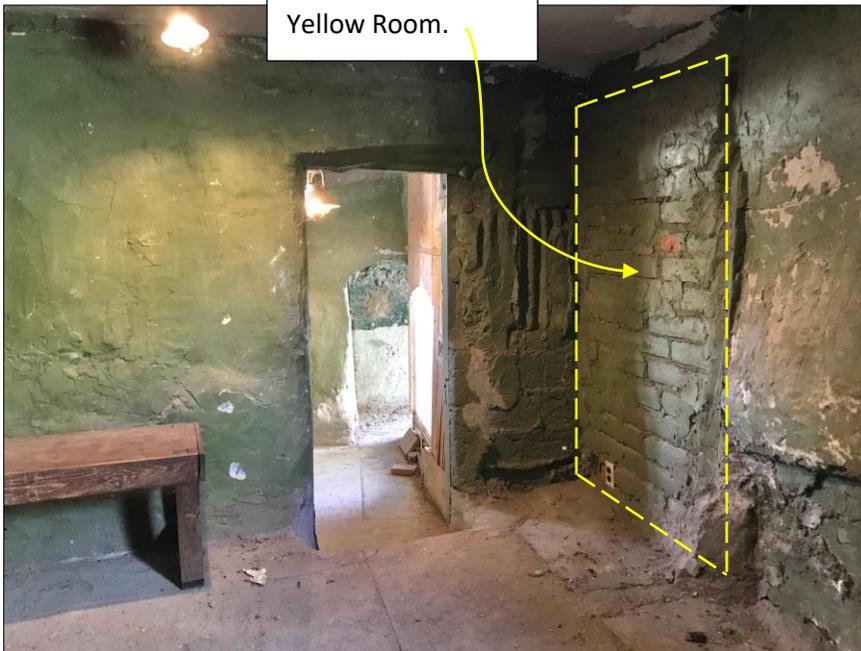
View from Room (F) toward Room (E). The rough brick infill indicates the closure of a doorway connecting this space to the Yellow Room.

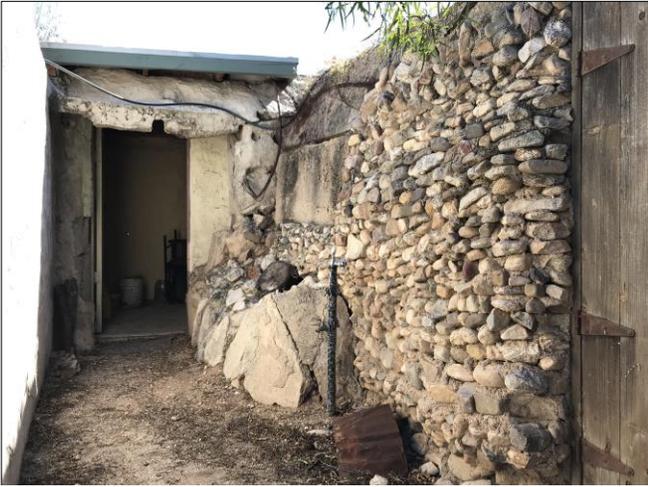
Above: Entry passage to the Yellow Room. To the right is the wooden entry door to the Enchanted Garden. Concrete work around the doorway needs repair due to cracking and material loss.

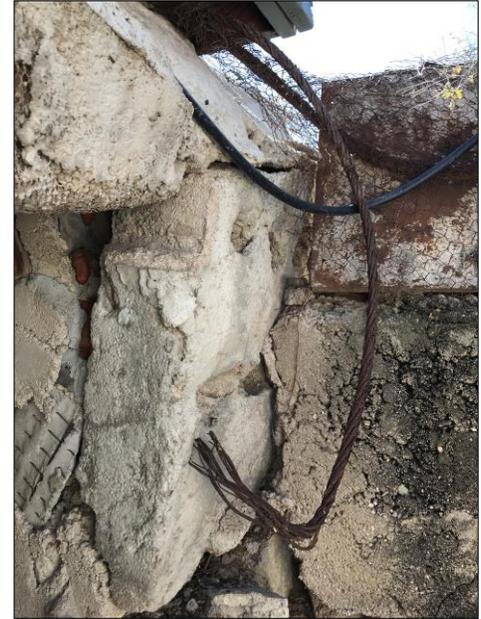
Above: An example of the numerous materials needing careful treatment to consolidate while preserving the essential character of the materials.

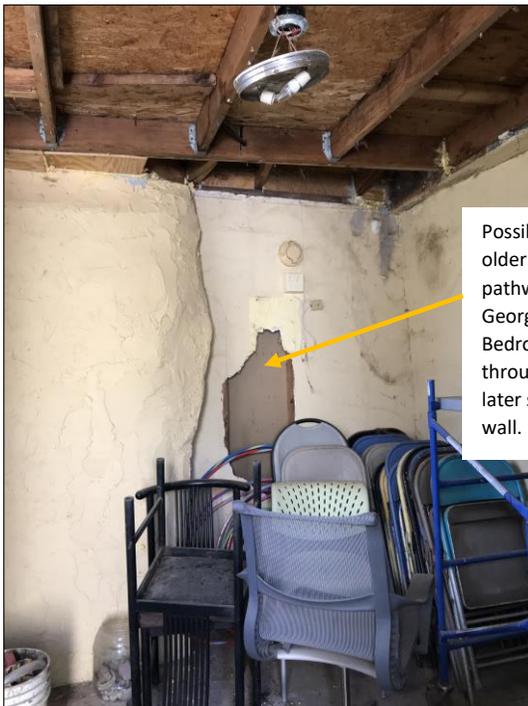
Above: Interior of the room with the rough plastered wall over the brick infill to Room (F) at left. Electrical work is needed here.

- Repair or replace non-functioning or damage electrical fixtures, including a new ceiling fixture of suitable design.
- Install a new frame and door to match rustic door to Enchanted Garden (so they match). Install a latch similar, but also install a keyed deadbolt for security.

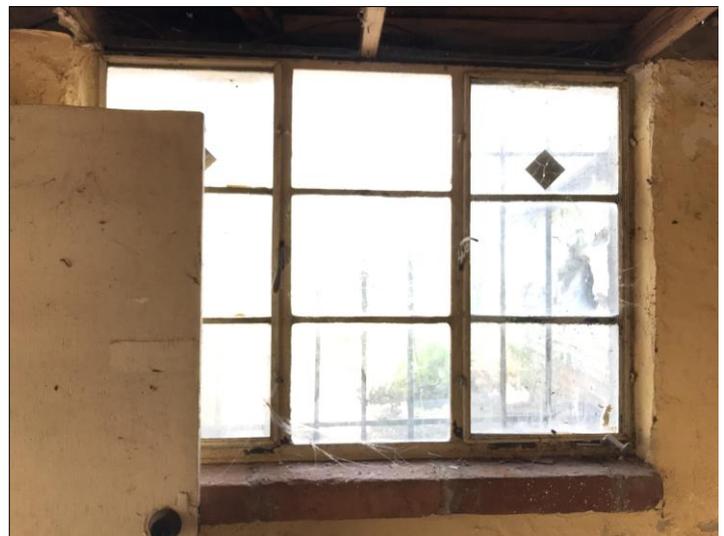
Above: View of the metal framed window. Although the sash mechanisms do not work, with careful servicing this window will last indefinitely. Once work has been completed, it is recommended all wall and ceiling be painted white.

- A decision can be made at this time whether to make an entry into the bedroom or not.
- Service steel window by removing rust and built-up paint. Remove and service mechanisms, re-glaze and repaint as needed, and install new replacement screens.

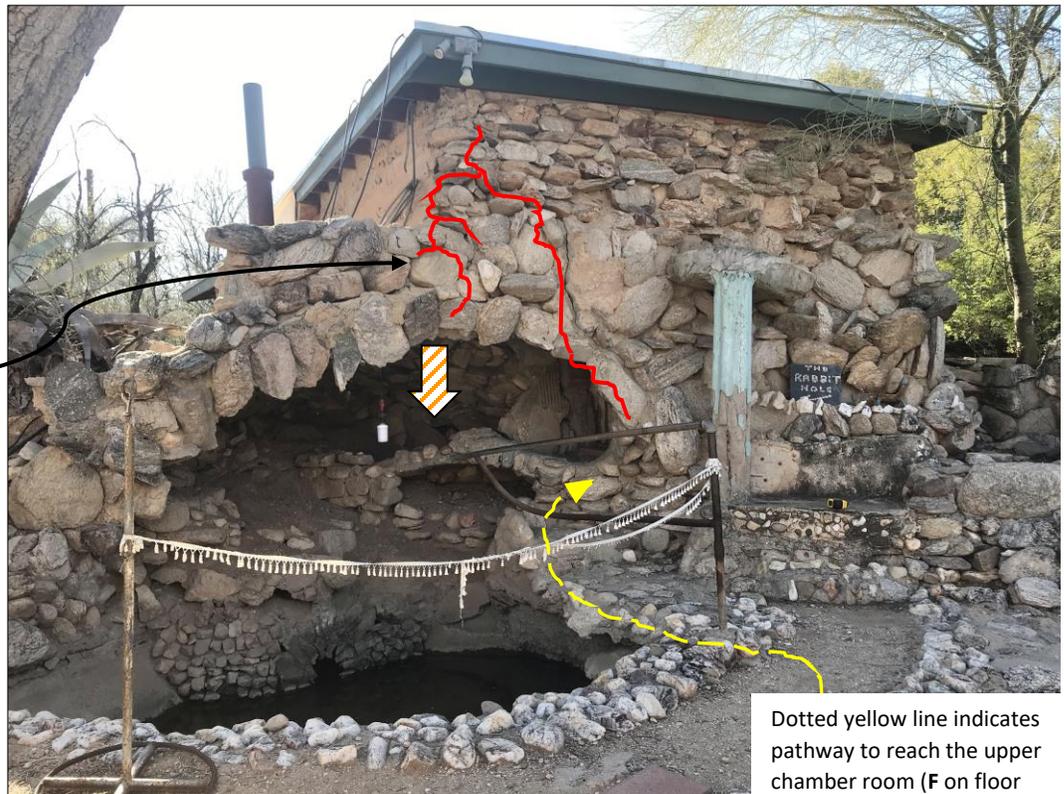
The vertical crack above the stone arch is indicative of structural settlement from pressure above. The weight of the corner of the building bears down on a point right of center of the masonry arch, and directly over the passage to the Rabbit Hole entrance. Consequently, staff have closed this entry point due to safety concerns. Short of rebuilding the entire arch (which would be highly disruptive and costly), a solution is sought that (1) supports the corner of the building, and (2) preserves the structural and visual integrity of the arch without demolition and reconstruction. The intent is to have minimal impact on the visual quality of the structure, once completed.

Red lines indicate areas of most visible cracking, indicating a downward movement of the stonework above the arch, and the arch itself. The largest separation crack is approximately 1.25 inches (vertical space). See also insert below.

Arrow below cave arch and corner of building indicates area of downward pressure from weight above which is likely causing the cracking.

It is recommended a new supporting arch of metal be fabricated under and behind the existing stone arch, supported by new footings at either end. Stones above the arch hang down like jagged teeth, a theme often repeated in Valley of the Moon features. Behind these stone teeth is a space or indent, which with careful sighting, might largely hide a custom steel arch support. One terminus of the new steel arch would be on the lefthand side of the arch above one edge of the pond, the other to the right near the doorway itself. It will require careful exploration to find the correct location to build the footings.
