2022 Strategic Preservation Master Plan

Valley of the Moon

Enchanted Garden, Cathedral Room & Wizard's Tower Complexes

The Cathedral Complex

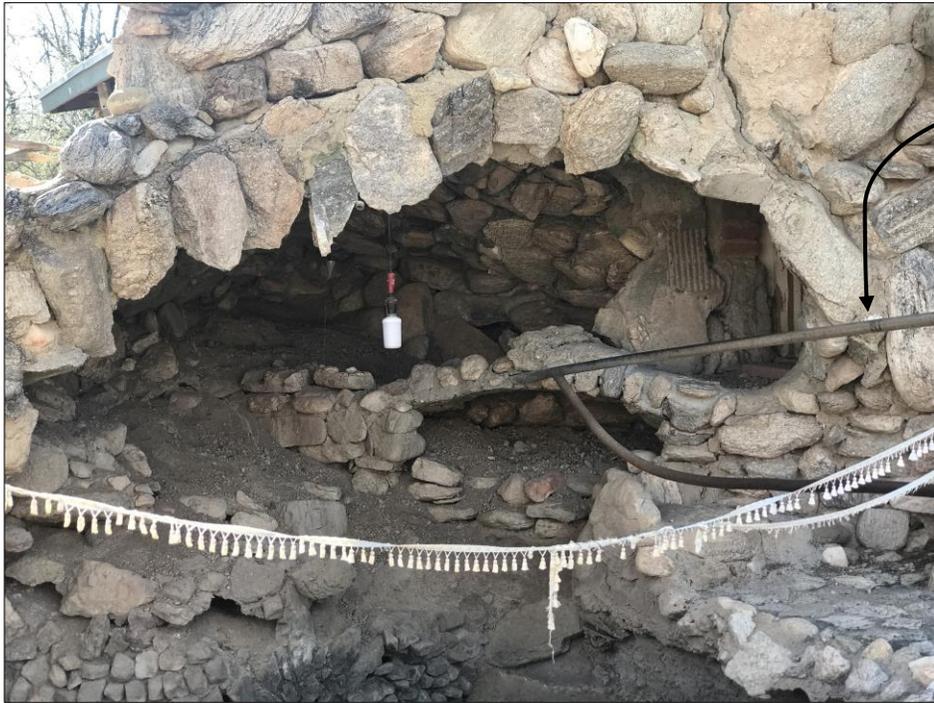
The metal pipe handrail is not original and engages the lower arch at a downward angle.

Its removal is recommended due to the visually intrusive nature of the railing.

The suggested steel supporting arch would be tucked behind the line of “dragon’s teeth” – like stones covering the arch opening. A temporary support for the cave area may be necessary during work.

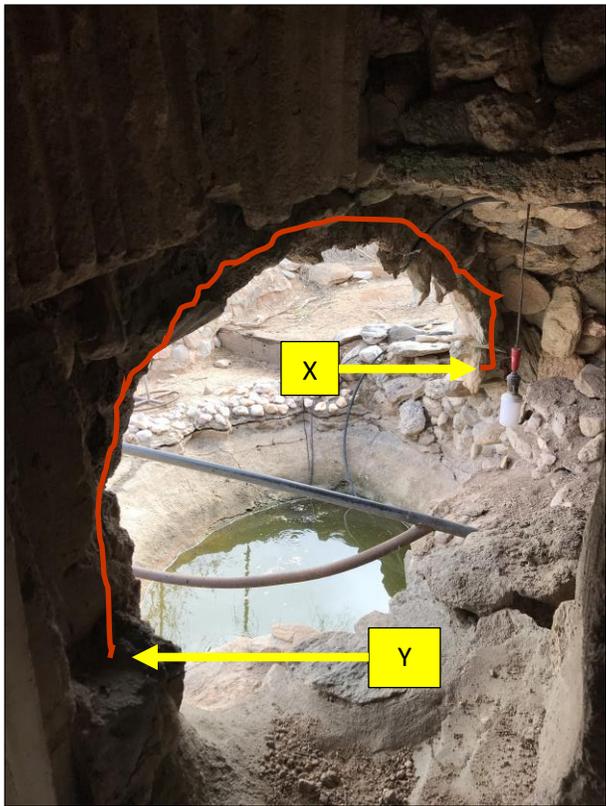
Above: View of the Rabbit Hole entry looking down from the entry door in Room F. Supports for the new steel arch (red line) would be located at points “X” and “Y” (which is the point nearest to the Rabbit Hole door). entrance.

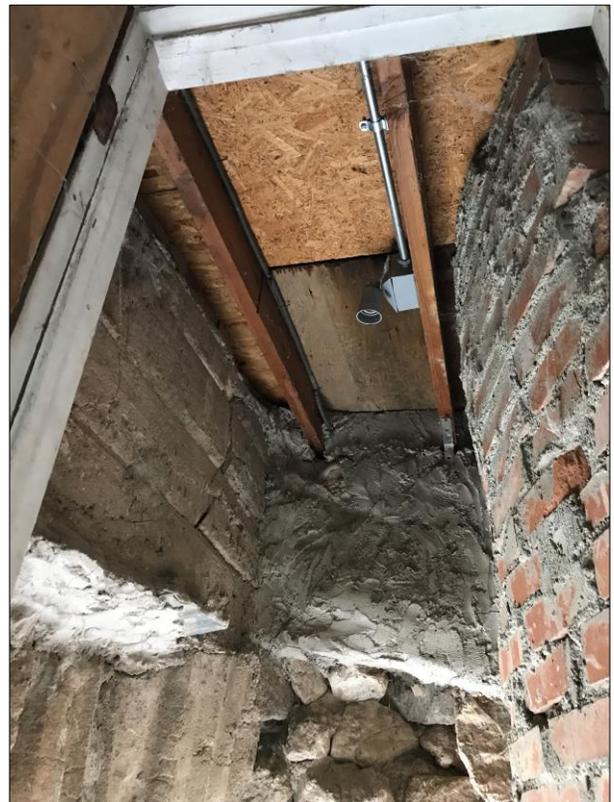
Above: View of the Rabbit Hole entry looking upwards where a light fixture is located. The door frame is visible at upper left. The area above entry should be finished-off.

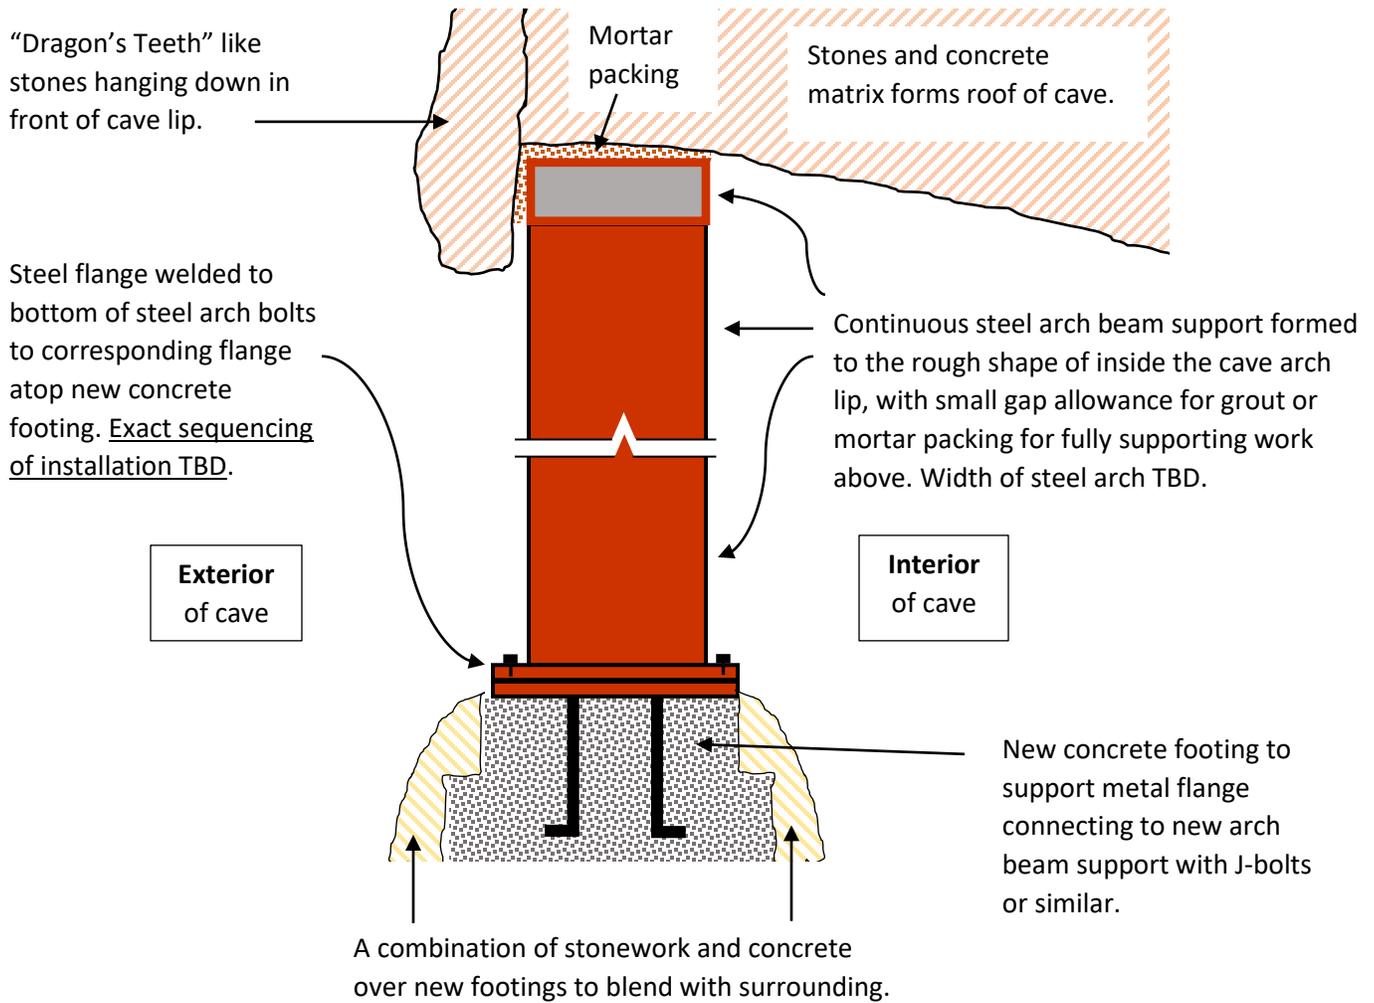
Concept drawing (section) of Proposed Metal Supporting Arch

Details of a proposed solution to support the stone arch over the Rabbit Hole entry and pool. Not to scale.
 (By Simon W. Herbert, and **subject to engineering design/approval**).

Once in place, the space between the top of the steel supporting arch and the stonework above can be filled with a suitable grout, thereby reestablishing structural support and integrity. At least one stone on the face of the arch above the passageway/railing has fallen off, and a replacement one of suitable size needs to be found and attached. Adjacent structural cracks should then be filled with mortar of the same texture and color as surrounding material. A structural engineer will need to examine the feasibility of this recommendation and discuss this and any possible alternatives with the team.

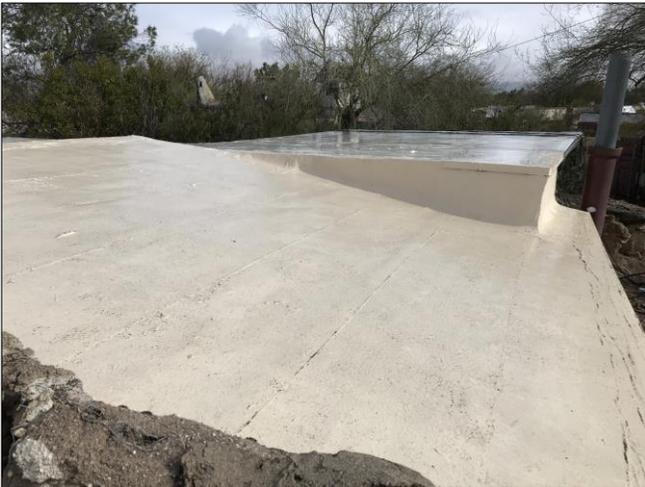
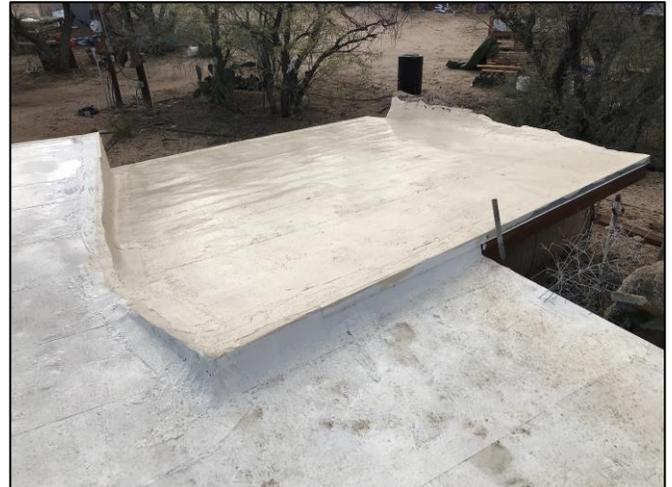
Above two photos:

In generally good condition, the roofing needs some basic maintenance and re-coating of surfaces.

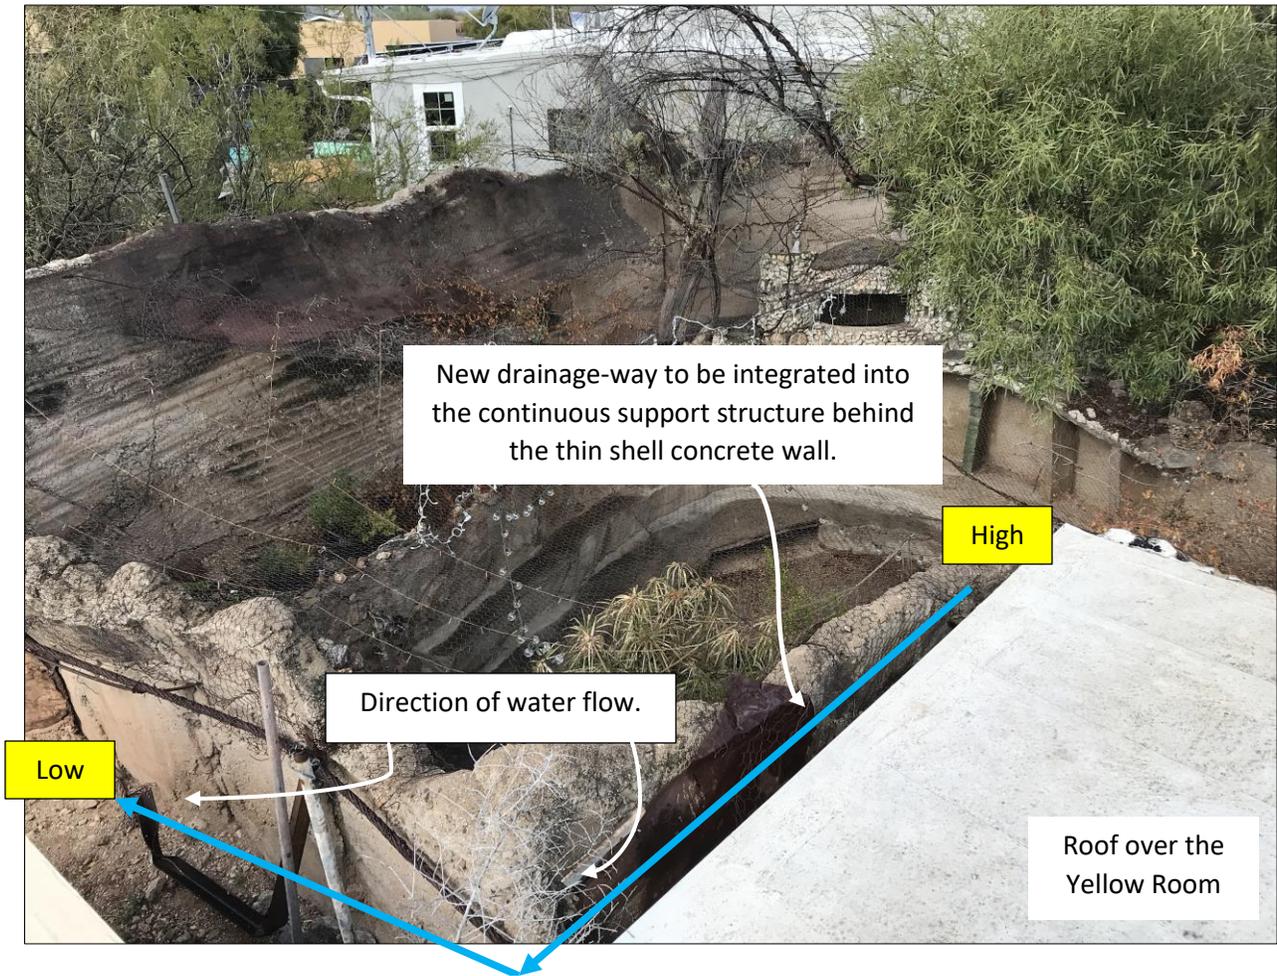
The main issue concerns the western edge of the roof over the Yellow Room, where a gap exists between the drip edge and the edge of the thin shell concrete wall. Here, water can penetrate between the wall of the building and the concrete wall. This is a likely contributor of damage and cracking to the structure above the pond area wall (see p.22).

View of roof above Yellow Room, showing gap between building and wall with a drainage issue.

- Remove debris in space between wall and thin shell concrete down to solid substrate.
- If possible, remove deteriorated wooden fascia (which may in turn disturb roofing and drip edge).
- Suggest an infill of mortar and brick to create a new sloping scupper between the two walls that collects and directs water away. Cover this with cement, form a clean slope, followed by a coating of roofing cement with good adhesion to surrounding surfaces including the back side of the thin shell concrete.
- Treatment of exterior wall of building can only be fully determined after exposure of materials.
- New drainage-way will need to be integrated into the new support wall for the thin shell concrete wall (see item No. 1, p.12).

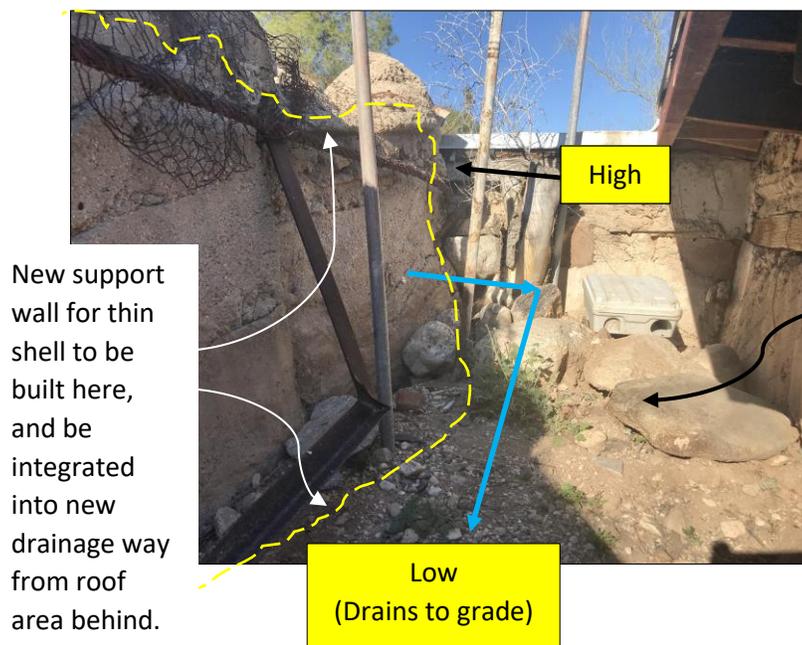
View looking up the path between the buildings and thin shell concrete wall of the garden (seen at left).

The area here also needs considerable clean-up and grading.

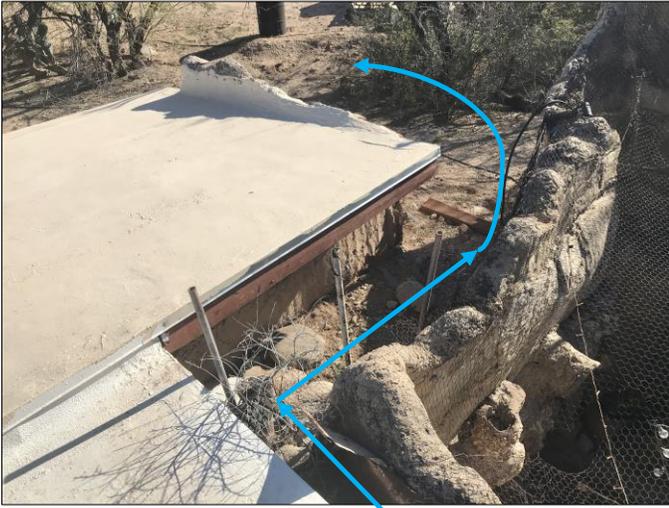
Above: Another view of the target repair area. Arrows in blue indicate drainage of water to grade as part of an integrated repair to the thin shell concrete wall and the space between it and the exterior wall of the Yellow Room.

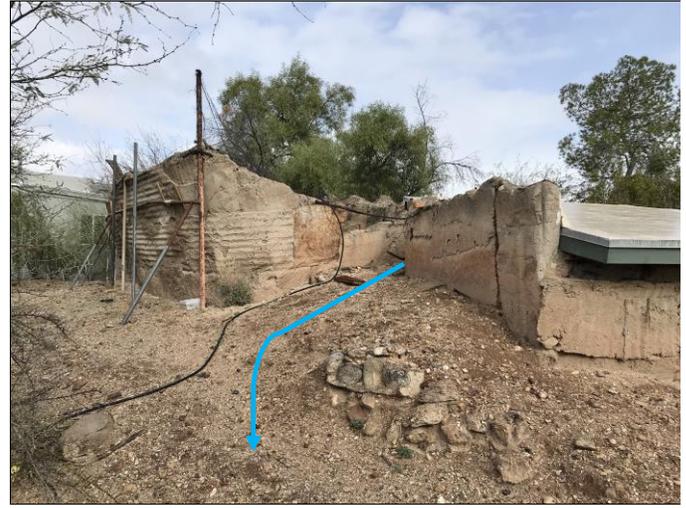
Above: View up toward the drainage-way between the thin shell wall and the building. The groundwork here will need to be reinforced, likely to include terracing and proper drainage to accommodate water run-off. The remains of a retaining wall seen in the foreground is the subject of section 11 (below).

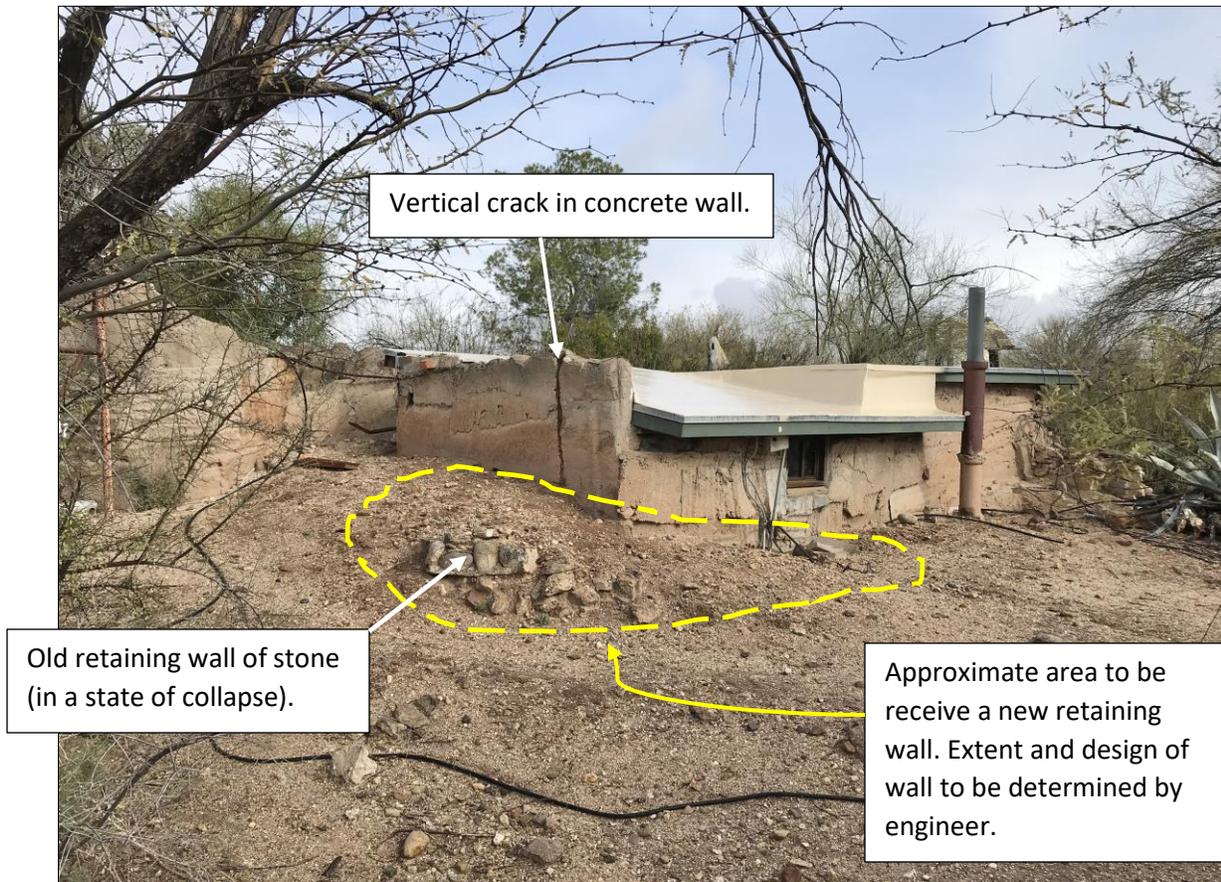
The remains a low rubble stone retaining wall are visible in between the corner of the building and the thin shell wall surrounding the garden. Over many years, wash-down and soil movement have almost obliterated the wall, which is still needed to help hold material back from around the building. This will also help stabilize the corner of the building which exhibits cracking.

Above: View of the southeast corner.

- Install a new retaining wall of suitable design which will also accommodate drainage from the roof area behind.
- A concrete wall is recommended, but this should be faced with stones (per original).

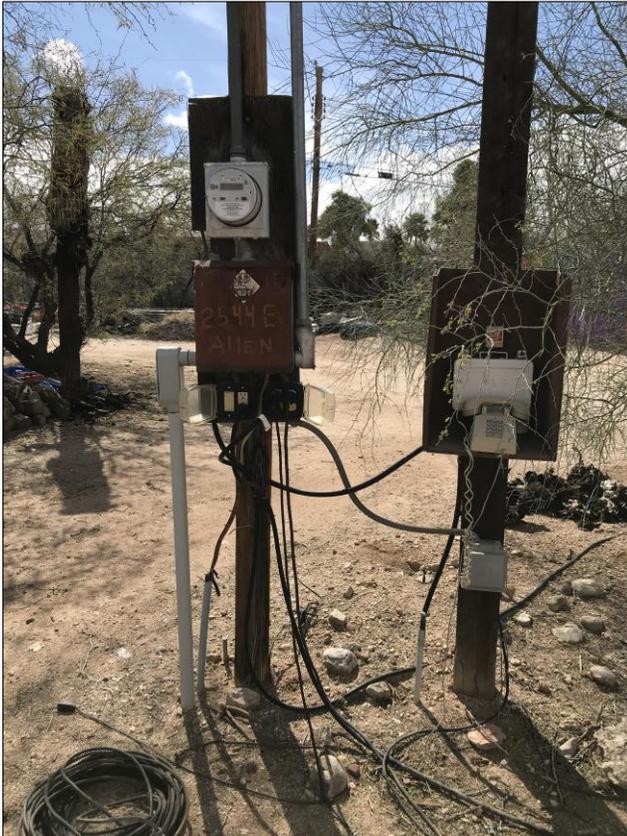
Above:
Electrical Panels mounted on poles just south of the Enchanted Garden Complex. These have a profusion of underground and surface electrical feeds. Some are connected directly into the panel, while others are plugged into outlets, with extension-type cords powering needed systems.

- a. Determine which circuits, fixtures, and string lights are not needed and remove them.
- b. Properly repair those fixtures and systems being kept, and upgrade.
- c. Replace non-LED light bulbs with LED bulbs for improved energy efficiency.

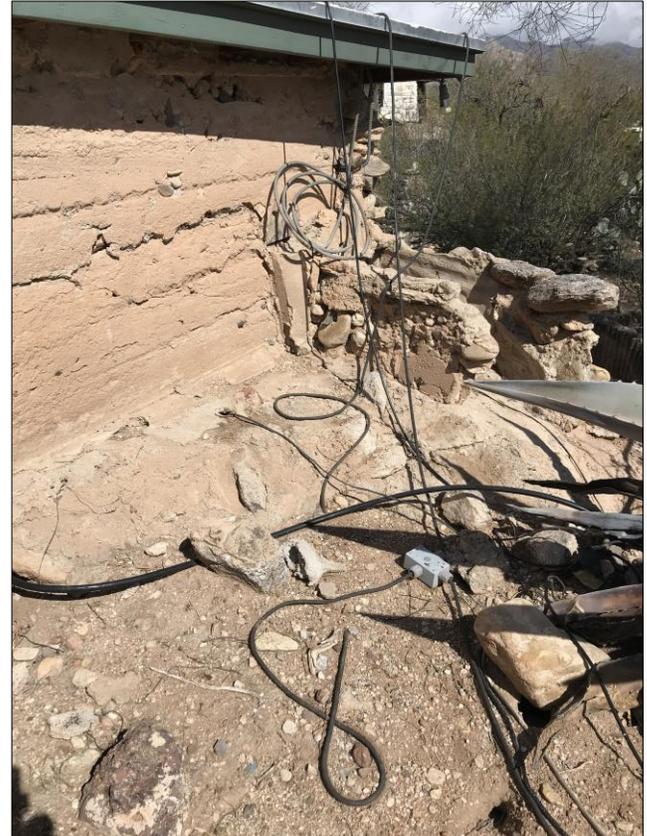
Above:
Example of wiring routes going to the Enchanted Garden complex from the panels (and typical of electrical distribution elsewhere at Valley of the Moon).

Cables laying loose on the ground constitute a hazard to the curious public, as such areas are not cordoned-off.

- d. Ensure exterior cable runs are not a hazard to the public. If necessary, cordon-off areas or pathways where hazards may exist.

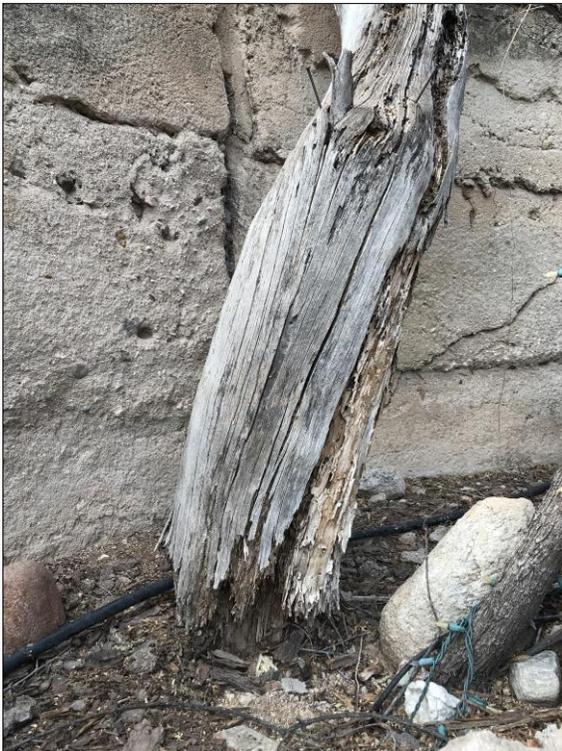
Example of a dead tree in the upper terrace area. Such items should be removed. This will visually clean-up the garden and allow room for new plantings suitable to the microclimate of space.

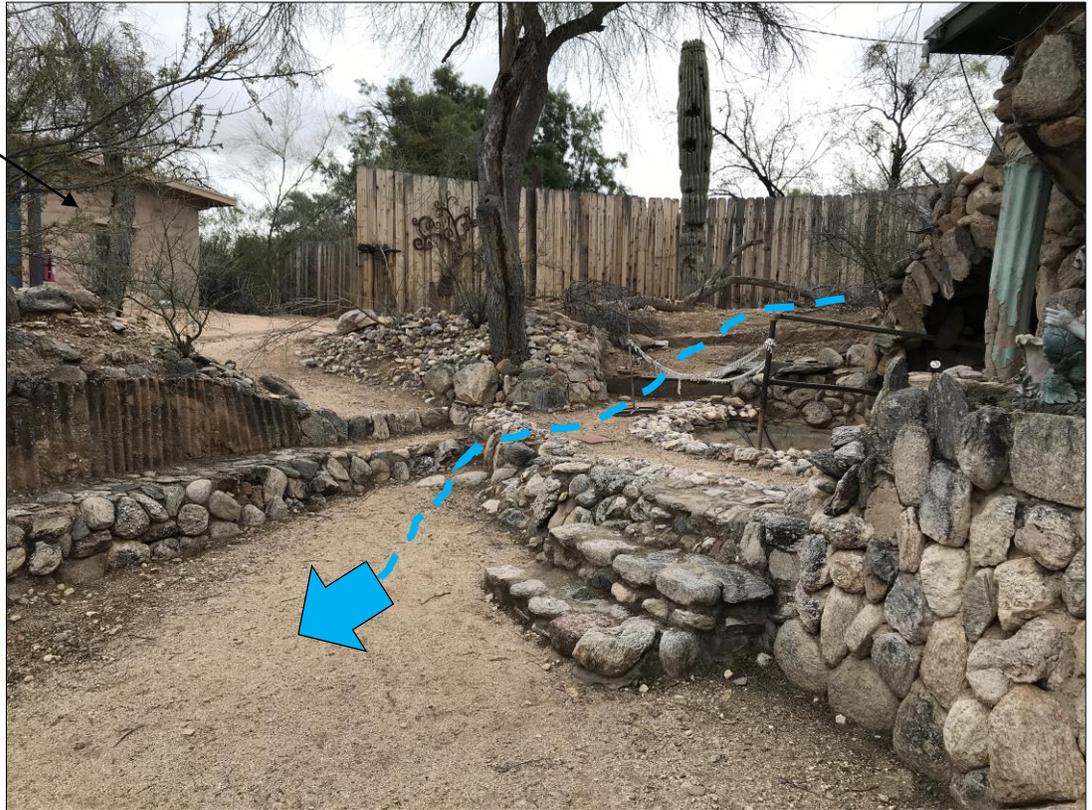
Right: View of the area near the pool and Rabbit Hole Entry.

The blue arrow represents an approximate path of water moving from high to low.

According to Jenni Sunshine, this area contains an important historical water and drainage feature (since partially buried). Further examination of how this feature worked is required before determining if and how it can be re-activated. Should this water feature project be placed on hold, then an intermediate plane must be devised that does not allow water run-off (especially during monsoon rains) to damage walls and other features.

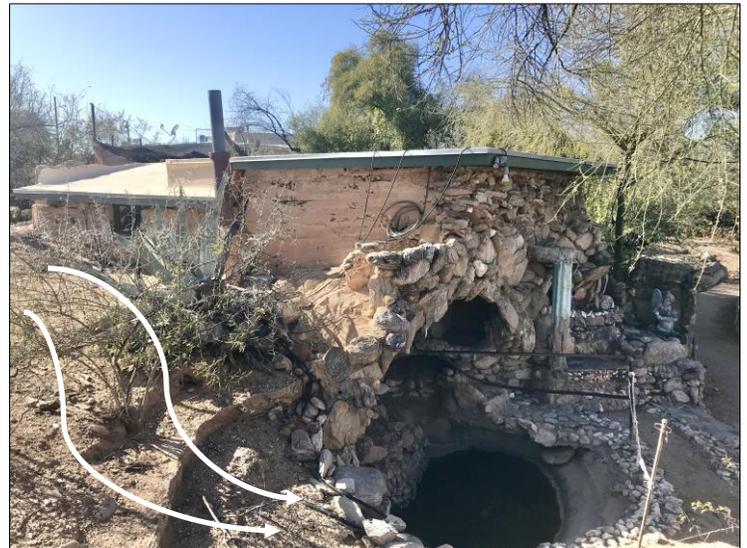
A former waterfall feature (abandoned) is atop the cave entry, and likely was tied in with the internal water feature inside **Room F**. It is recommended this water feature **not** be restored at this time.

Due to ground slope, water run-off is directed to the pool below (white arrows). Improved terracing and directing water to plantings and drainage paths is recommended. Much of this aspect of the landscaping could be accomplished with a clear plan using volunteers under good supervision.

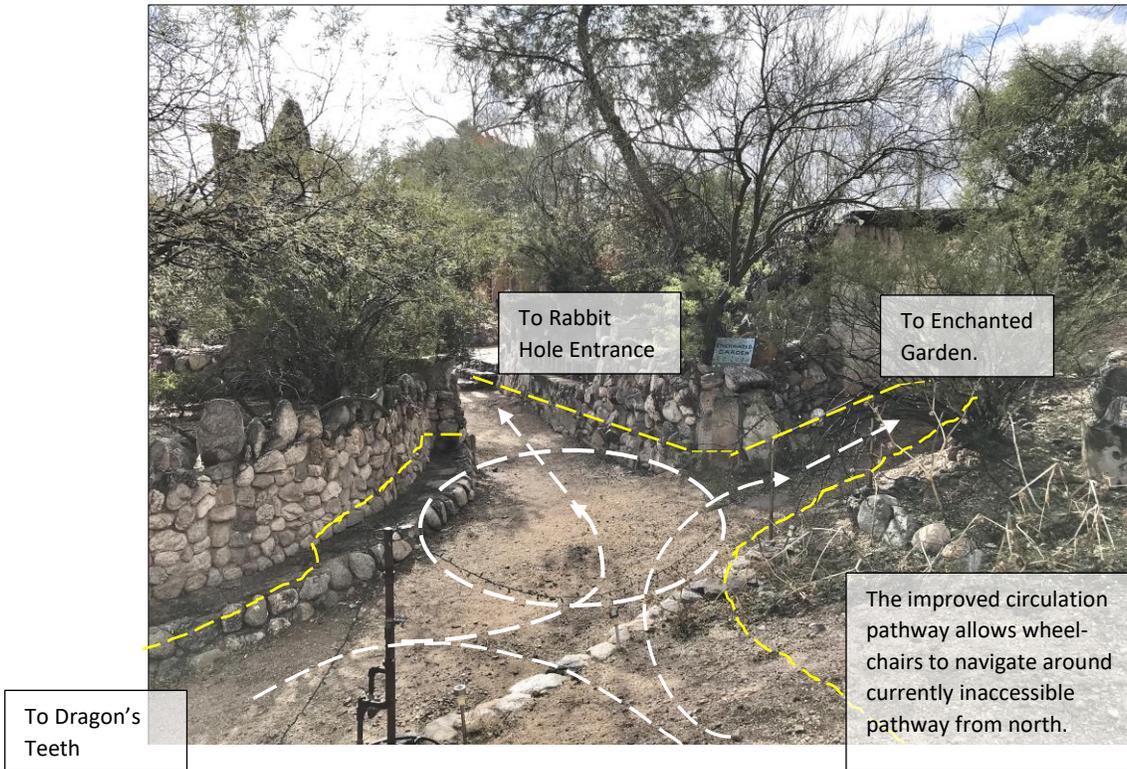
An approximate line (in yellow dashed) showing how a change of grade in the entry area could greatly improve the accessibility of not only the Enchanted Garden, but of surrounding features.

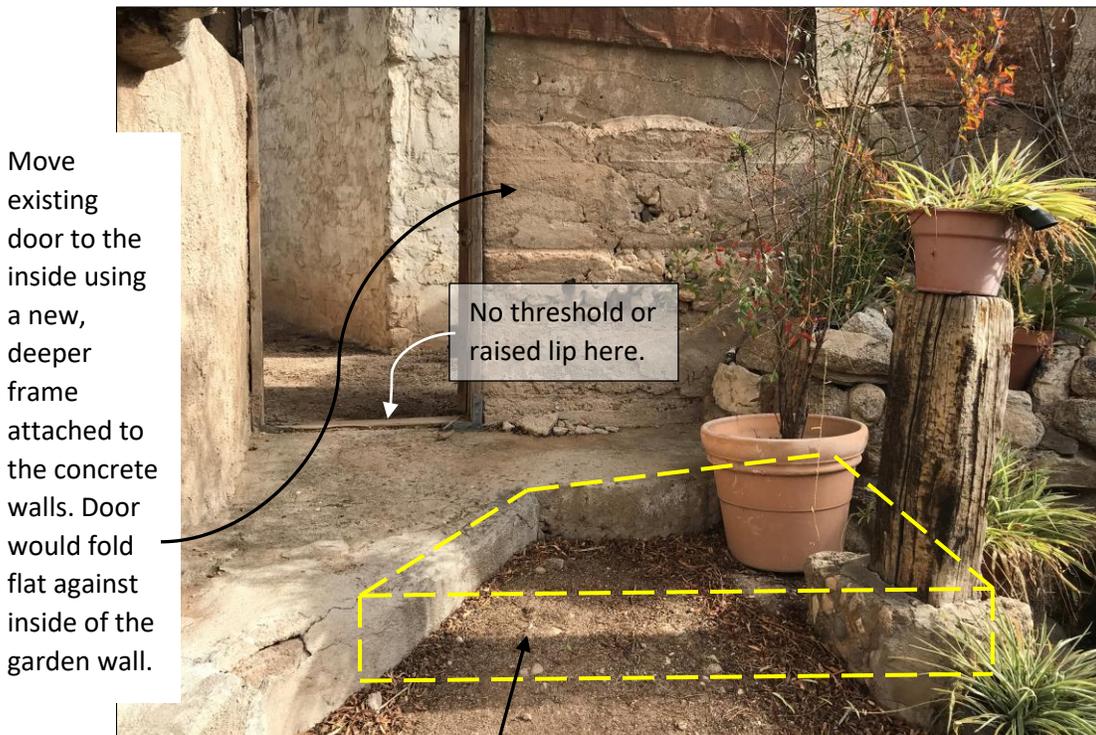
By inserting a raised masonry platform (alternatively one made from treated lumber framing and plastic composite material decking), a wheelchair or walker could be situated just inside the door, still allowing people to circulate in and out of the garden. A partial railing would be needed on the front side to prevent wheelchairs from rolling forward.

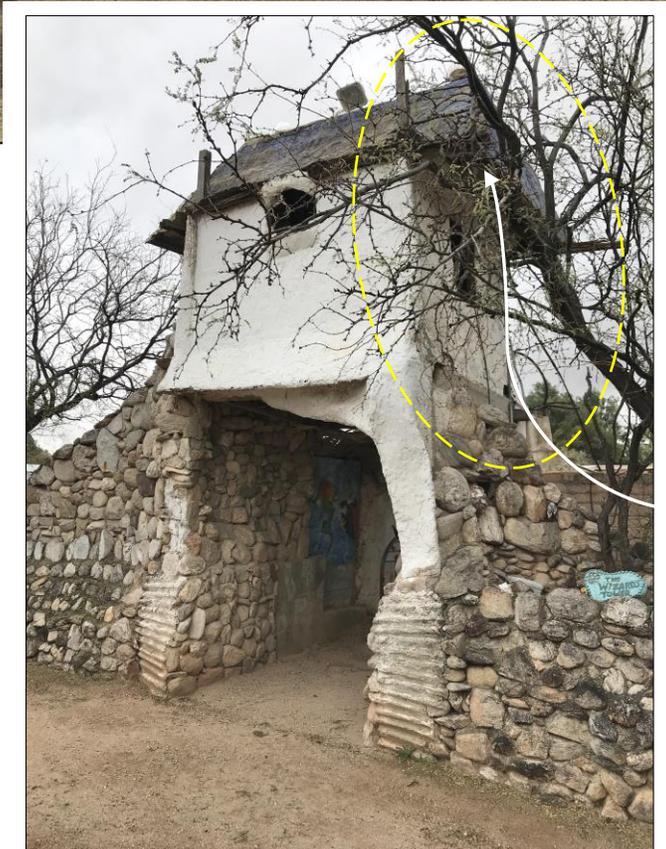
Left:
View of the northwest corner of the front of the Wizard's Tower.

Branches from this tree abrade the structure and must be properly trimmed back.

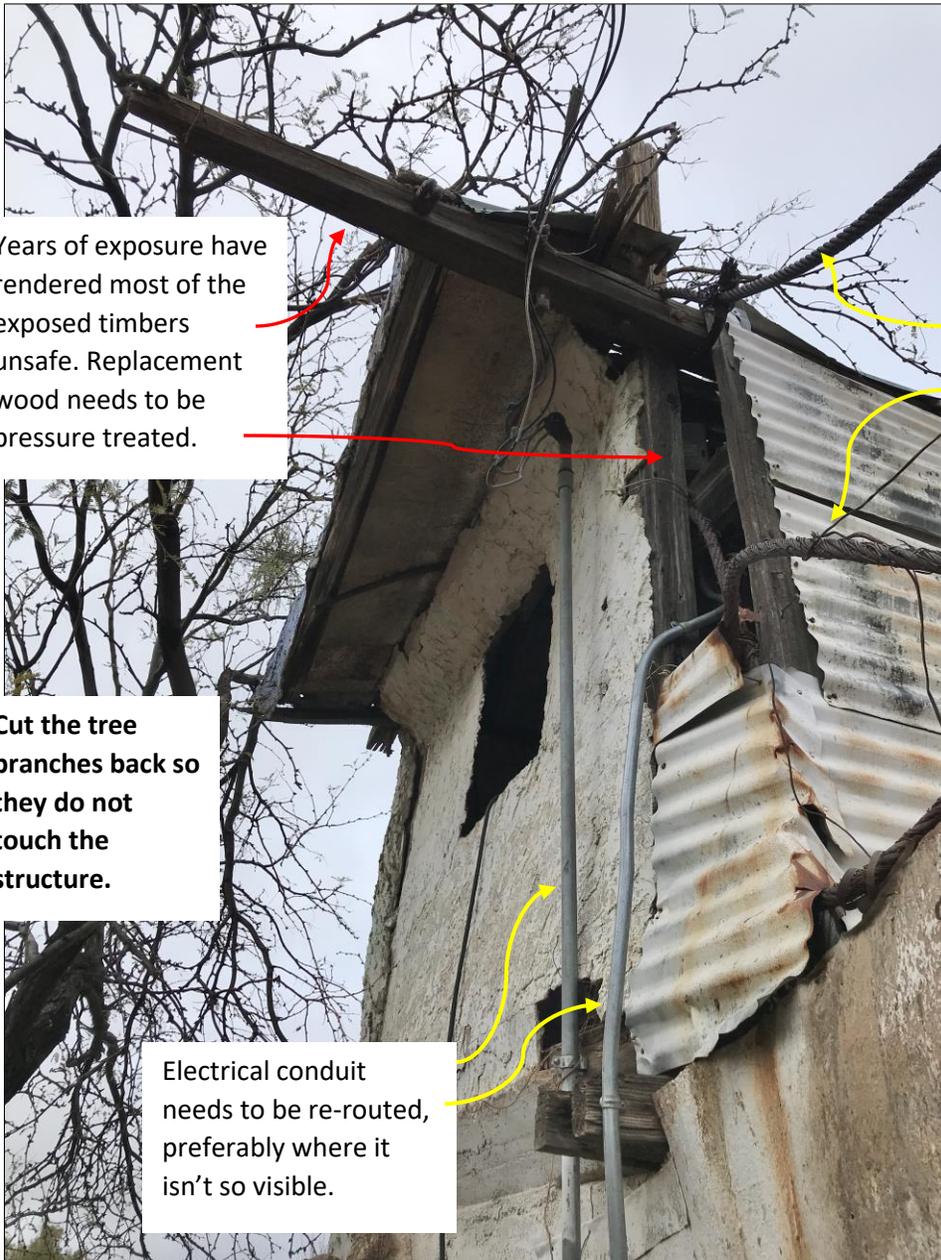
Above: View of southwest corner.

Weather easily enters the tower's structure contributing to years of slow degradation. The repaired structure will need to be capable of keeping the interior dry, but this should also be ventilated.

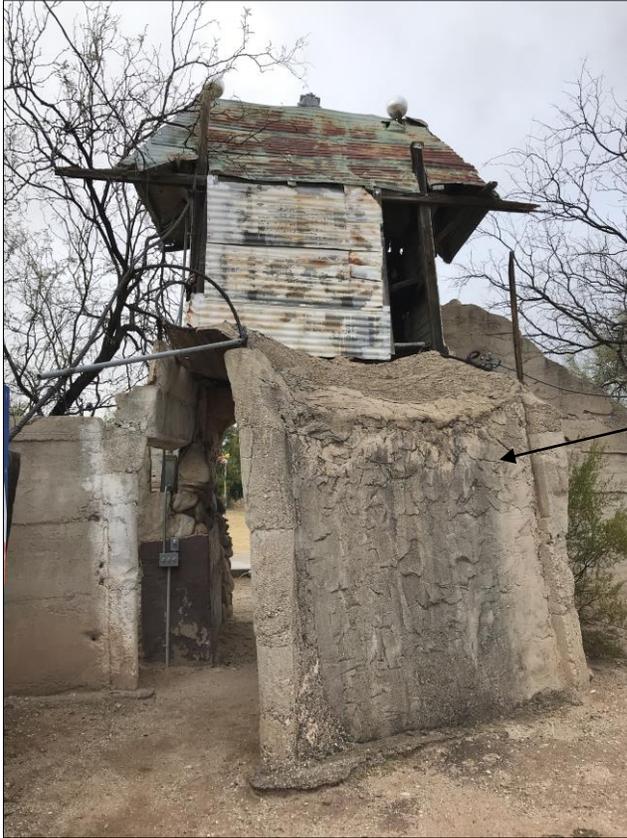
View north of the thin shell concrete shell-like structure attached to the tower.

While the lower portion of the wall is likely salvageable, the roof portion is in a state of collapse and must be replaced. A structural evaluation will determine whether some, or all of this part of the structure must be rebuilt.

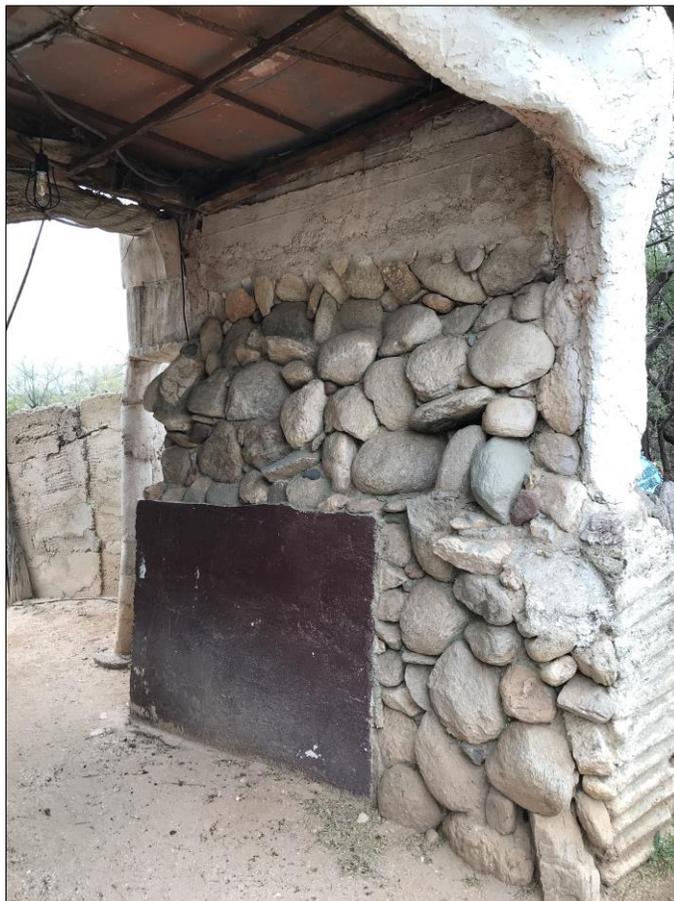
West inner wall of the tower.

The painted surface is cement or concrete. Paint should be carefully removed to determine if a historic mural exists below.

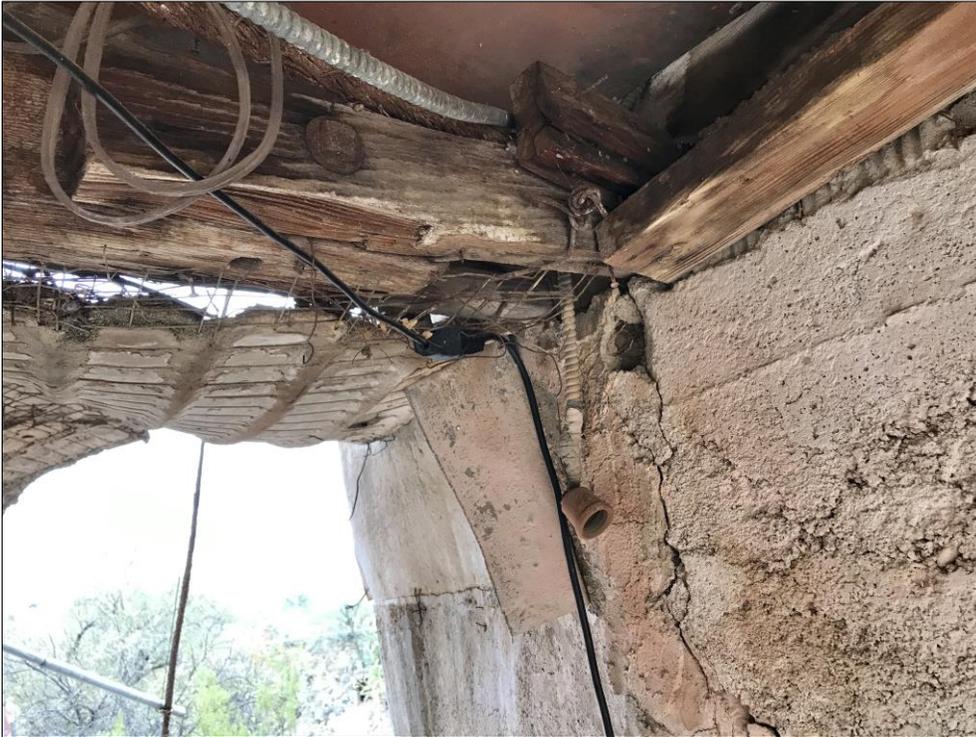
Above: Inside view of southwest corner.

Supporting wood framework is a jumble of discontinuous sections in deteriorating condition. With timbers so compromised, replacement with new material is the only option. A new supporting steel framework is being recommended on which to build a new wooden frame upper structure and roof.

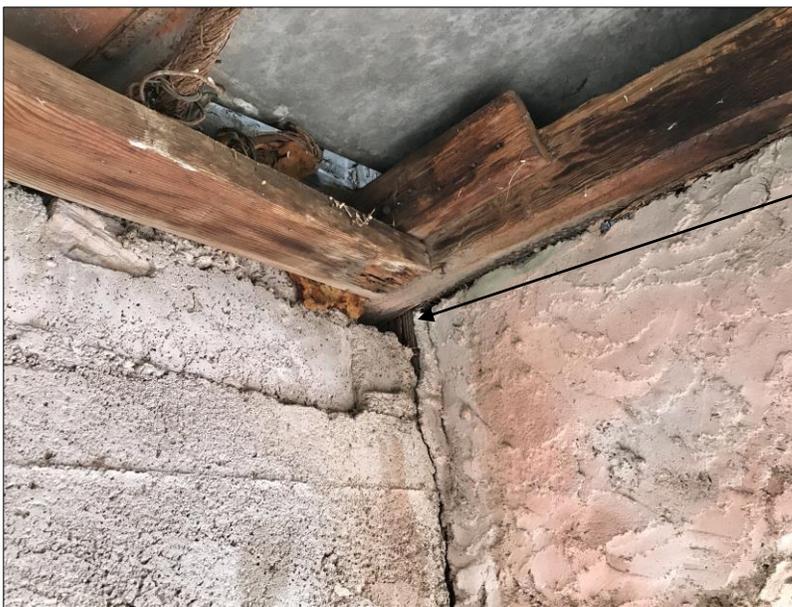
Left: Interior view of northwest corner.

Barely visible in the corner is one of the 4 x 4 wooden post that has been surrounded by masonry materials.

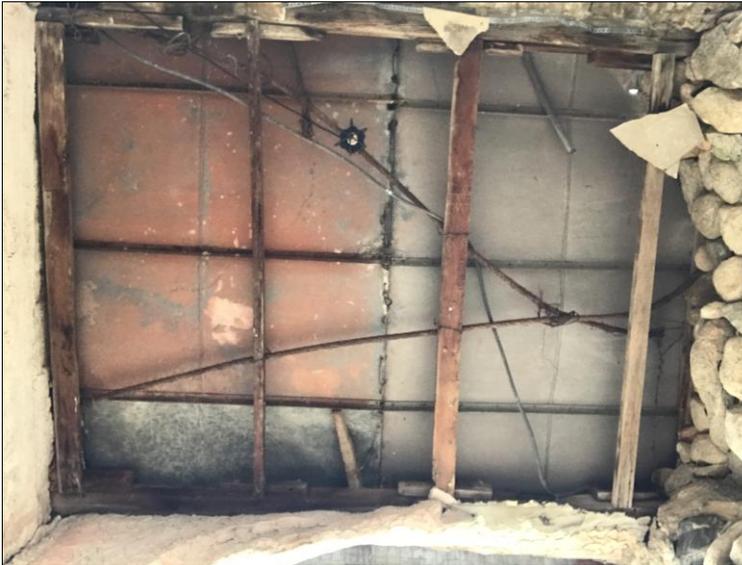
Left:
View looking up at the underside of the floor of the upper room.

The floor material is thin galvanized sheet metal over an under-structured steel bracing over deteriorating wood members.

The floor is unsafe and must be replaced.

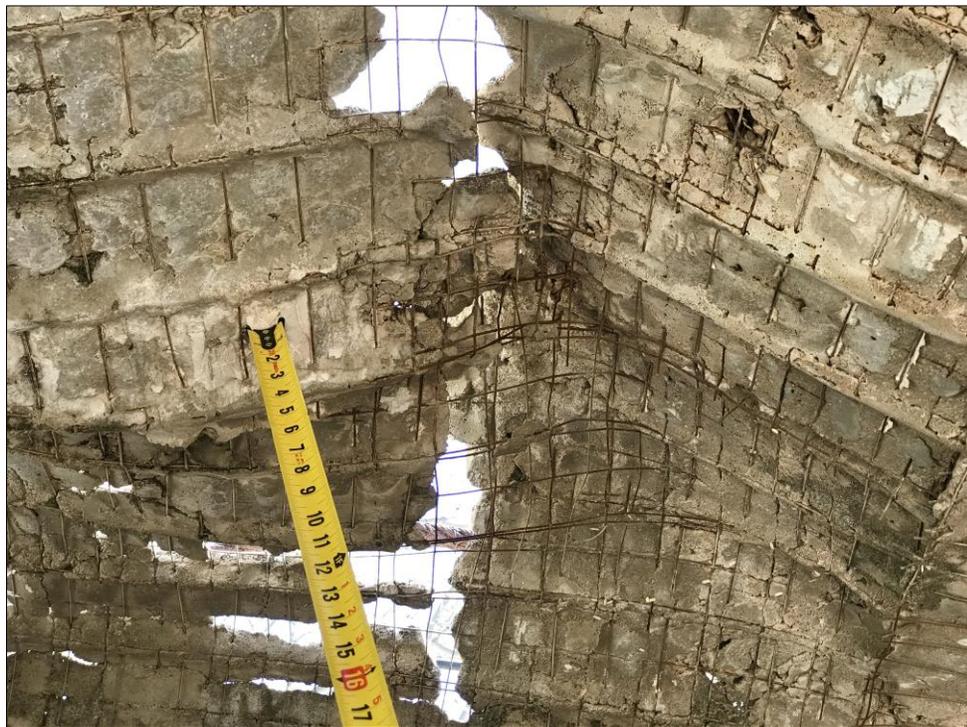
This Page: Views of the roof portion of the thin shell concrete “nave”. The structure is deflecting downward under its own weight and is in a dangerous condition. Many areas of the concrete material have already dislodged and are open to the elements. This portion of the structure should be rebuilt using stronger materials that retain the intended appearance.

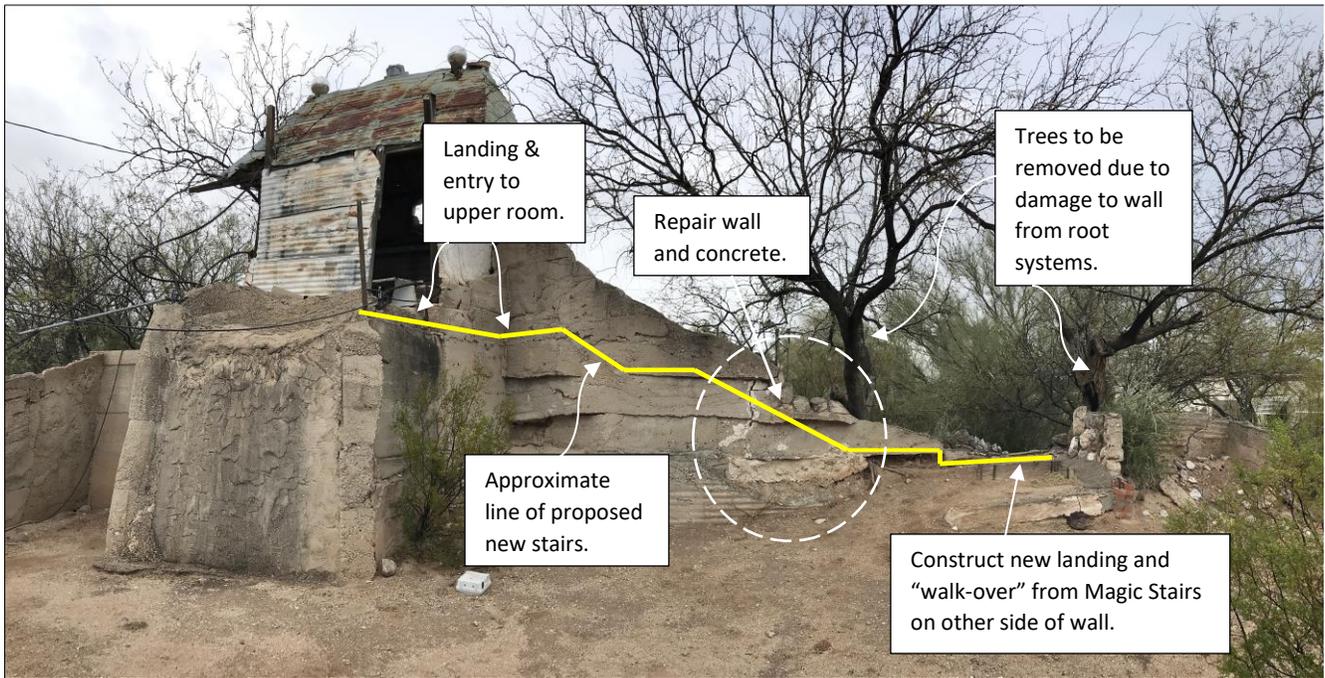
Above: Panoramic photo showing the south side of the Wizard's Tower wall.

It is recommended a new stair be constructed against the concrete wall that provides safe access to the upper room. Unfortunately, both trees will need to be removed, along with as much of their root structures as possible as they are continuing to damage the wall.

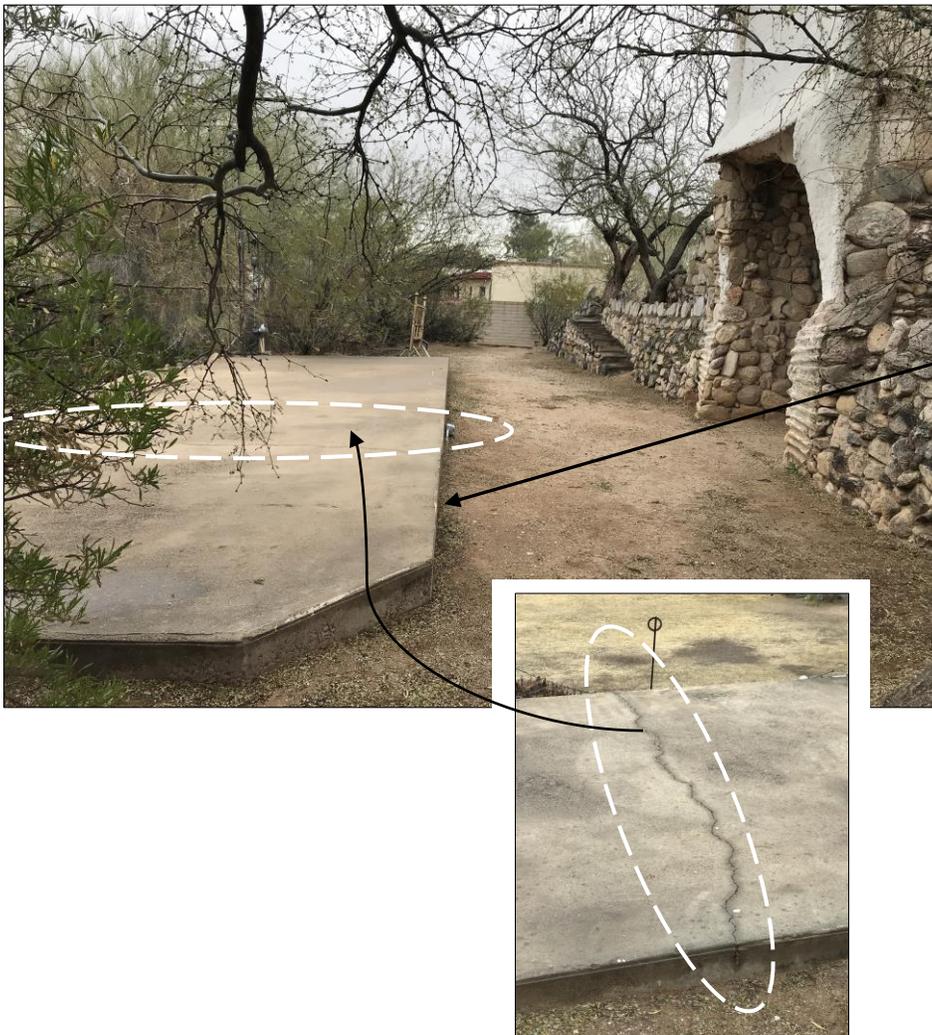
View east of the stage with the Wizard's Tower at right.

The white circle shows the north-south crack in the slab.

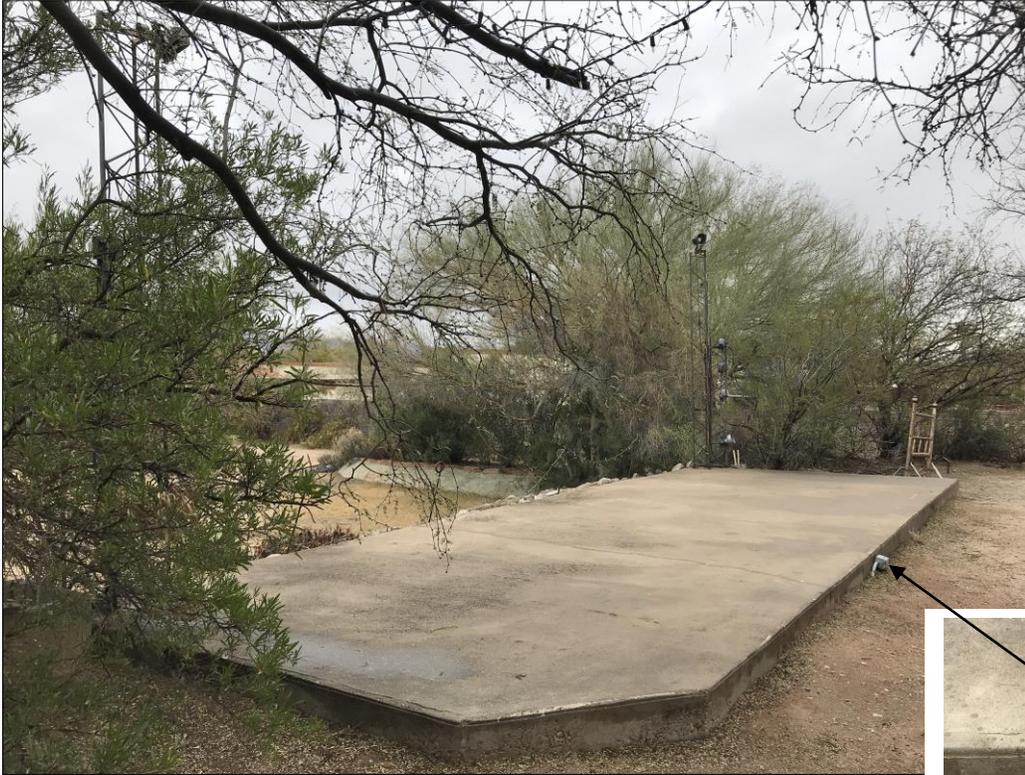
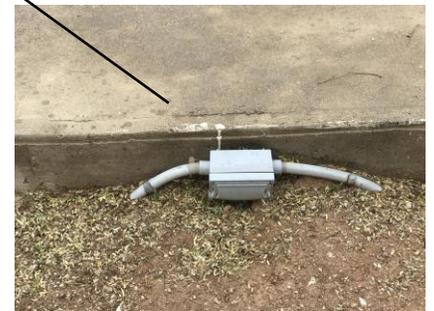
Left:
View northeast of the
concrete slab.

Inset: A two-gang
electrical outlet at the
front of the stage. Over
the years it has been
stepped-on and is
pulling away from the
edge of the slab.

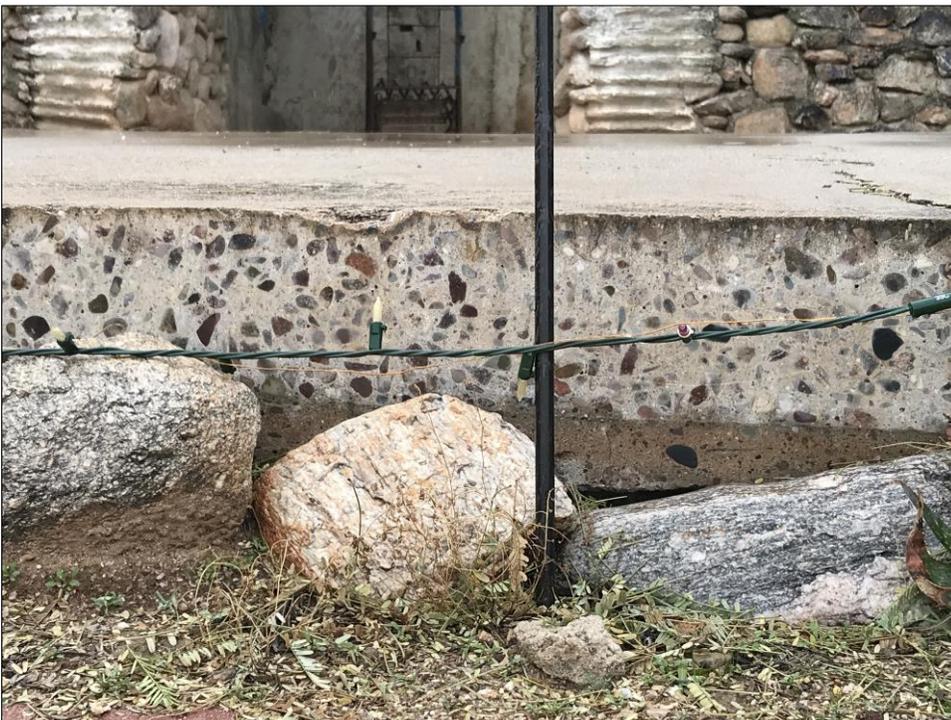
Left:
The front of the concrete
stage was cut back in the
past, exposing the
aggregate. The reason for
the cutback is unknown.
