2022 Strategic Preservation Master Plan

Valley of the Moon

Enchanted Garden, Cathedral Room & Wizard's Tower Complexes

The Cathedral Complex

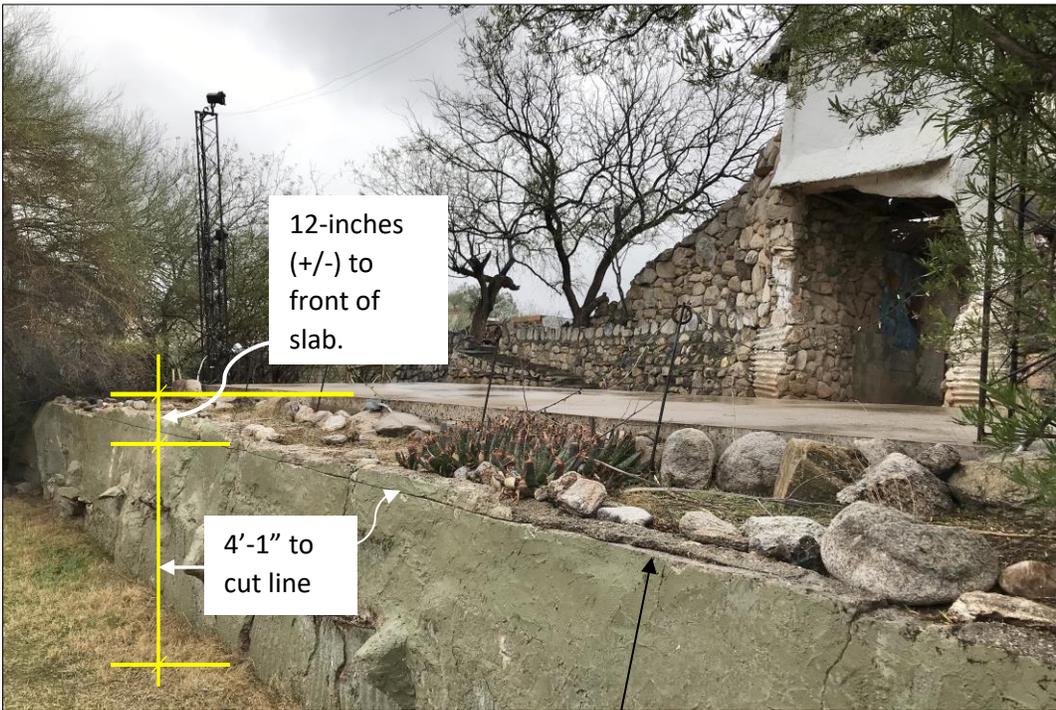
Above: View of stage to the east.

At one time a horizontal saw cut was made in the wall about 4'-1" from the grass, possibly as an effort to lower the height of the wall. Total height from existing concrete stage at rear to grass area below is 5'-1" (approximately). The concrete stage ends some 36-inches from the wall, preventing performers from getting close to the edge.

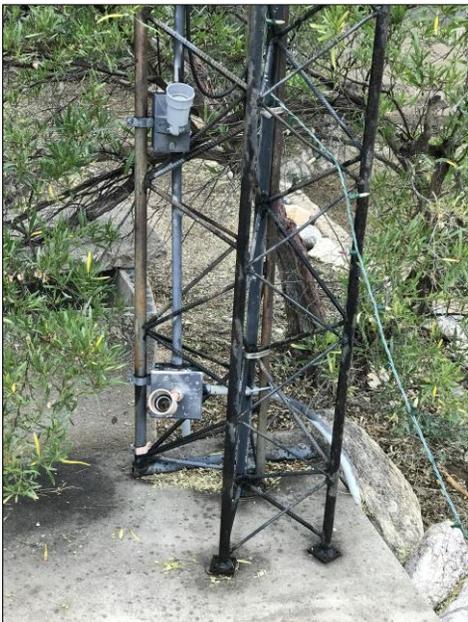
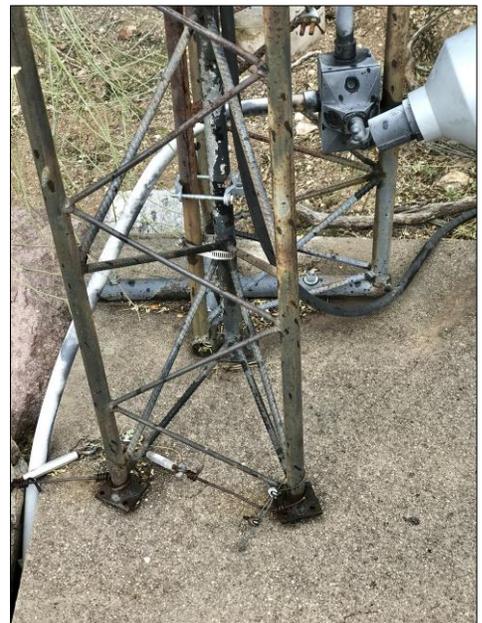
Left & Right: Both the west lighting pylon (above) and the east pylon appear to be re-purposed welded towers and contain a variety of lighting fixtures. Much repaired over the years, they could continue to serve, or be replaced.

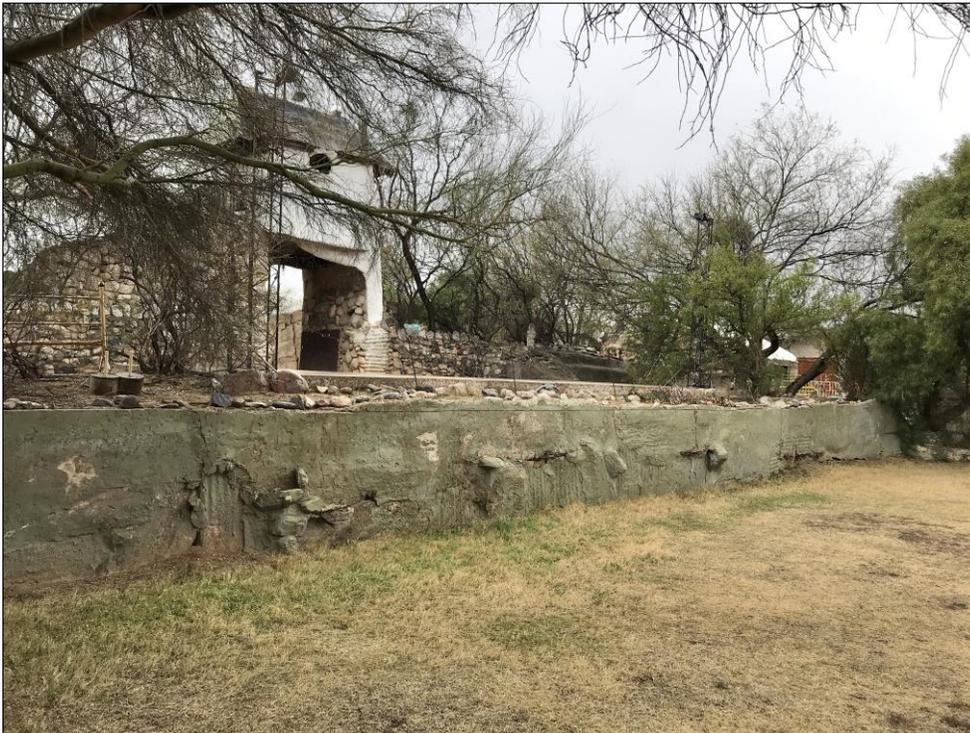
Left: Front of the wall view to the southwest.

The entire length of the wall is approximately 72ft. section with the center “exposed” center section approximately 62 ft.

The wall was painted a dark green but was originally exposed concrete with natural stones protruding.

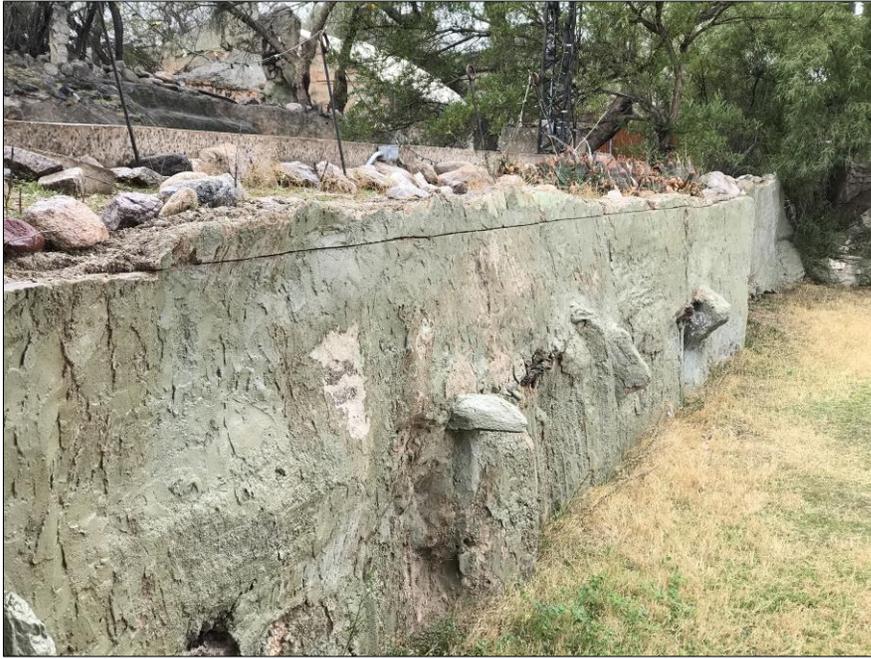
Detail of part of the wall with the horizontal saw-cut showing. Portions of the upper cut of material have been removed.

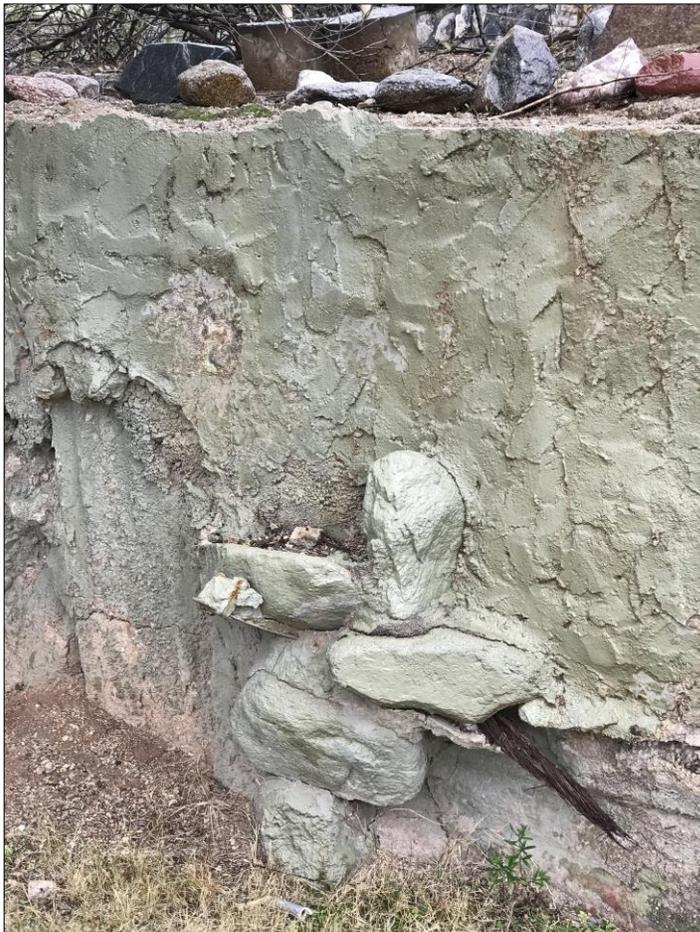
Detail of the wall showing rough formwork for the concrete, with additional stucco applied to the outer surface (likely non original).

Heavy mining cable can be seen weaving in and out of the wall. In the reconstruction (Option Two), it is recommended this not be re-used, as the cable is rusted and frayed and potentially dangerous to the public, especially children.

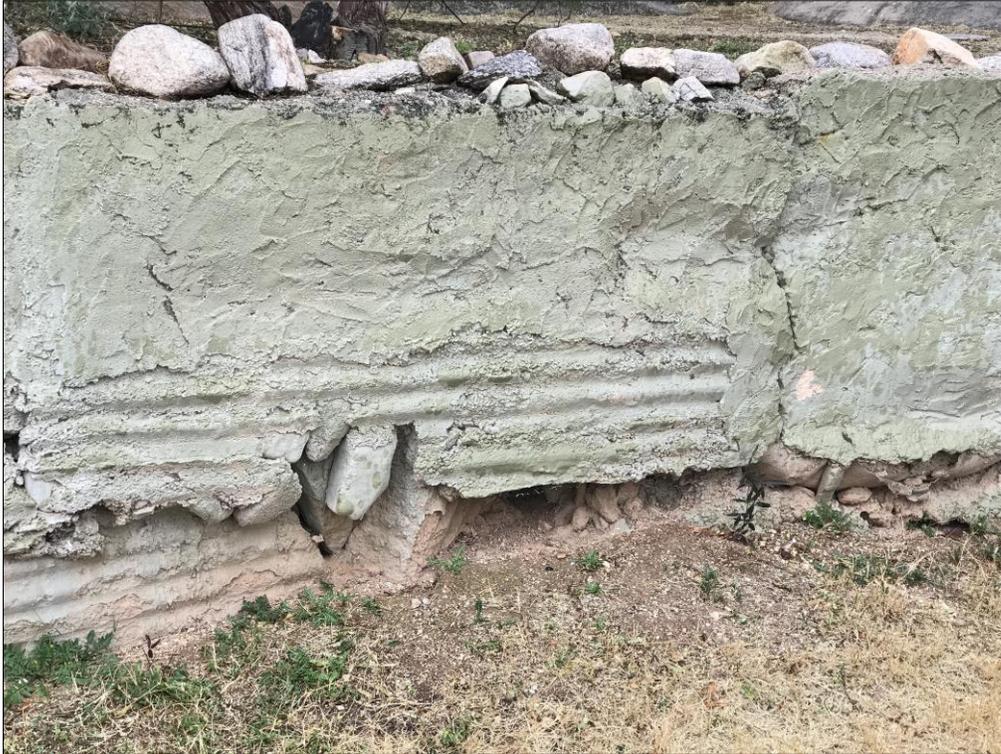
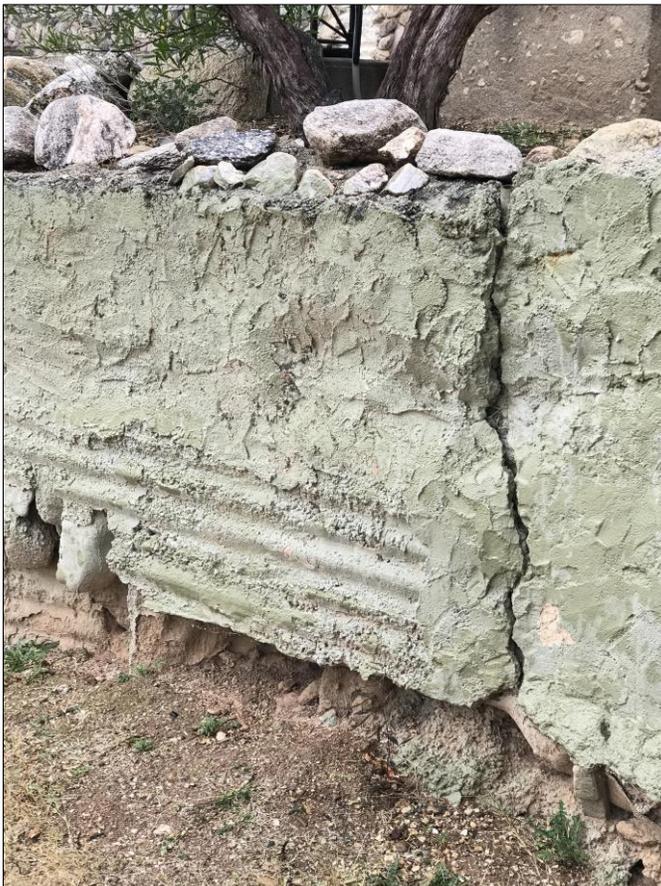
Detail of deteriorated section of the wall (toward the west side).

Vertical cracking, undermining of the footing, and multiple patch repairs indicate movement and weakness of the wall.

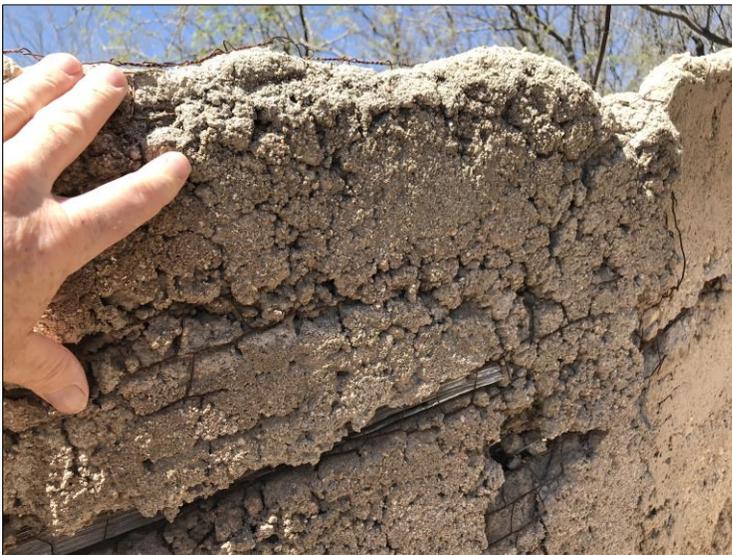
Left: The thin shell concrete wall near the tower.

The wall is in a very fragile condition, with large sections loose or missing. The section shown here could easily be moved by hand, held only by the chicken wire reinforcement. With time, this piece will fall.

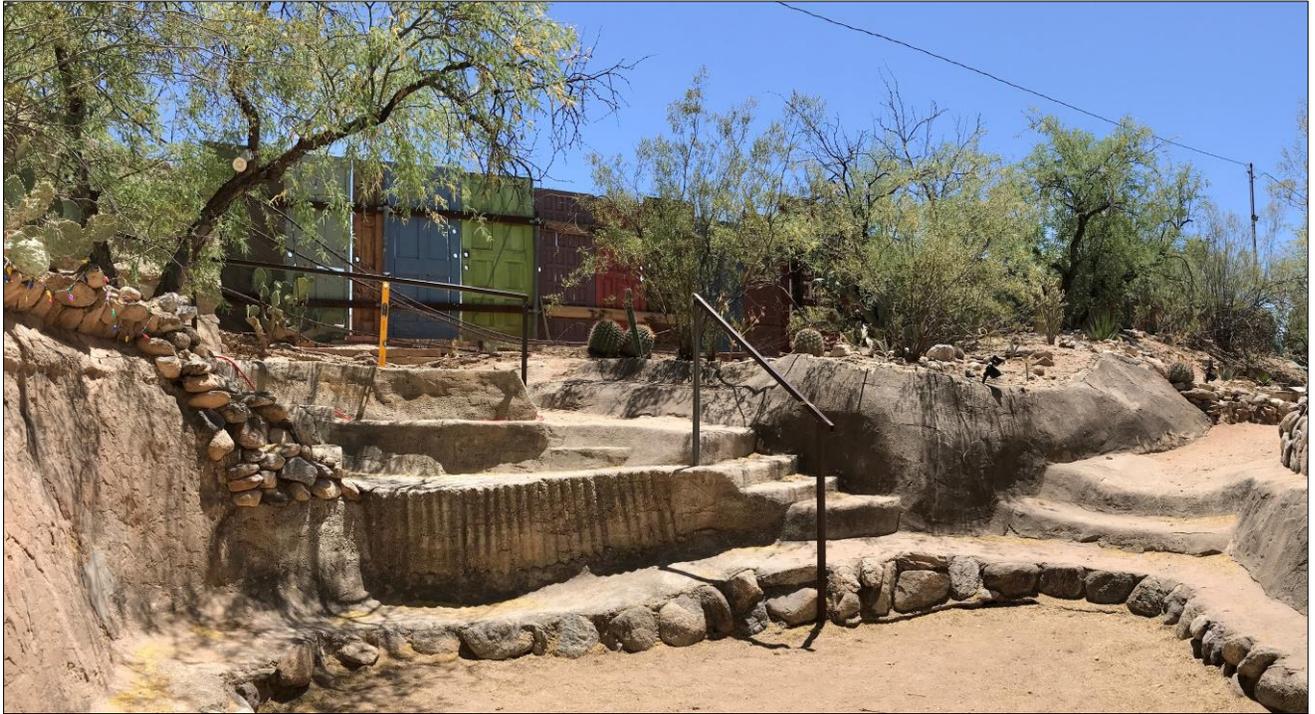
Above: View east of the "wall of doors" from the Pennyland amphitheater area.

The doors shield views to and from the space but are something of a visual intrusion. It is recommended this wall be constructed of formed concrete (similar in character to the deteriorating historic section to the north). Native plantings will further reduce any impact and "soften" the area.

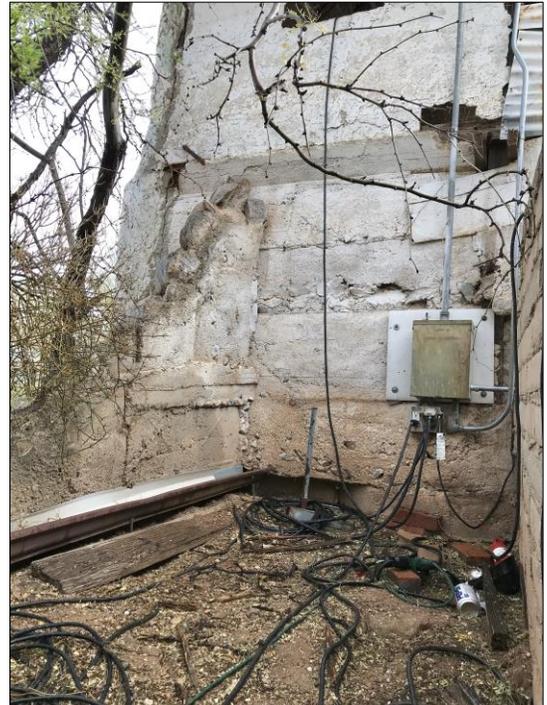
A multitude of electrical cables plug into sockets below the panel.

There is an urgent need to upgrade the electrical system and make it safe for users and the public.
